Punalu‘u Beach Restoration Feasibility Study

Punalu‘u Beach Park, O‘ahu

April 2024

Sea Engineering, Inc.
Makai Research Pier
41-305 Kalaniana‘ole Hwy
Waimānalo, Hawai‘i 96795

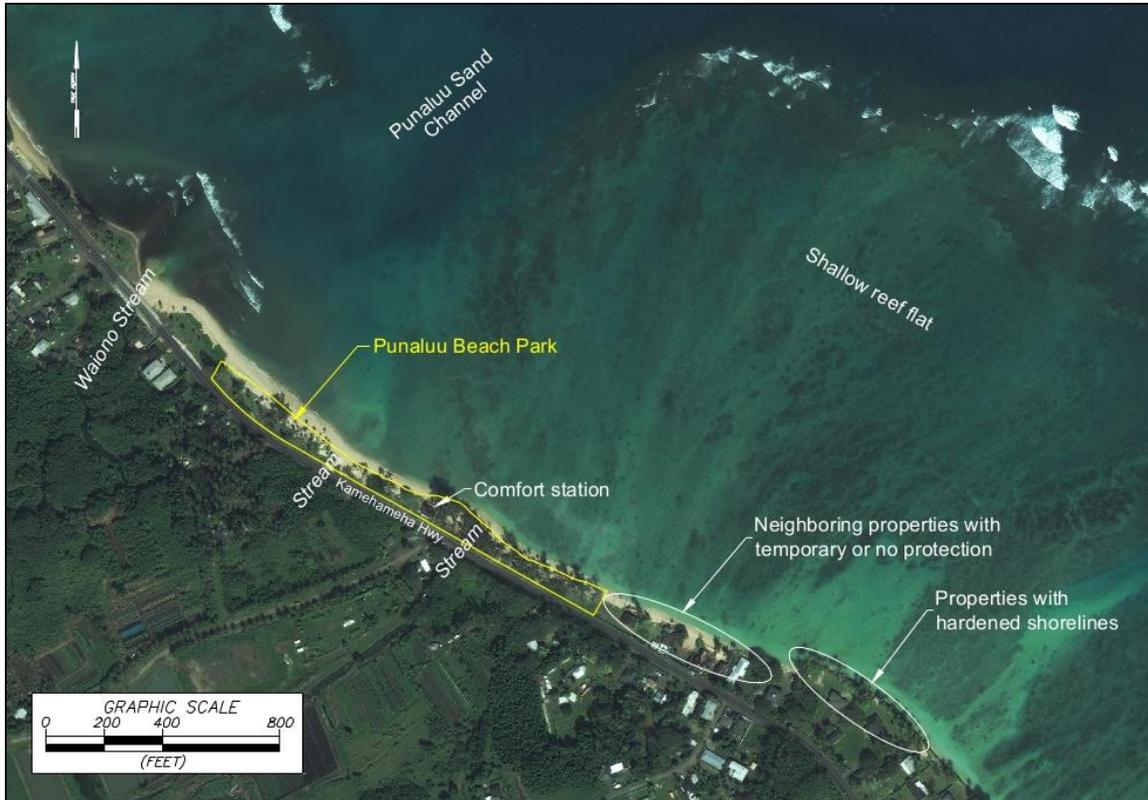
Figure 3-1. Punalu‘u Beach Park site map (regional view)

The Punalu‘u Beach Park shoreline is fronted by a shallow reef that extends nearly 2,000 ft offshore along most of the park. LiDAR and topographic survey data shows that depths measured over the reef are typically 3 to 5 ft below mean sea level (MSL), occasionally reaching 6 ft. Offshore of this reef is the open ocean. The dominant wave energy is produced by the northeast tradewinds and north swell. The shallow reef dissipates a high percentage of the offshore wave energy through broken waves. The waves over the reef are depth limited, meaning that the maximum wave height is a function of water depth. More wave energy can impact the shoreline at higher water levels. At low tide, very little wave energy was observed reaching the shoreline.

North of the park, a deep paleo channel, referred to as the Punalu‘u Sand Channel, extends from the mouth of Wai‘ono Stream and divides the fringing reef. The offshore substrate in this region includes alluvial basalt cobbles and boulders that are likely derived from the nearby streams.

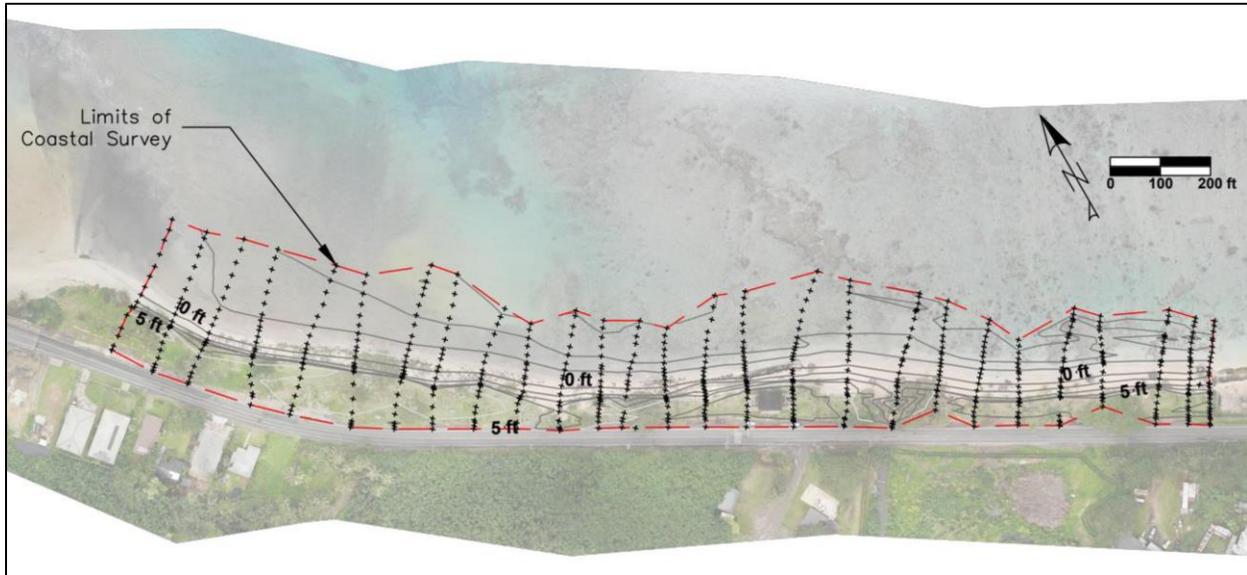
Figure 3-2. SEI topographic survey points and contours overlaid on drone aerial mosaic (survey and drone image date: November 22, 2022)

SEI completed an aerial drone and topographic survey of the Punalu‘u shoreline on November 22, 2022. Beach profile data was collected at approximately 50 ft spacing along the shoreline using a Real-Time Kinematic (RTK) Global Positioning System (GPS). A drone aerial photographic survey was conducted concurrently with the topographic survey and the photographs collected by the drone were compiled together to produce a detailed aerial mosaic of the Punalu‘u study area. Figure 3-2 shows the beach survey points and contours overlaid on the collected drone mosaic. Beach sand samples were also collected at six (6) locations along the shoreline. These sand samples were analyzed for grain size and turbidity which is discussed in Sections 7.3 and 7.6 of this report.

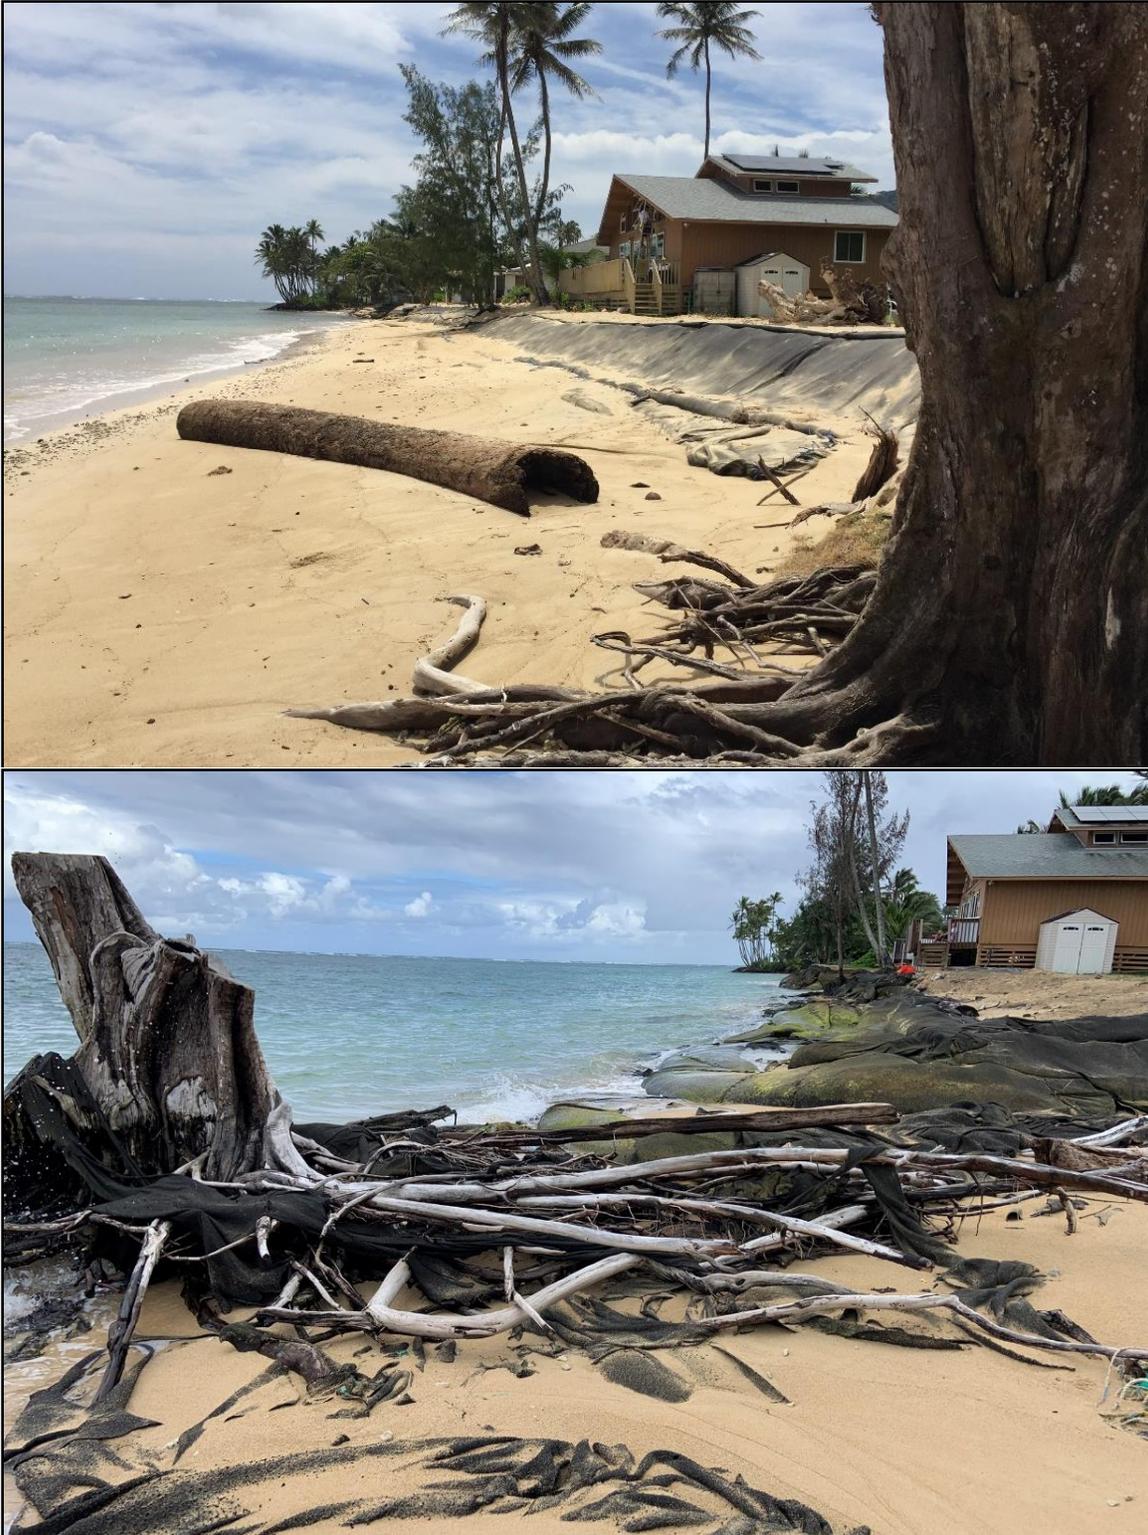
Figure 3-3. Comparison of shoreline south of Punalu'u Beach Park in April 2018 (top photo) and November 2022 (bottom photo)

South of Punalu‘u Beach Park, the shoreline fronts eight private parcels which have employed various erosion control measures to protect against chronic beach erosion in this area. Figure 3-3 shows a comparison between April 2018 and November 2022 of some of the erosion control attempts fronting the private homes and the evident beach loss since 2018. These measures may have slowed the land loss due to erosion; however, most are showing signs of failure and the beach is narrow or completely eroded fronting the structures. A wooden fence, shown in Figure 3-4, separates the beach park from these private parcels. A more recent photo from April 2024, shows part of the fence, erosion control measures, and house have been removed from the property to the south (Figure 3-5) since the initial site visit in 2022.

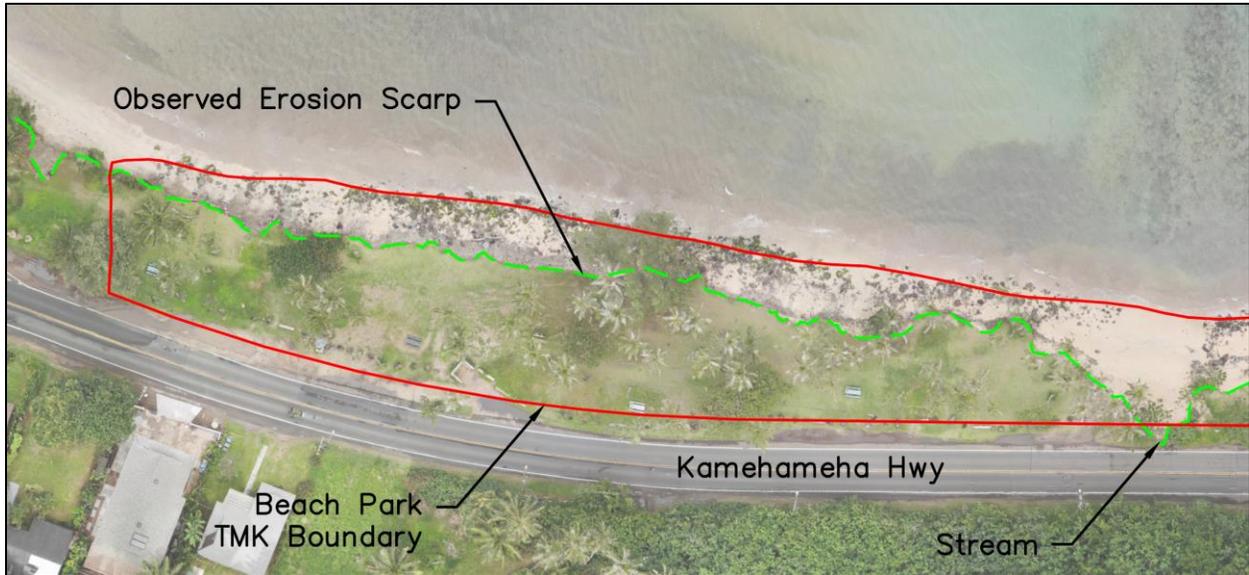
Figure 3-11. Drone mosaic overview of northern area of beach park (November 22, 2022)

The northern portion of Punalu‘u Beach Park consists of the area between the ephemeral stream (or may be better described as a drainage ditch or outfall) north of the comfort station and the northern limit of the beach park as shown in Figure 3-11. An erosion scarp is evident along this entire region. Backshore elevations in this area are generally lower than the central and southern area of the park with elevations between about +4.5 and +5.5 ft MSL. However, the width of the backshore between the edge of road and observed erosion scarp is greater in this area compared to the central and southern areas with widths between about 30 and 90 ft. The shoreline in this area had little to no beach sand during the time of the survey and was dominated by basalt boulders between the erosion scarp and the water line. Figure 3-12 shows a comparison of the shoreline between March 2019 and November 2022. The offshore is composed of basalt gravel and cobbles as opposed to limestone reef fronting most of the beach park. This condition begins at the ephemeral stream and continues northward beyond Wai‘ono Stream. The Punalu‘u sand channel comes close to the shoreline near the ephemeral stream where nearshore water depths are slightly deeper due to the presence of this channel. The sand channel is likely a paleochannel historically when sea level was lower.

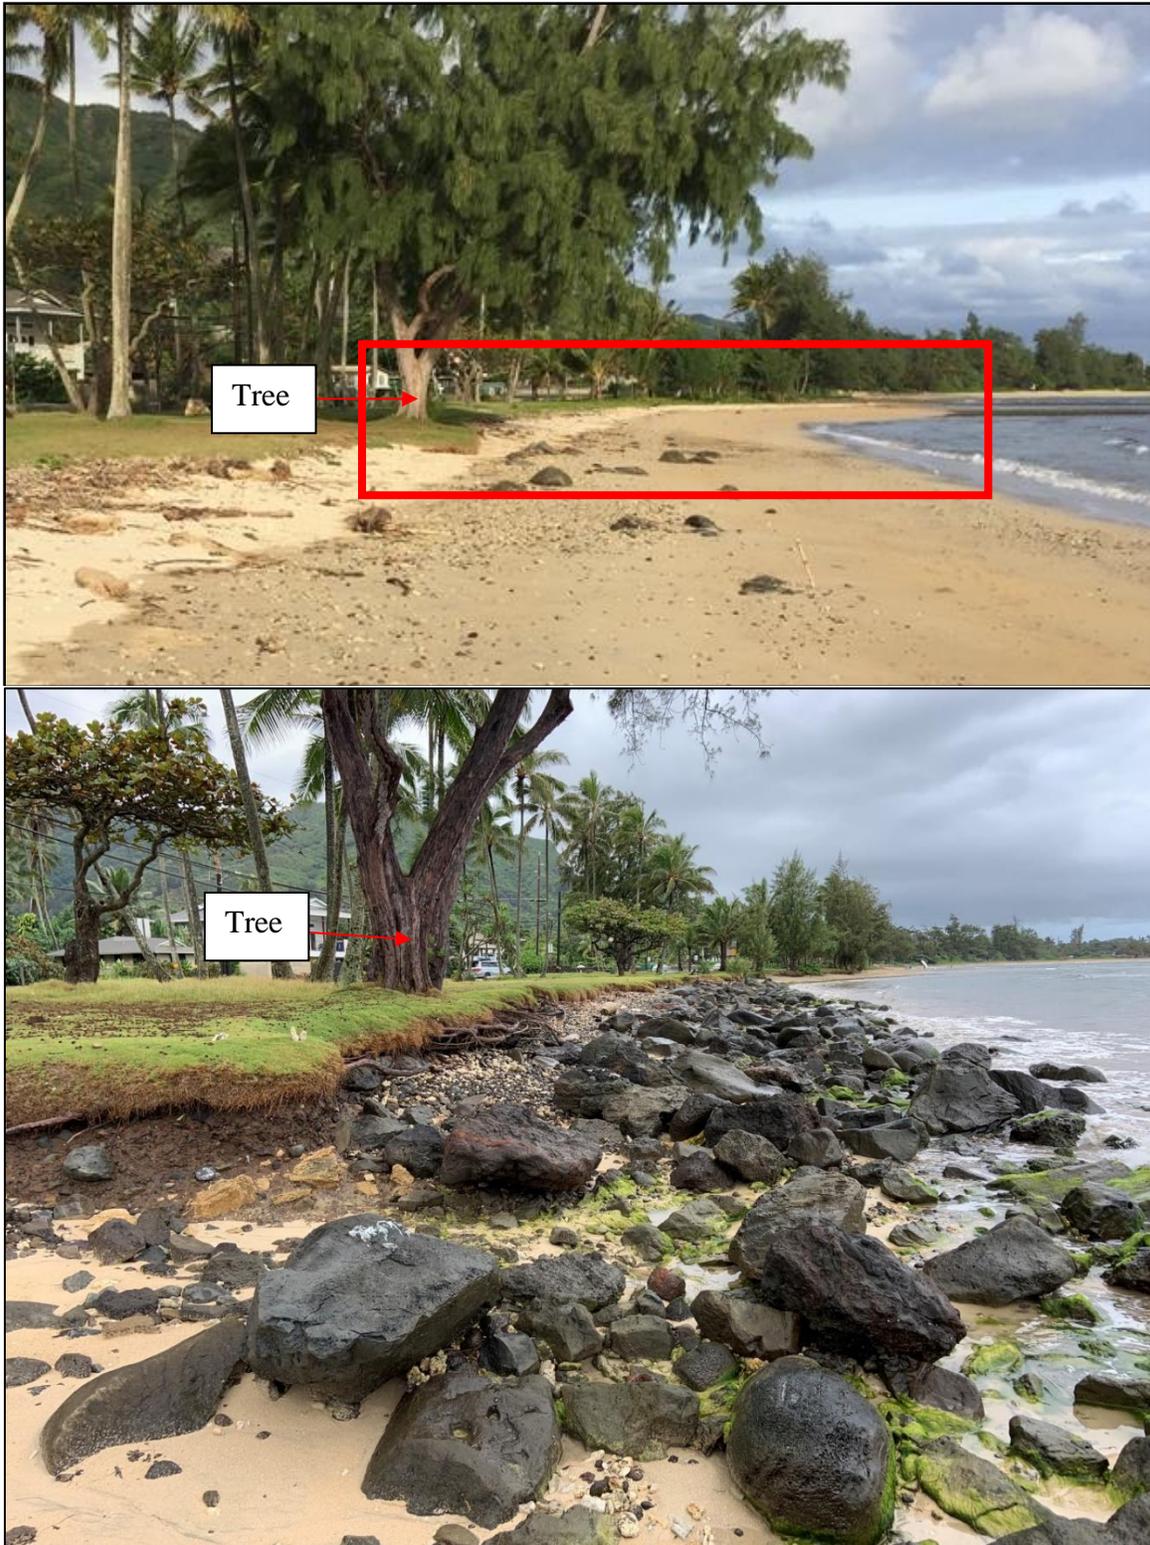
Figure 3-12 . Comparison of northern area shoreline in March 2019 (top photo) and November 2022 (bottom photo)

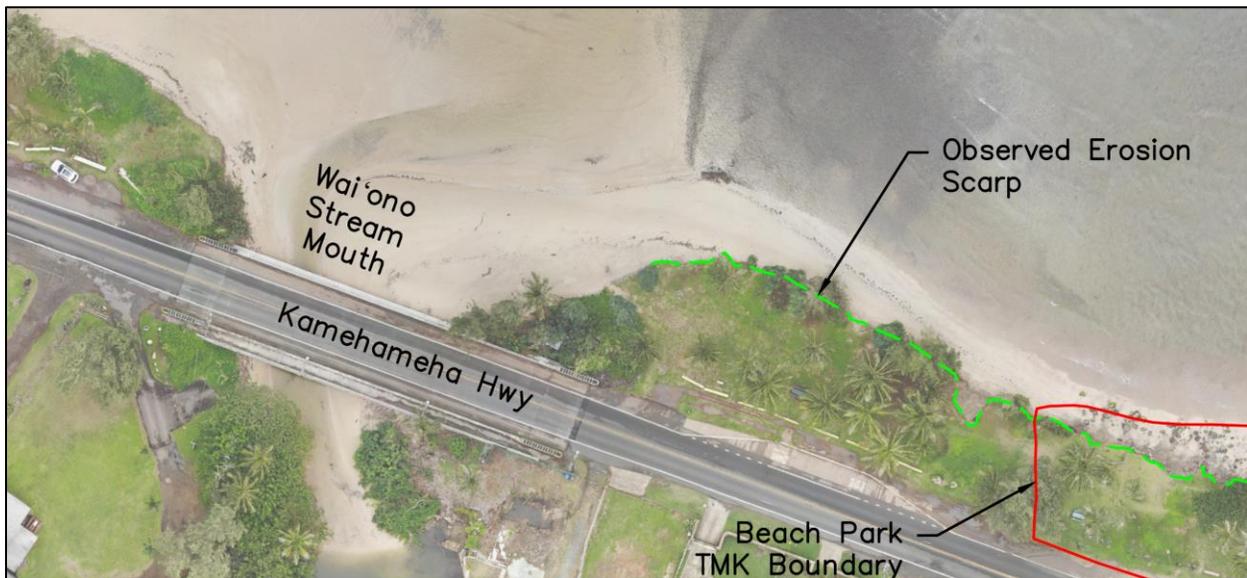
Figure 3-13. Drone mosaic overview north of beach park (November 22, 2022)

The area north of the beach park is shown in Figure 3-13. The backshore in this area served as a construction staging area and temporary road realignment for the South Punalu'u Bridge replacement project completed in 2012. The project utilized a temporary steel bridge makai of the bridge replacement which required removal of much of the backshore vegetation in the area. The area was re-vegetated at the end of the project and heavily irrigated. Figure 3-14 shows a comparison of the vegetated shoreline in March 2019 and April 2024. It is evident from the comparison that the vegetated berm has receded, and the thick plant beds no longer exist between the sand beach and backshore area. An erosion scarp now exists between the beach and the backshore in this area. Figure 3-15 shows the beach further north on the south side of Wai'ono Stream. This area showed no signs of an erosion scarp but frequent overwash in this area has deposited fresh sand and limited vegetative growth. Signs of sand accumulation coupled with offshore sand transport from stream discharge was evident fronting the Wai'ono Stream mouth.

The offshore substrate north of the beach park is composed of basalt gravel and cobbles as opposed to limestone reef fronting most of the beach park. This condition begins at the ephemeral stream and continues northward beyond Wai'ono Stream.

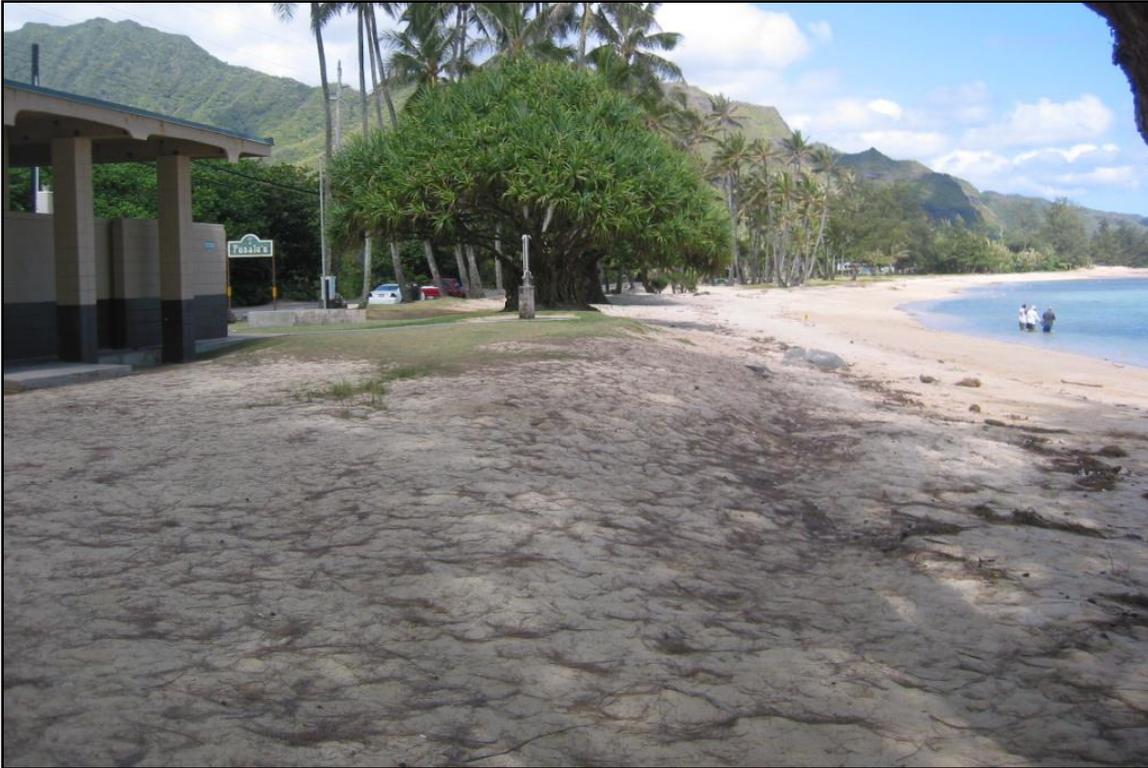
Figure 4-4. Comfort station vegetation line (August 2008)

There have been significant episodic chronic problems in the area fronting the comfort station, as evidenced by both the elevation of the erosion scarp and the presence of the temporary armoring along the face. A series of photographs are presented that show the dynamic nature of the shoreline fronting the comfort station. Figure 4-4 **Error! Reference source not found.** was taken in August of 2008 and shows the gradual transition from backshore to the beach. There was no scarp apparent

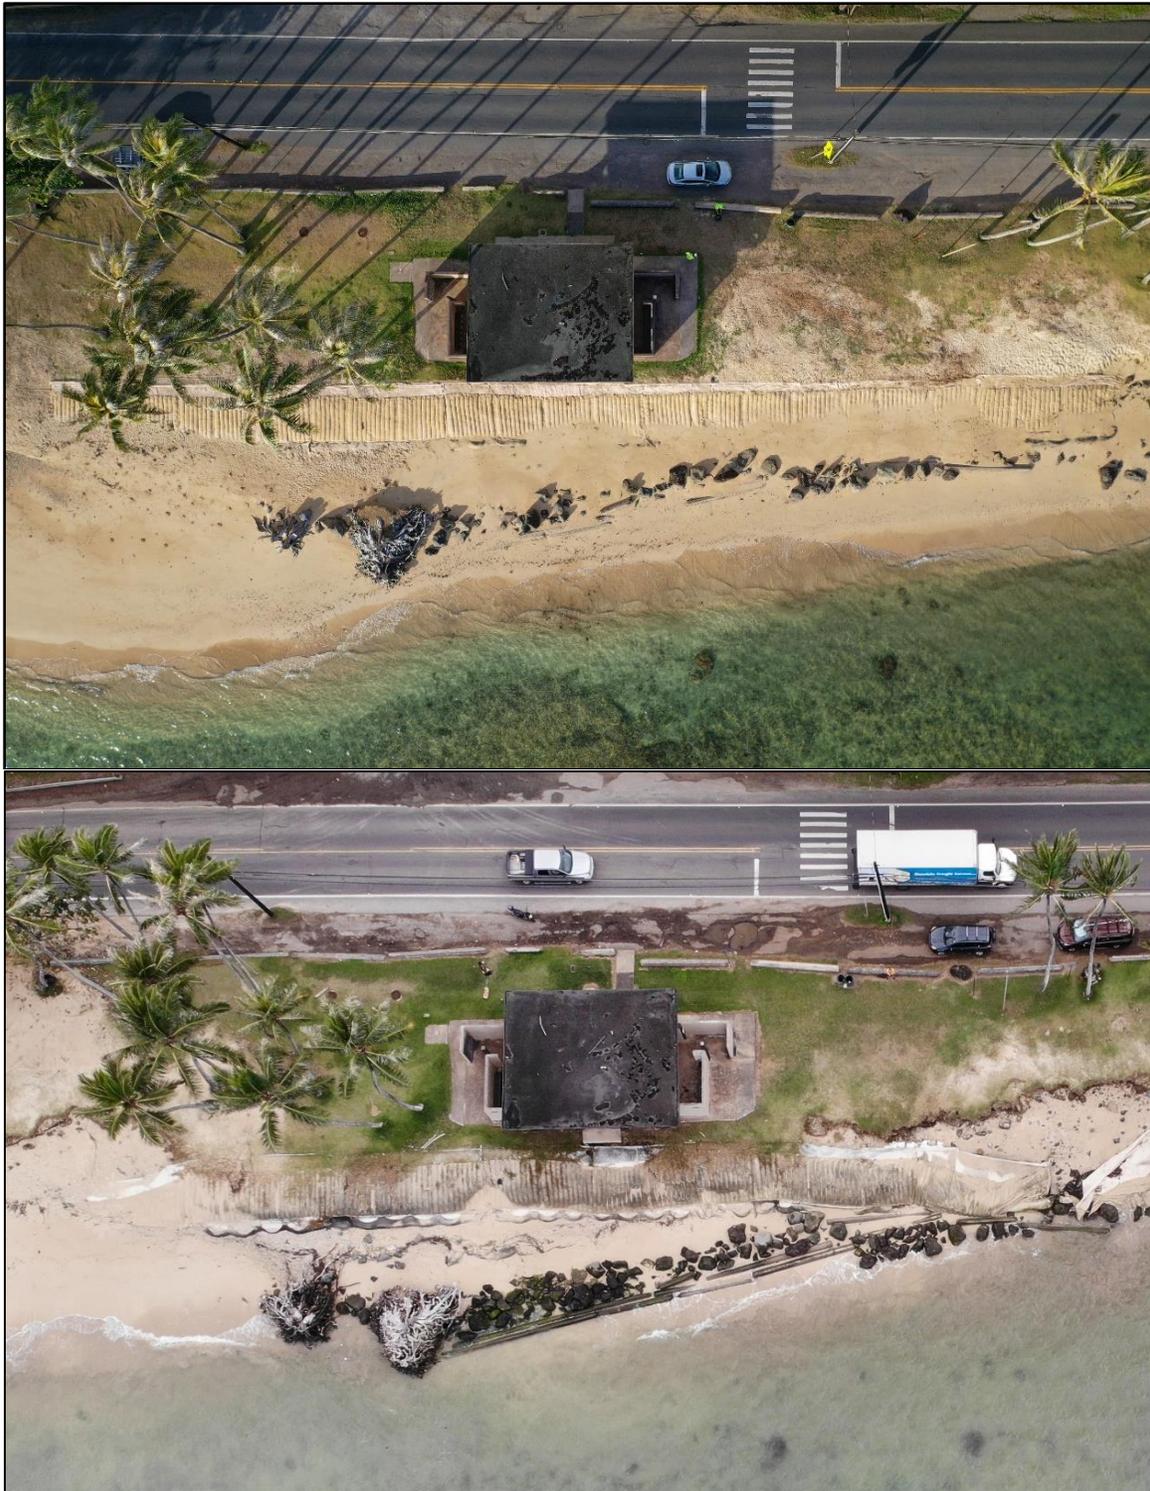
Figure 4-13. Comparison of temporary erosion after installation in June 2020 (top photo) versus its condition in November 2022 (bottom photo)

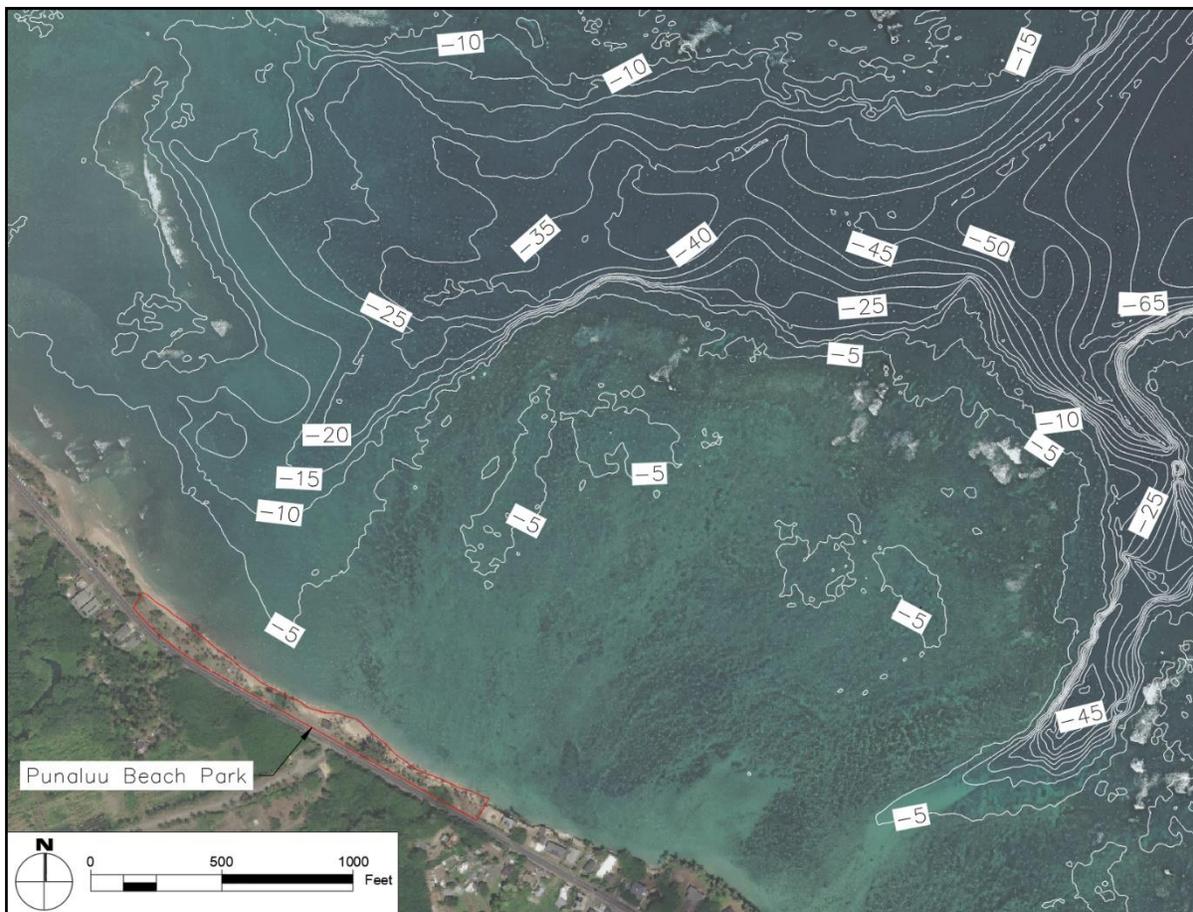
Figure 5-1. Regional view of bathymetry, Punalu'u Beach Park (elevations in ft relative to MSL)

Figure 5-1 presents a regional view of the offshore depths fronting Punalu'u Beach Park. The offshore bottom is composed of distinct areas of reef and sand. A shallow reef flat extends approximately 2,000 ft offshore. The reef flat is composed of fossil or living reef, which dissipates nearshore wave energy. Depths over the reef flat are typically 4 to 5 ft MSL, occasionally reaching 6 ft deep. The shallow reef is bounded on the north and offshore by deep relict stream channel referred to as the Punalu'u Sand Channel. An additional smaller channel through the reef can be seen in the bathymetry offshore of Punalu'u Point to the south. This channel cuts through the reef, and although it diminishes near shore, it does provide a pathway for circulation over the reef to exit offshore. The channel joins the Punalu'u Sand Channel on the offshore side of the reef.

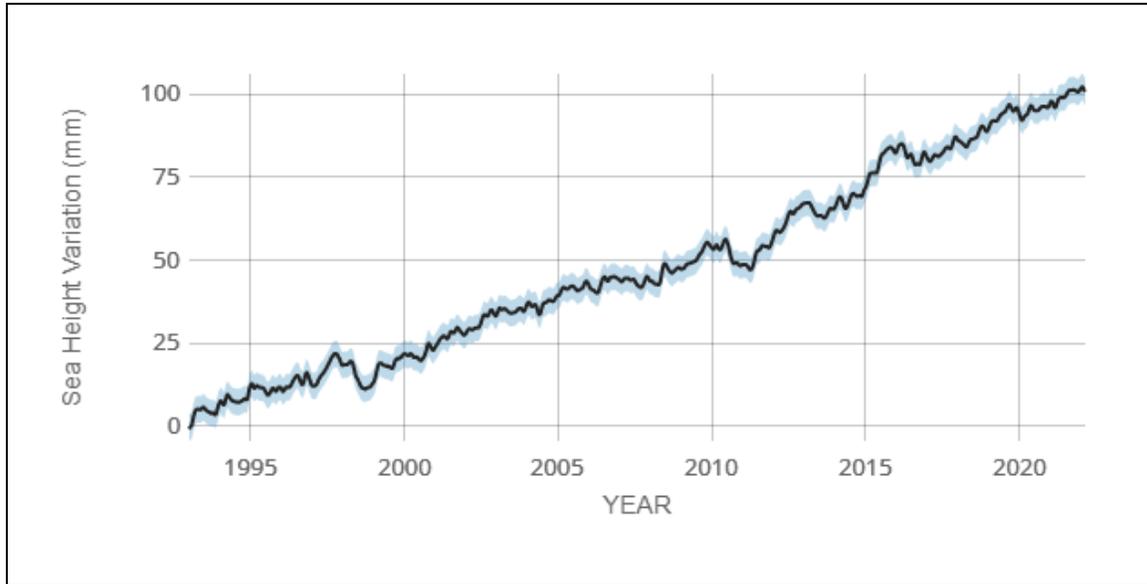
Figure 5-3. Global satellite sea level rise variability from 1993 to 2022 (Sweet et al. 2022)
 (Black line shows the average sea level rise during the time period.)

Global mean sea level is the average height of the entire ocean surface. The present rate of global mean sea level change is +3.1 mm/yr (Sweet et al., 2022, Figure 5-3), where a positive number represents a rising sea level. Global mean sea level rise has accelerated over preceding decades compared to the mean of the 20th century (Sweet et al., 2017). Regional effects cause sea levels to increase in some parts of the planet while decreasing or remaining relatively stable in other areas. In the contiguous United States (U.S.), sea level has risen on average by 6.5 inches (in) since 1950 (Sweet et al., 2018). Based on the Honolulu tide station, sea level has risen by about 4.5 inches (in) since 1950. Factors contributing to the observed rise in sea level include melting of land-based glaciers and ice sheets and thermal expansion of the ocean water column.

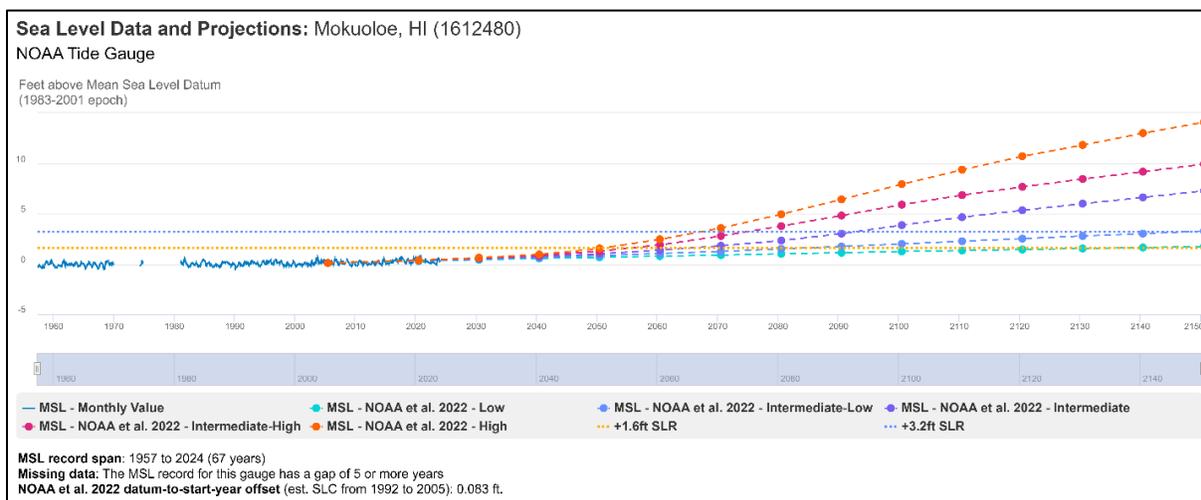
Figure 5-5. NOAA 2022 sea level rise projections for Moku o Lo‘e Island with thresholds of +1.6 and +3.2 ft

The Sea Level Rise and Coastal Flood Hazard Scenarios and Tools Interagency Task Force (NOAA 2022) recently revised their sea level change projections through 2150, considering up-to-date scientific research and measurements. The Task Force consists of representatives from the National Aeronautics and Space Administration (NASA), National Oceanic and Atmospheric Administration (NOAA), U.S. Environmental Protection Agency (EPA), U.S. Geological Survey (USGS), U.S. Army Corps of Engineer (USACE), and additional partners within academia. The most recent report entitled *Global and Regional Sea Level Rise Scenarios for the United States: Updated Mean Projections and Extreme Water Level Probabilities Along U.S. Coastlines* (Sweet, et al., 2022), provides the most up to date sea level rise projections for all the U.S. states and territories. Five (5) scenarios are also included in the NOAA 2022 report including *Low*, *Intermediate-Low*, *Intermediate*, *Intermediate-High*, and *High* and correspond to mean sea level values of 1.2, 2.0, 3.8, 5.8, and 7.9 ft, respectively, for Honolulu by the year 2100. These values are referenced to a baseline 0 in 2000 and are adjusted accordingly to the current tidal epoch defining MSL.

For this study, SLR values of +1.6 and +3.2 ft were chosen for assessment and development of conceptual shoreline restoration alternatives. The upper bound of +3.2 ft is currently adopted by the State of Hawai‘i for planning and design purposes and was derived from the 2013 IPCC Fifth Assessment Report as the global mean sea level rise by 2100. SLR of +1.6 ft was chosen as half of +3.2 ft as a mid-level value to represent potential sea level mid-century. The USACE Sea Level Rise Analysis Tool¹ (SLAT) was utilized in this study to look at the projected timings of when +1.6 and +3.2 ft of SLR may occur. The tool allows visualization of various sea level change projections at a specific tide station and accounts for local effects including vertical land motion and historical sea level trends. Figure 5-5 shows the SLAT output for Moku o Lo‘e Island tide station for the NOAA 2022 projections. Table 5-2 lists the timings of when +1.6 and +3.2 ft may occur based on the NOAA 2022 projections.

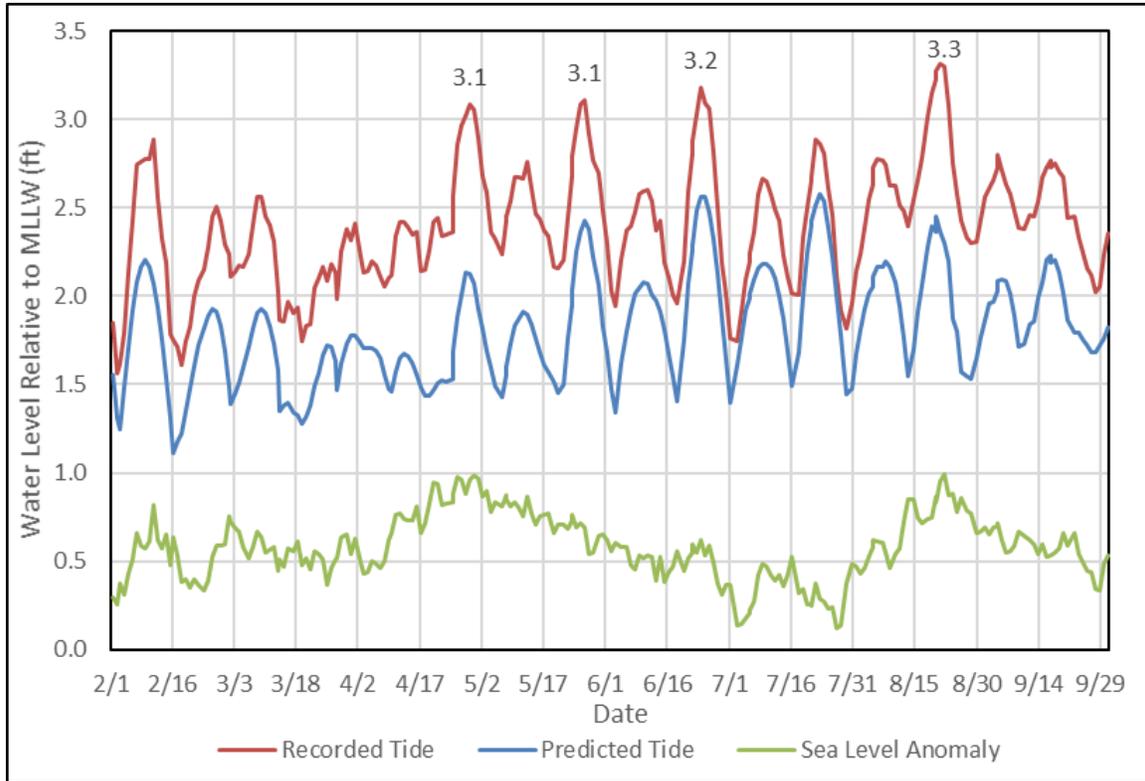
Figure 5-6. Daily maximum measured tides at Honolulu Harbor and corresponding predicted tides and sea level anomaly (Feb 1 - Oct 1, 2017)

In 2017, Hawai‘i experienced anomalous sea levels which caused significant inundation of low-lying urban areas such as Waikiki, Ala Wai Boulevard, and Mapunapuna. The daily maximum recorded tides at Honolulu Harbor from February through October 2017 are shown in Figure 5-6. The plot also shows the corresponding predicted tide and sea level anomalies for the daily maximum recorded tide. Table 5-3 extends this data, presenting the recorded and predicted tides at Honolulu Harbor from February 2017 to present.

The media widely reported that the flooding was the result of *King Tides* referring to peak annual astronomic tides; however, sea level anomalies during those high-water events ranged from approximately 0.5 foot to 1 foot above the astronomical tide, contributing significantly to the high water levels. The occurrence of summer swells during this period of elevated water levels added to the inundation. The end of 2019 also marked an extended period of large sea level anomalies. Figure 5-7 shows the extreme water levels from December 24 to 27, 2019. During this time period, sea level anomalies of +0.6 to +1.1 ft MLLW added to the winter *King Tides* resulting in the highest recorded water level at Honolulu Harbor of +3.4 ft MLLW.

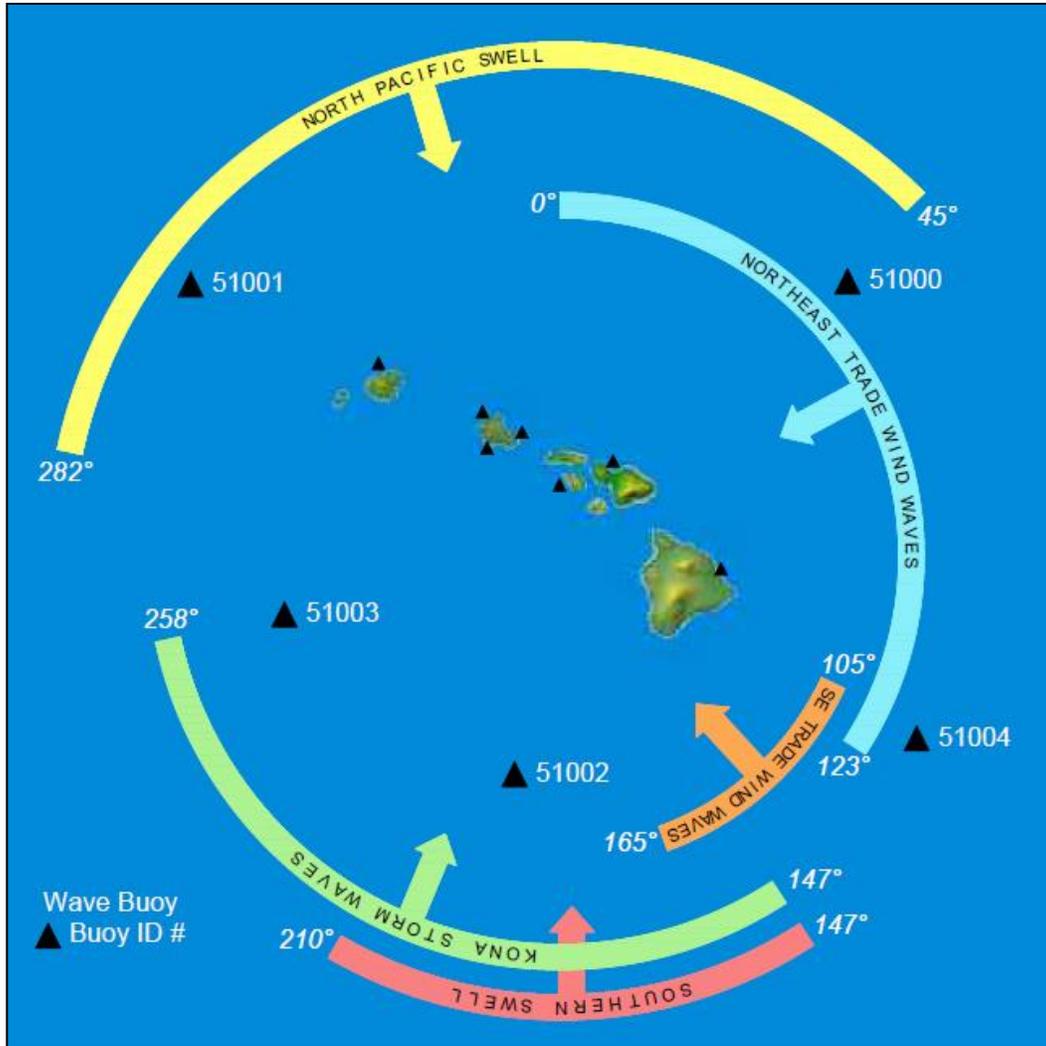
Figure 5-8. Hawai'i dominant swell regimes

The wave climate in Hawai‘i is typically characterized by four general wave types. These include northeast tradewind waves, southern swell, North Pacific swell, and Kona wind waves. Tropical storms and hurricanes also generate waves that can approach the islands from virtually any direction. Unlike winds, any and all of these wave conditions may occur at the same time. The dominant swell regimes for Hawai‘i are shown in Figure 5-8.

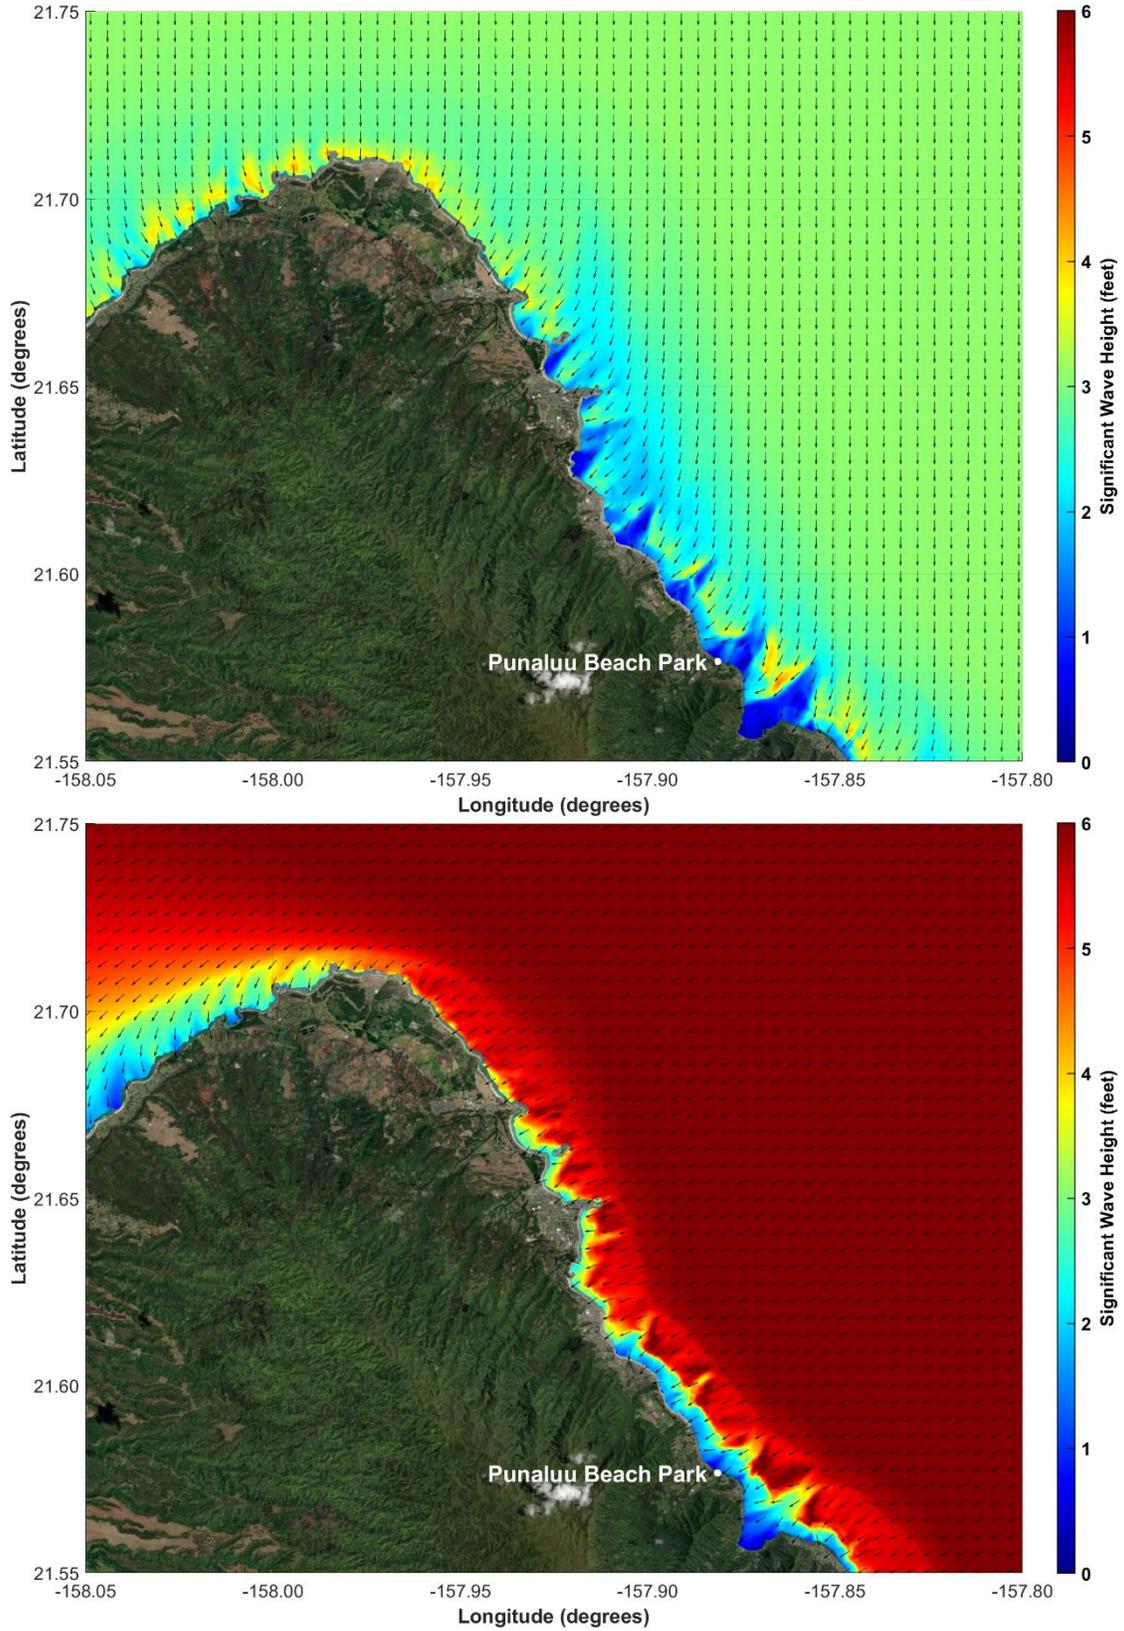
Figure 6-2. SWAN modeled significant wave height for prevailing north swell (top) and tradewind waves (bottom)

The most prevalent waves that reach the Punalu'u shoreline are winter northerly swells and tradewind waves. Table 6-2 lists the prevailing deepwater wave parameters (see Section 5.4) used as input for the SWAN model for each prevailing wave condition. These parameters are applied along all boundaries of the unstructured SWAN grid. Figure 6-2 shows the modeled output for significant wave height near the project site for both prevailing north swell and tradewind waves. The results illustrate the propagation of offshore wave energy associated with typical winter (north swell) and tradewind waves along the windward Oahu coastline and where wave energy may converge or diverge based on the seafloor contours. For both north swell and tradewind waves, wave energy appears to focus to the north and east of Punalu'u and slightly diverge to the northeast. More energy is distributed along the offshore reef edge and closer to shore for tradewind waves than north swell which may influence nearshore wave processes differently in the surrounding region. Nearshore wave processes are modeled using XBeach-NH (see Section 6.3).

Wave Case	Deepwater Wave Parameters		
	Hs (ft)	Tp (sec)	Dir. (deg. TN)
North Swell	3.1	12.5	360.0
Tradewind Waves	6.0	8.0	67.5

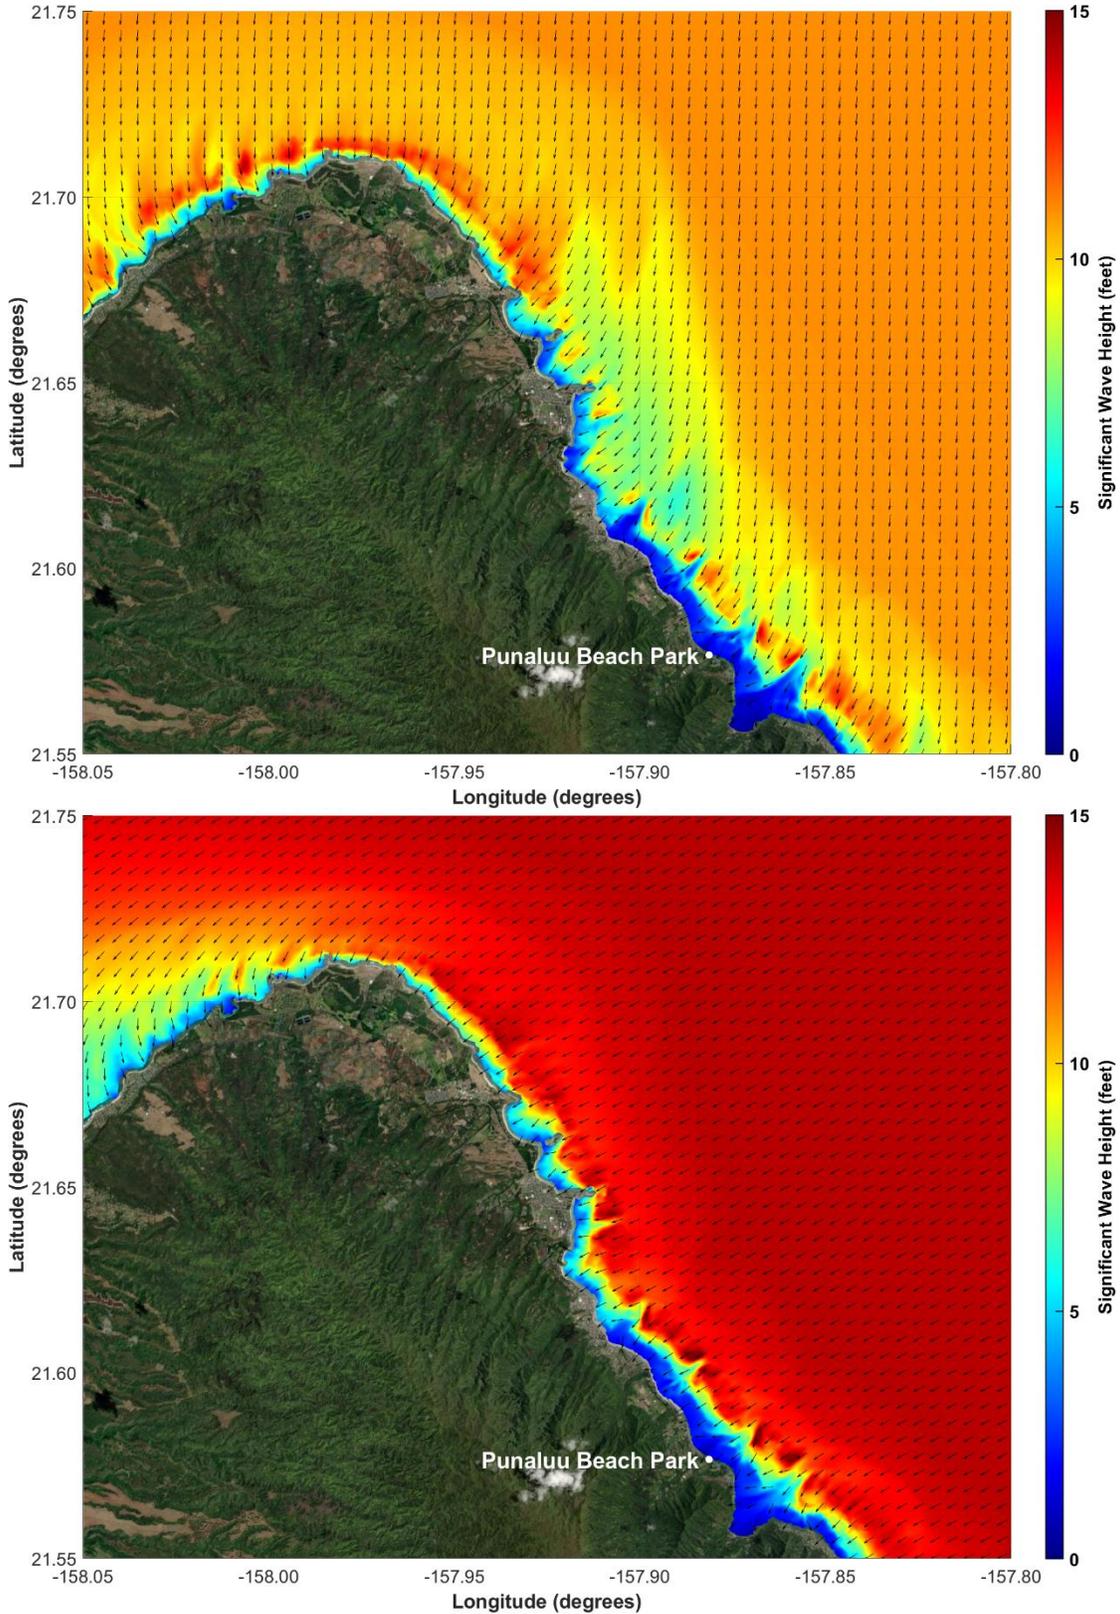
Figure 6-3. SWAN modeled significant wave height for an annual north swell (top) and tradewind waves (bottom)

Table 6-3 lists the annual deepwater wave parameters (see Section 5.4) used as input for the SWAN model for each wave condition. These parameters are applied along all boundaries of the unstructured SWAN grid. Figure 6-3 shows the modeled output for significant wave height near the project site for both the annual north swell and tradewind wave events. Similar to prevailing waves, both north swell and tradewind wave energy appears to focus to the north and east of Punalu'u and slightly diverge to the northeast. More energy is distributed along the offshore reef edge and closer to shore for tradewind waves than north swell which may influence nearshore wave processes differently in the surrounding region. Nearshore wave processes are modeled using XBeach-NH (see Section 6.3).

Wave Case	Deepwater Wave Parameters		
	Hs (ft)	Tp (sec)	Dir. (deg. TN)
North Swell	11.0	15.0	5.0
Tradewind Waves	13.9	10.0	67.5
