Punalu‘u Beach Restoration Feasibility Study

Punalu‘u Beach Park, O‘ahu

April 2024

Sea Engineering, Inc.
Makai Research Pier
41-305 Kalaniana‘ole Hwy
Waimānalo, Hawai‘i 96795

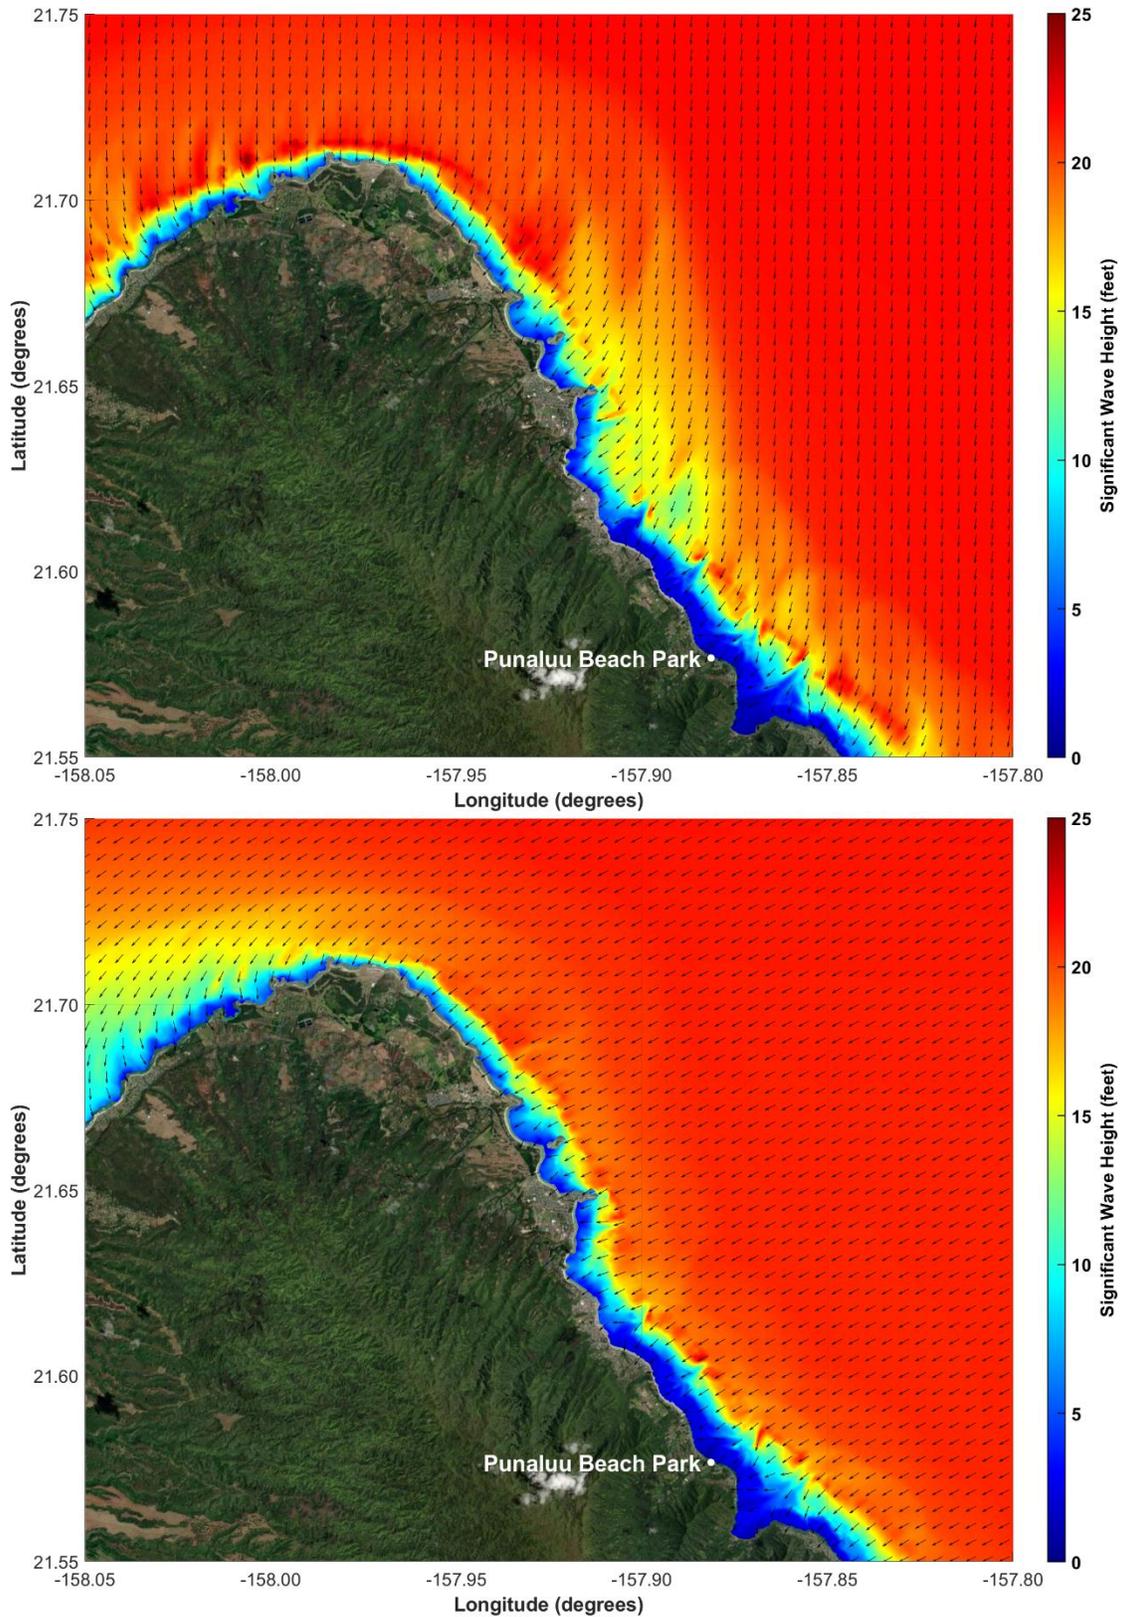
Figure 6-4. SWAN modeled significant wave height for a 50-yr north swell (top) and tradewind waves (bottom)

Wave Case	Deepwater Wave Parameters		
	Hs (ft)	Tp (sec)	Dir. (deg. TN)
North Swell	21.7	15.0	5.0
Tradewind Waves	21.2	12.0	67.5

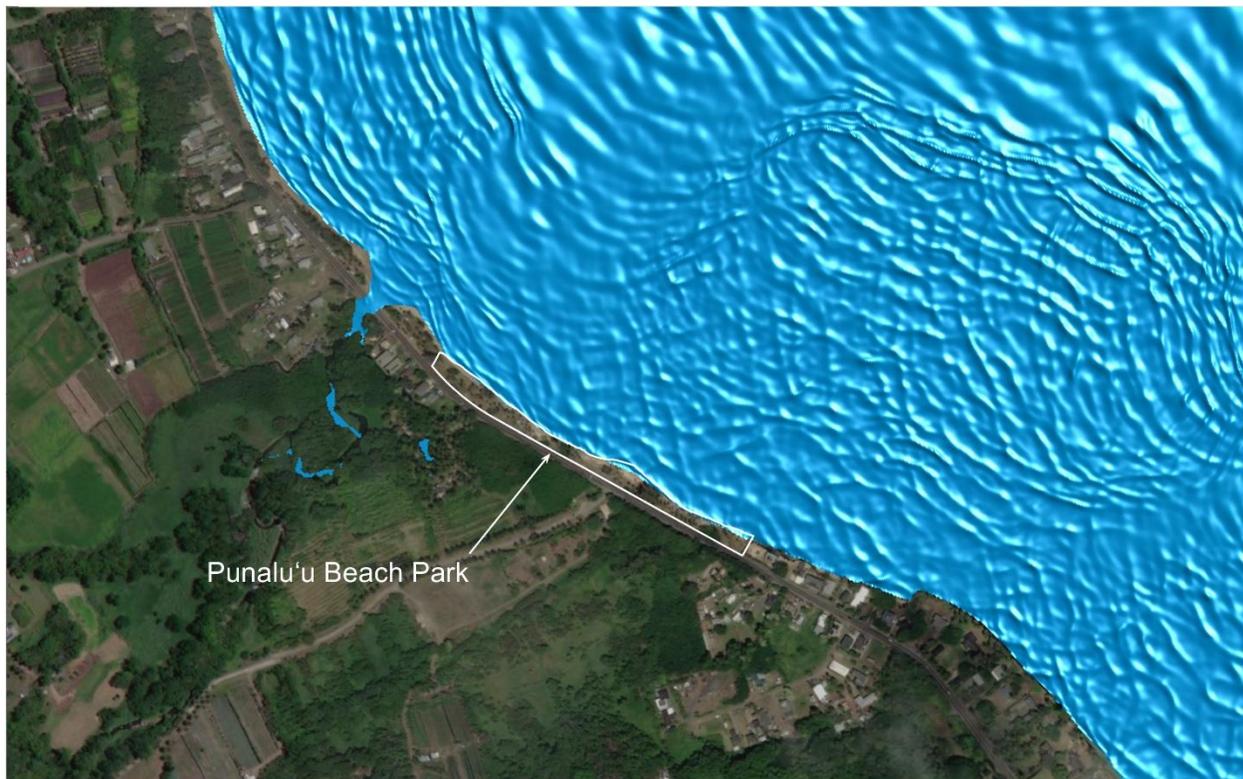
Figure 6-9. Water surface snapshot from XBeach-NH model for a prevailing tradewind waves

Depth-averaged flow patterns from the model for the tradewind wave case show similar patterns as the north swell wave case. North to south flow of water is observed along the shoreline north of the Punalu'u sand channel and south to north flow south of the sand channel. Modeled flow paths converge at the sand channel and are redirected offshore from the beach park. These flow patterns may promote longshore sediment transport during tradewind wave conditions. Any sediment suspended off of the beach by the waves and into the nearshore waters may be carried by these nearshore currents until they settle to the seafloor. These results suggest that sand eroded from Punalu'u beach may be transported by a combination of nearshore waves and currents away from the shoreline and out of the beach system via the sand channel.

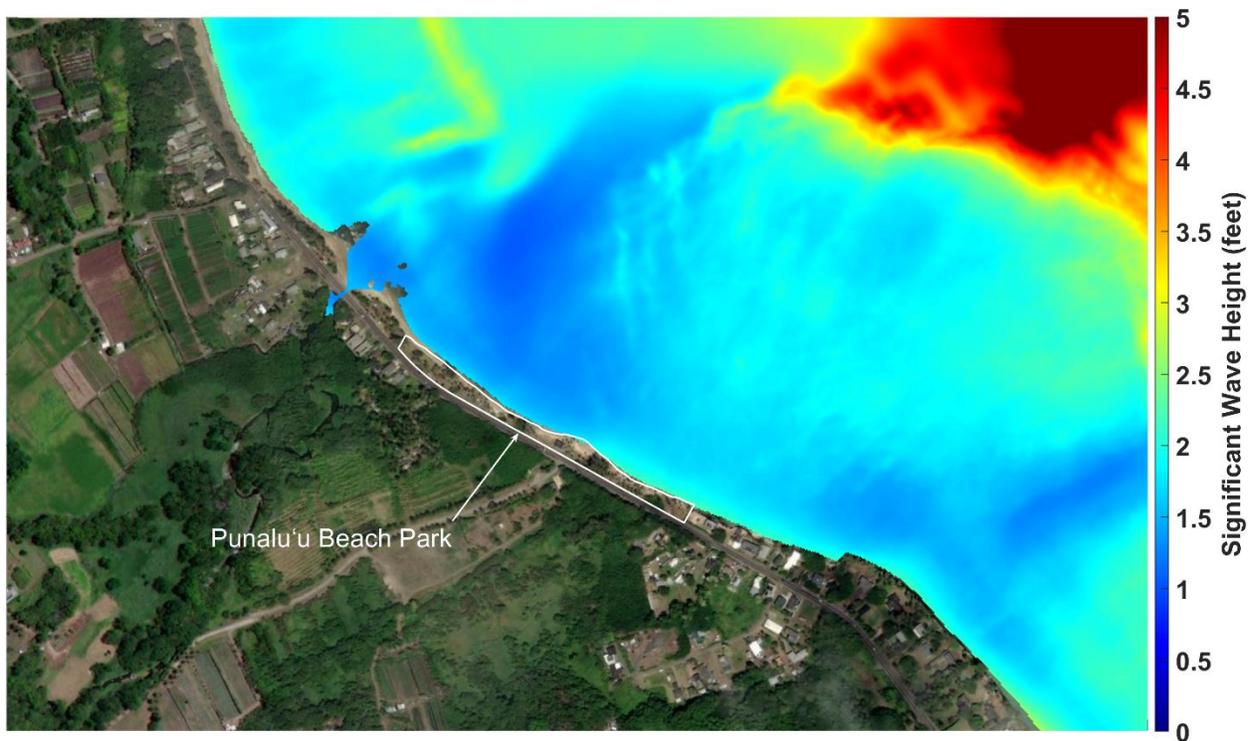
Figure 6-12. Significant wave height from XBeach-NH model for annual tradewind waves under existing sea level

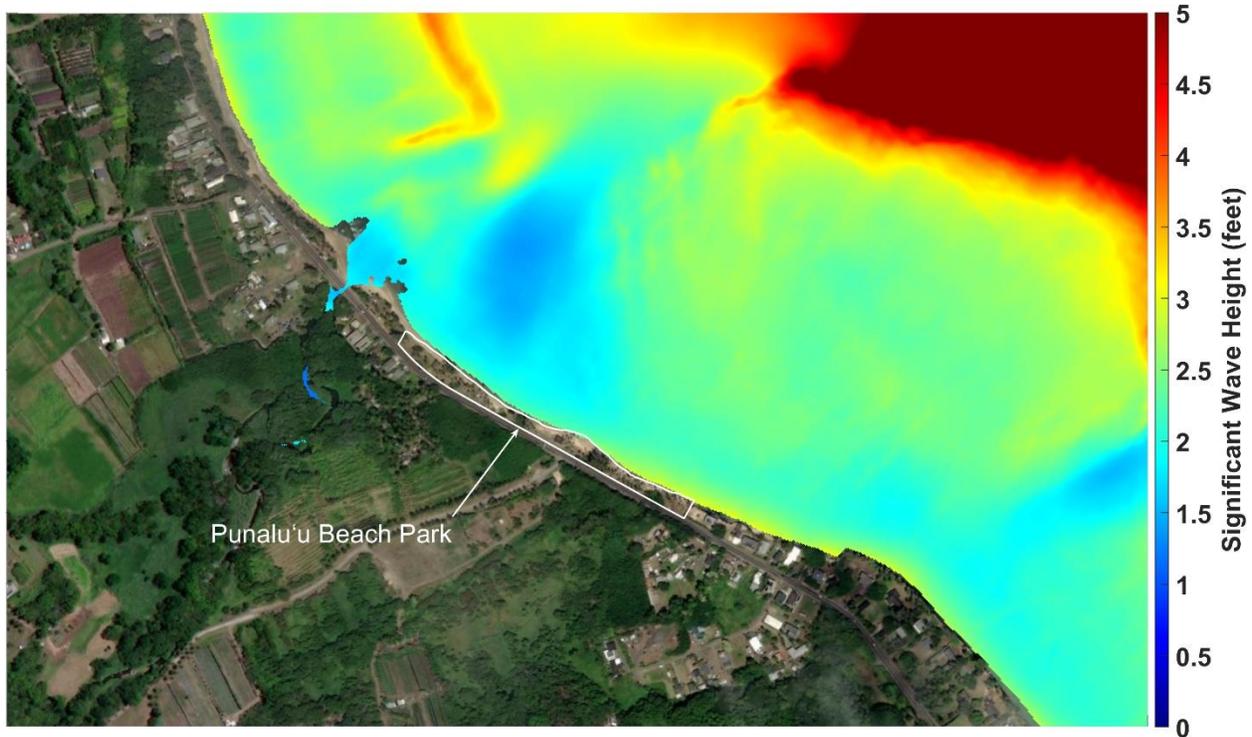
Figure 6-15. Significant wave height from XBeach-NH model for 50-yr tradewind waves under existing sea level

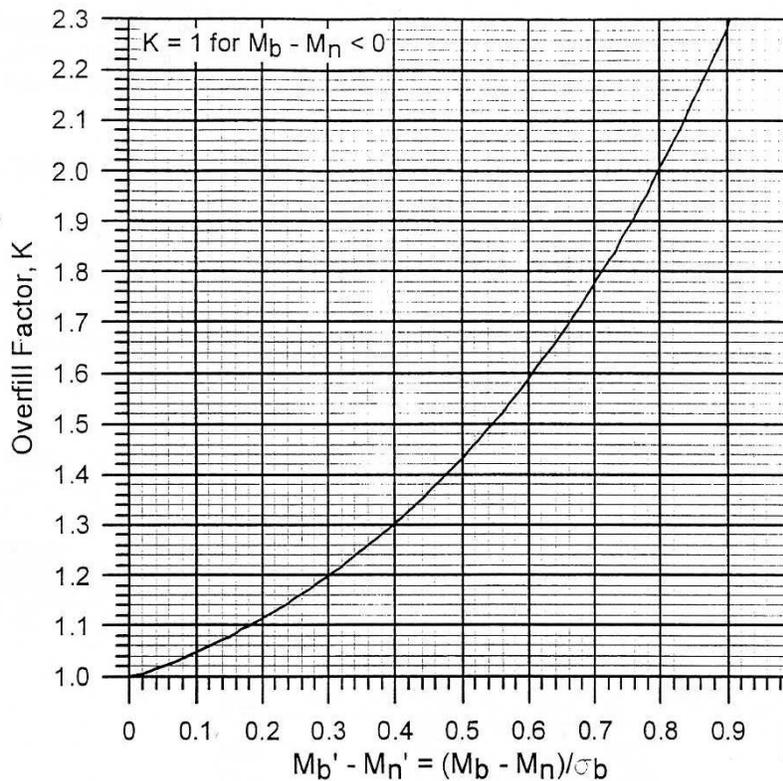
Figure 7-8. Dean’s overfill ratio expressed as a single curve (Bodge, 2004).

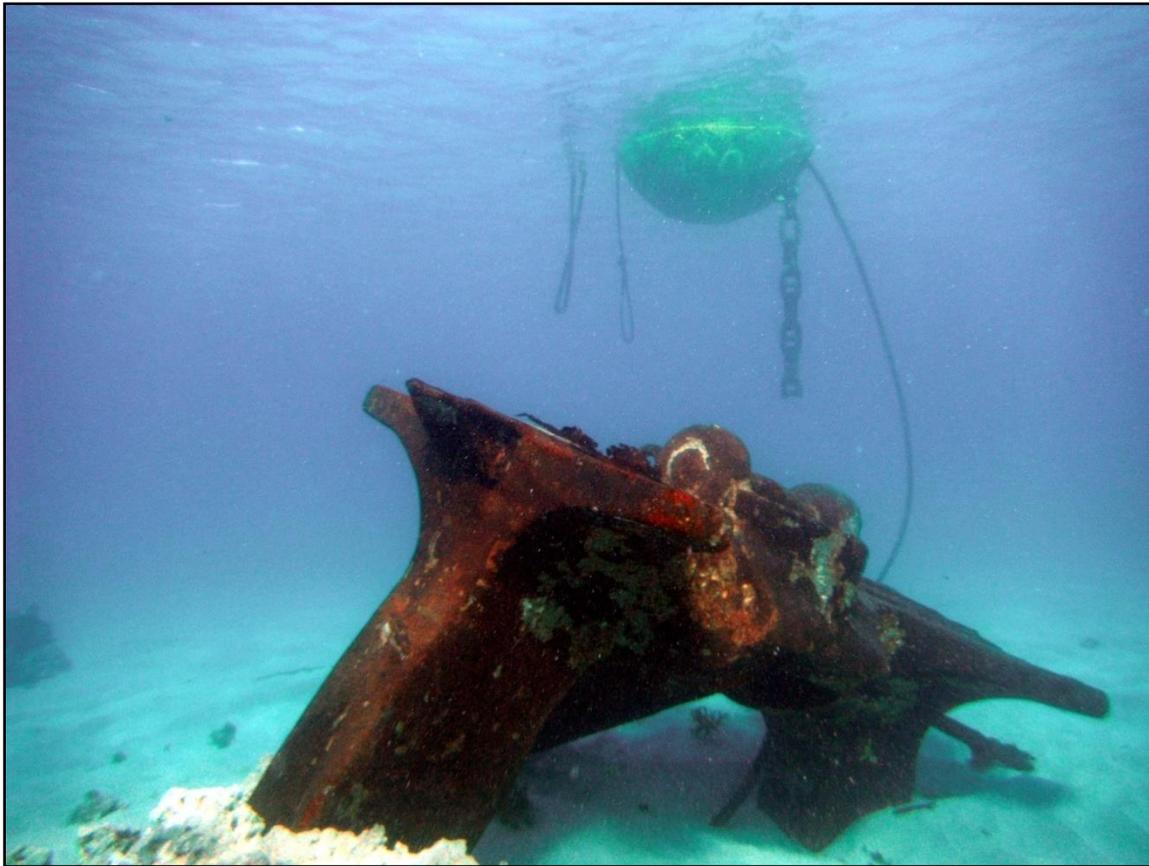
Figure 8-4. Example: anchor and anchor float used in the 2012 Waikiki Beach Maintenance Project

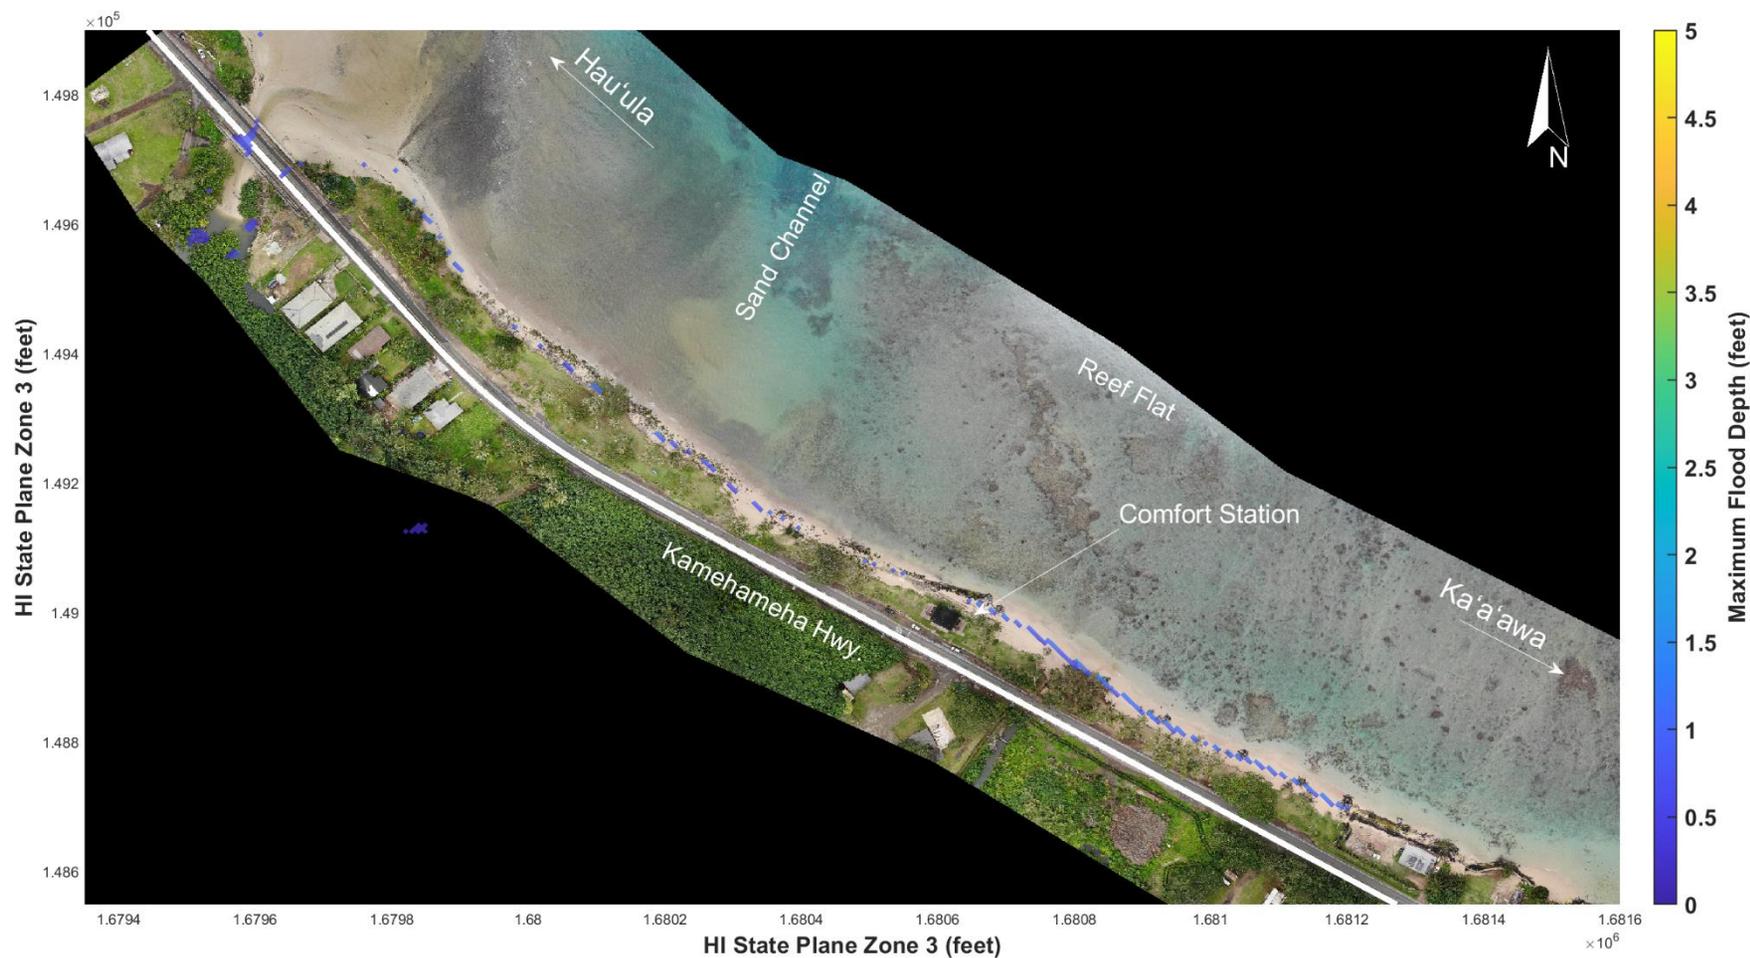
Figure 11-1. Maximum modeled flood depth for existing conditions for existing sea level during a prevailing wave event

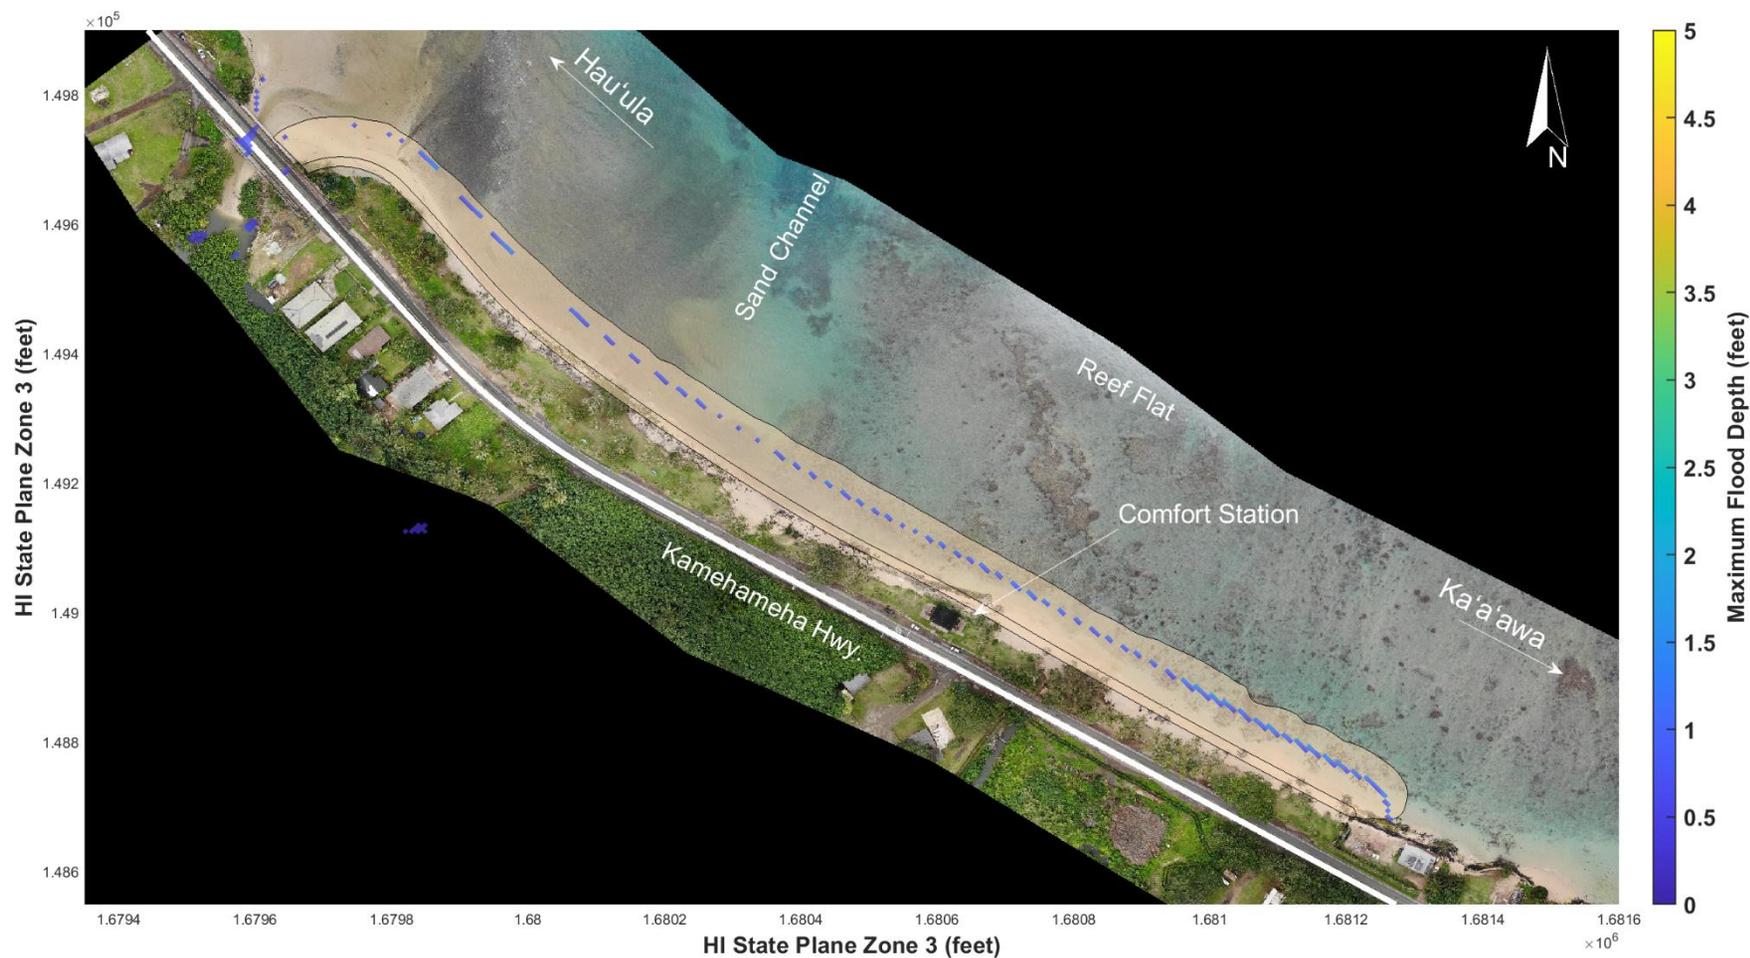
Figure 11-2. Maximum modeled flood depth for the beach nourishment concept for existing sea level during a prevailing wave event

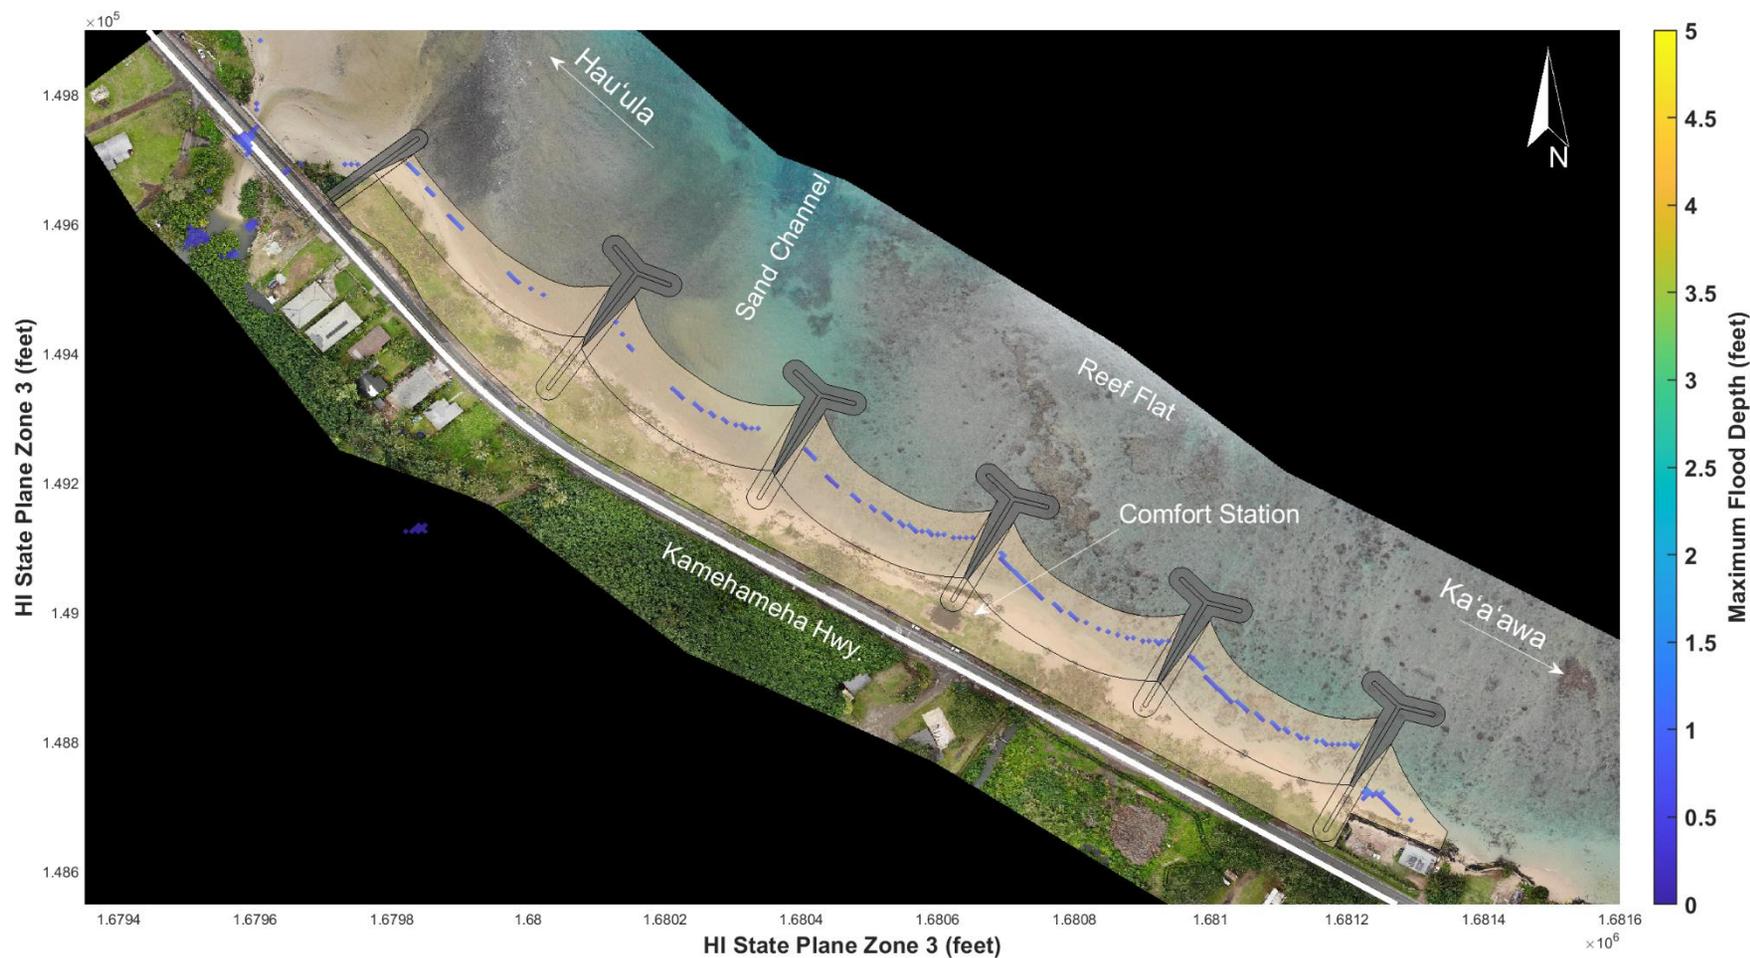
Figure 11-3. Maximum modeled flood depth for stabilized pocket beaches concept for existing sea level during a prevailing wave event

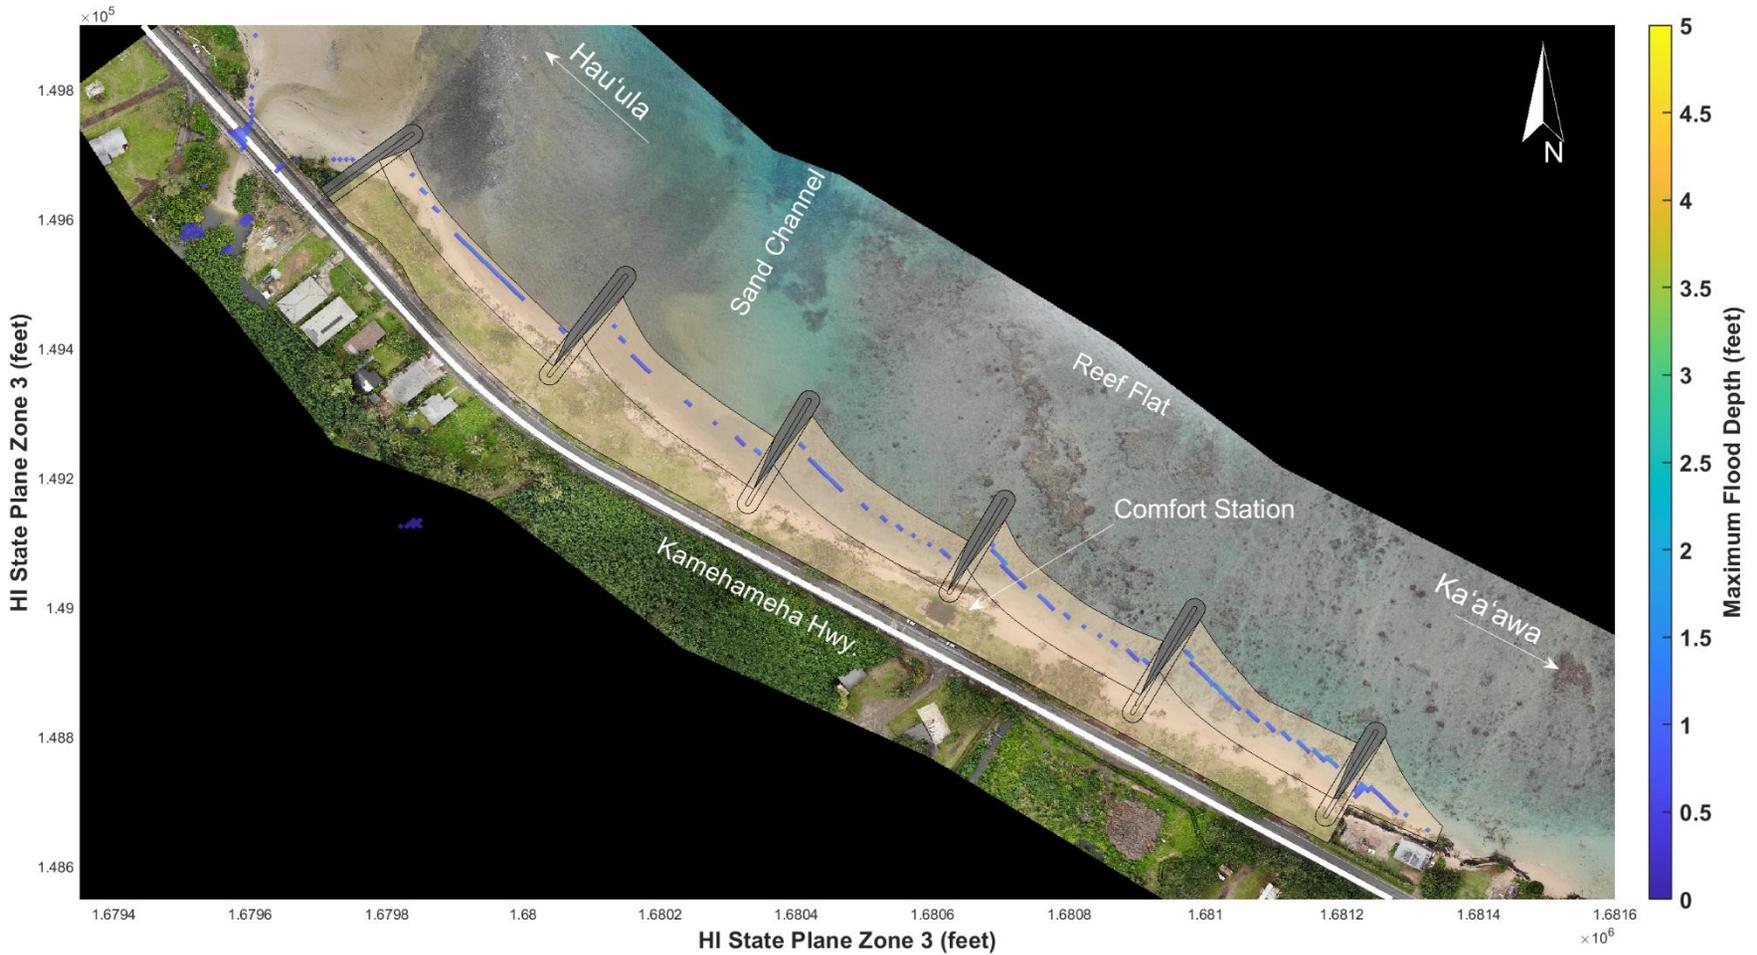
Figure 11-4. Maximum modeled flood depth for the partially stabilized pocket beaches concept for existing sea level during a prevailing wave event

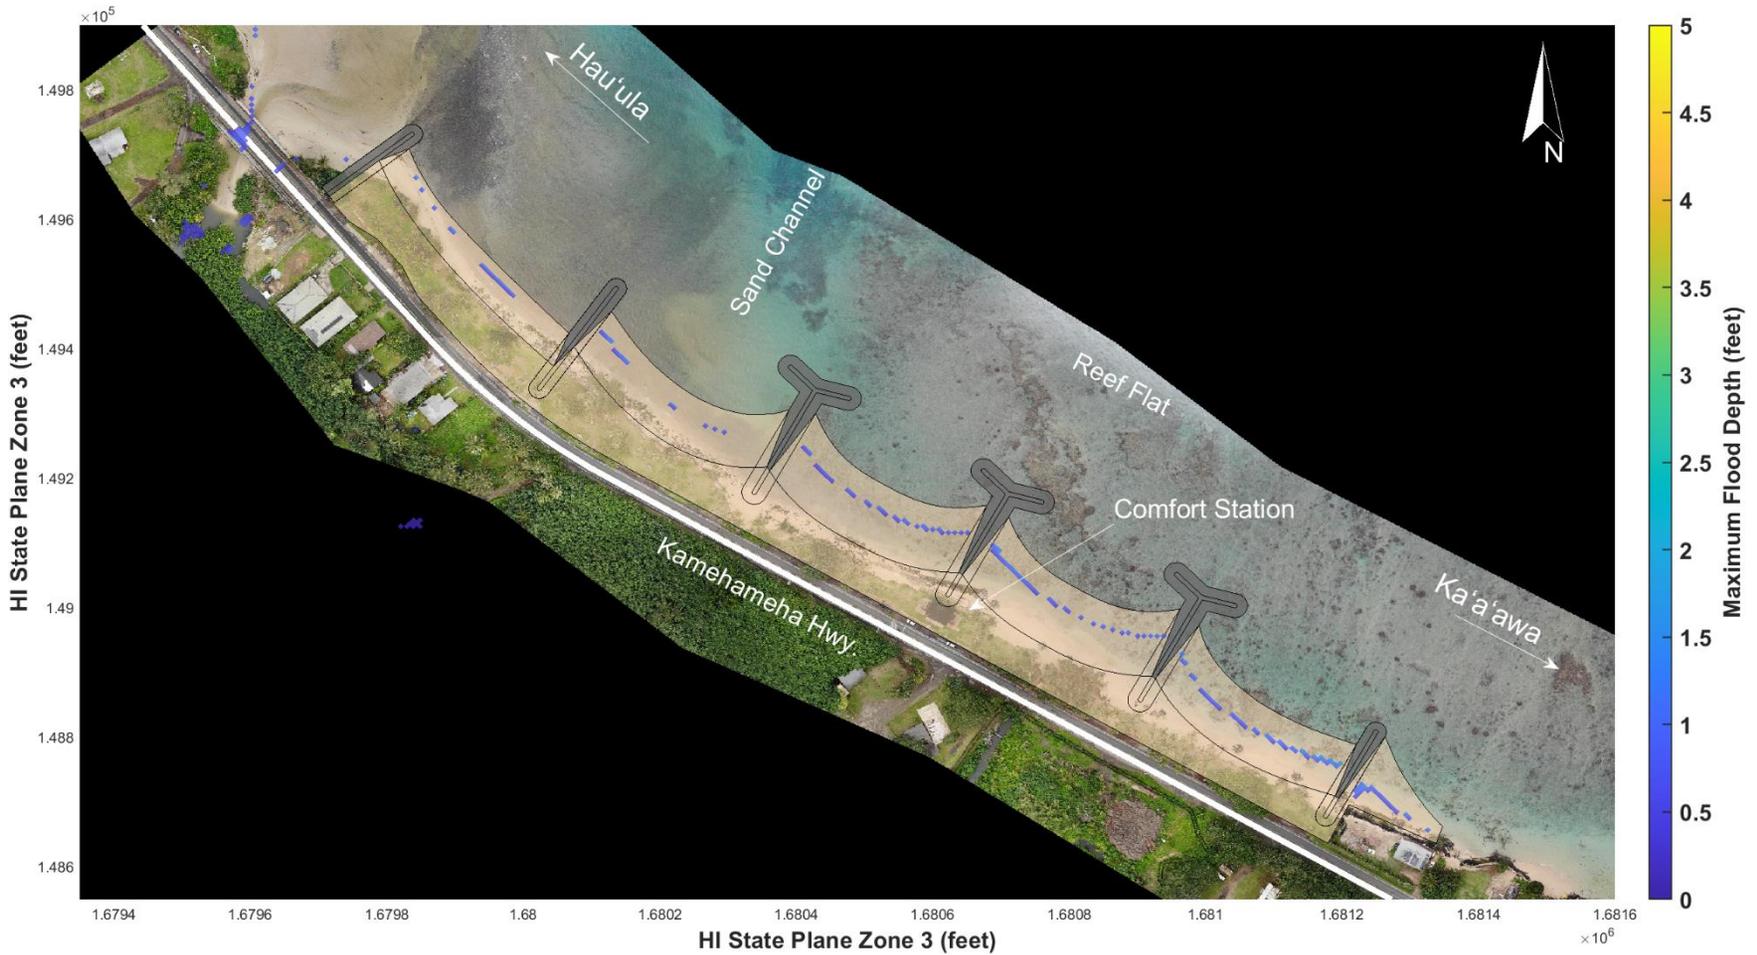
Figure 11-5. Maximum modeled flood depth for the hybrid stabilized pocket beaches concept for existing sea level during a prevailing wave event

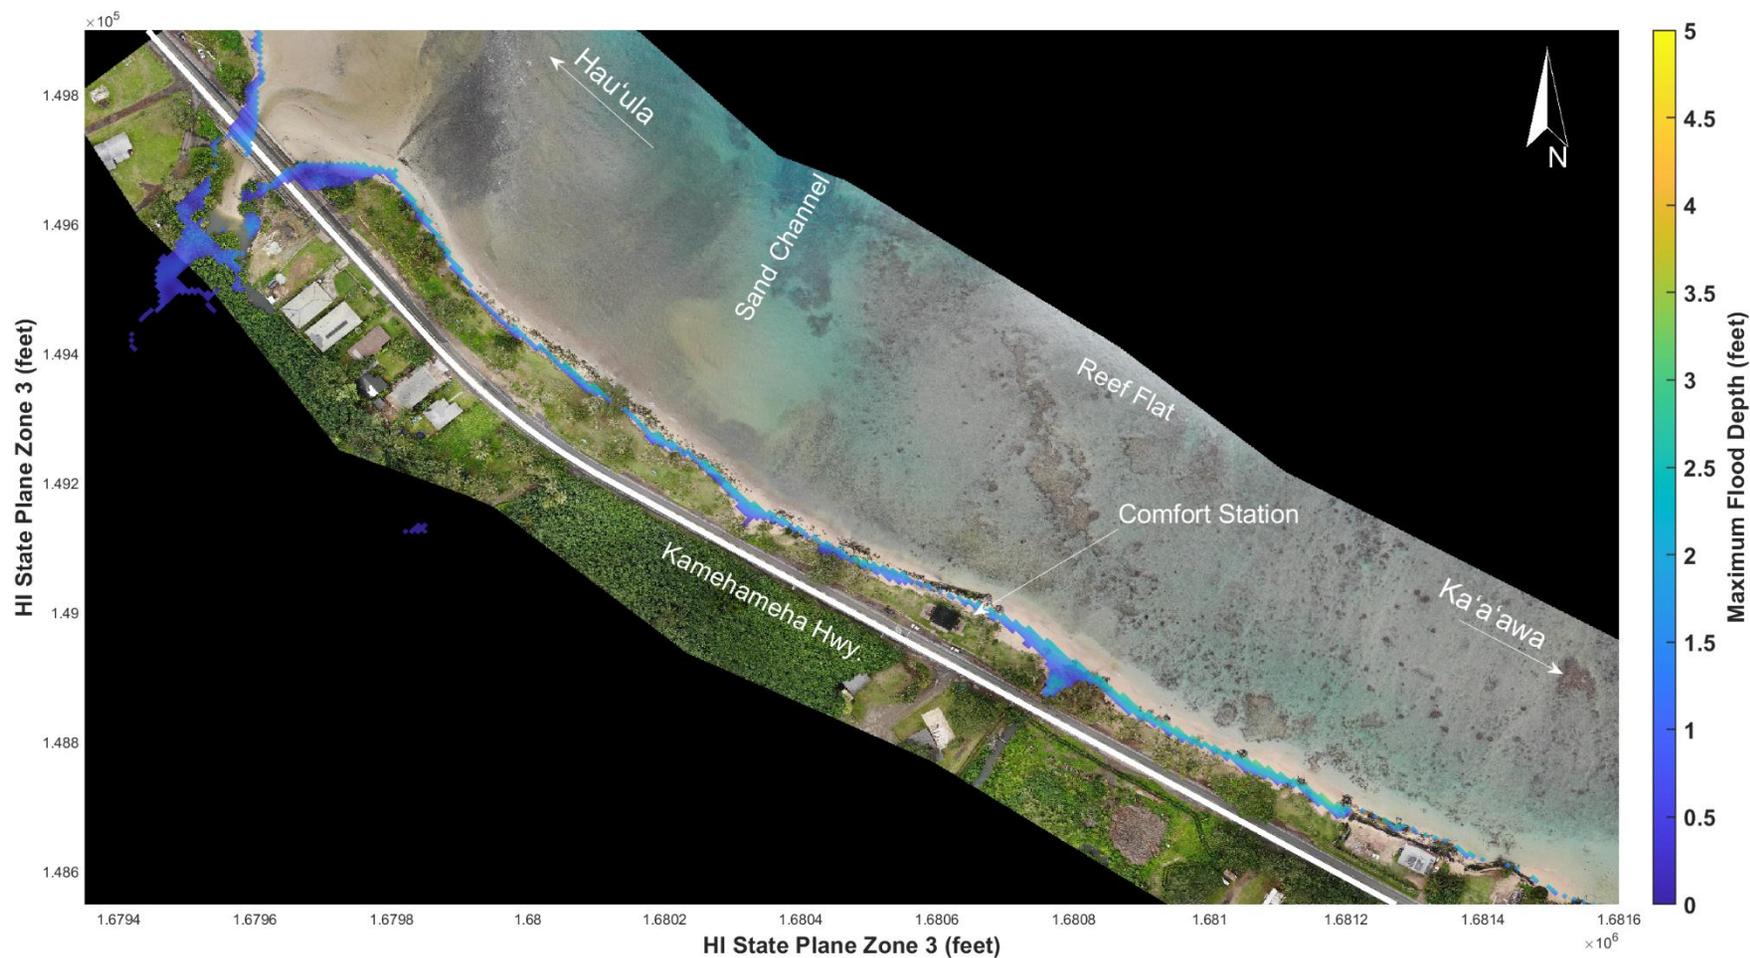
Figure 11-6. Maximum modeled flood depth for existing conditions for existing sea level during an annual wave event

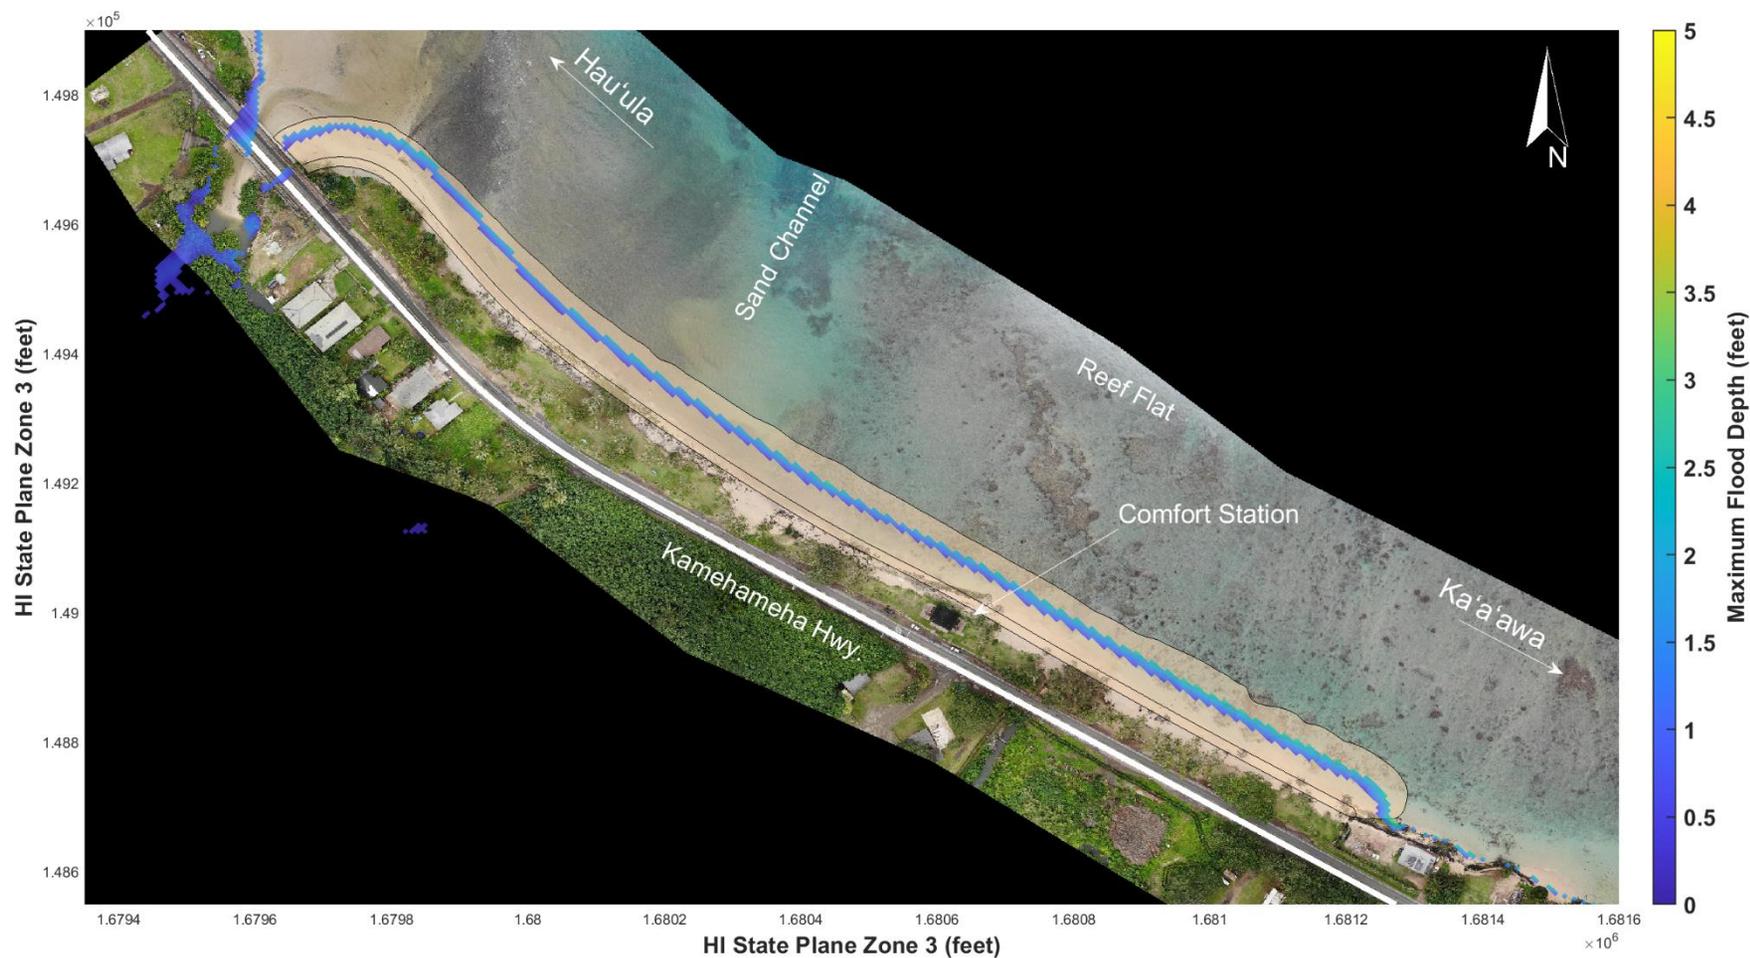
Figure 11-7. Maximum modeled flood depth for the beach nourishment concept for existing sea level during an annual wave event

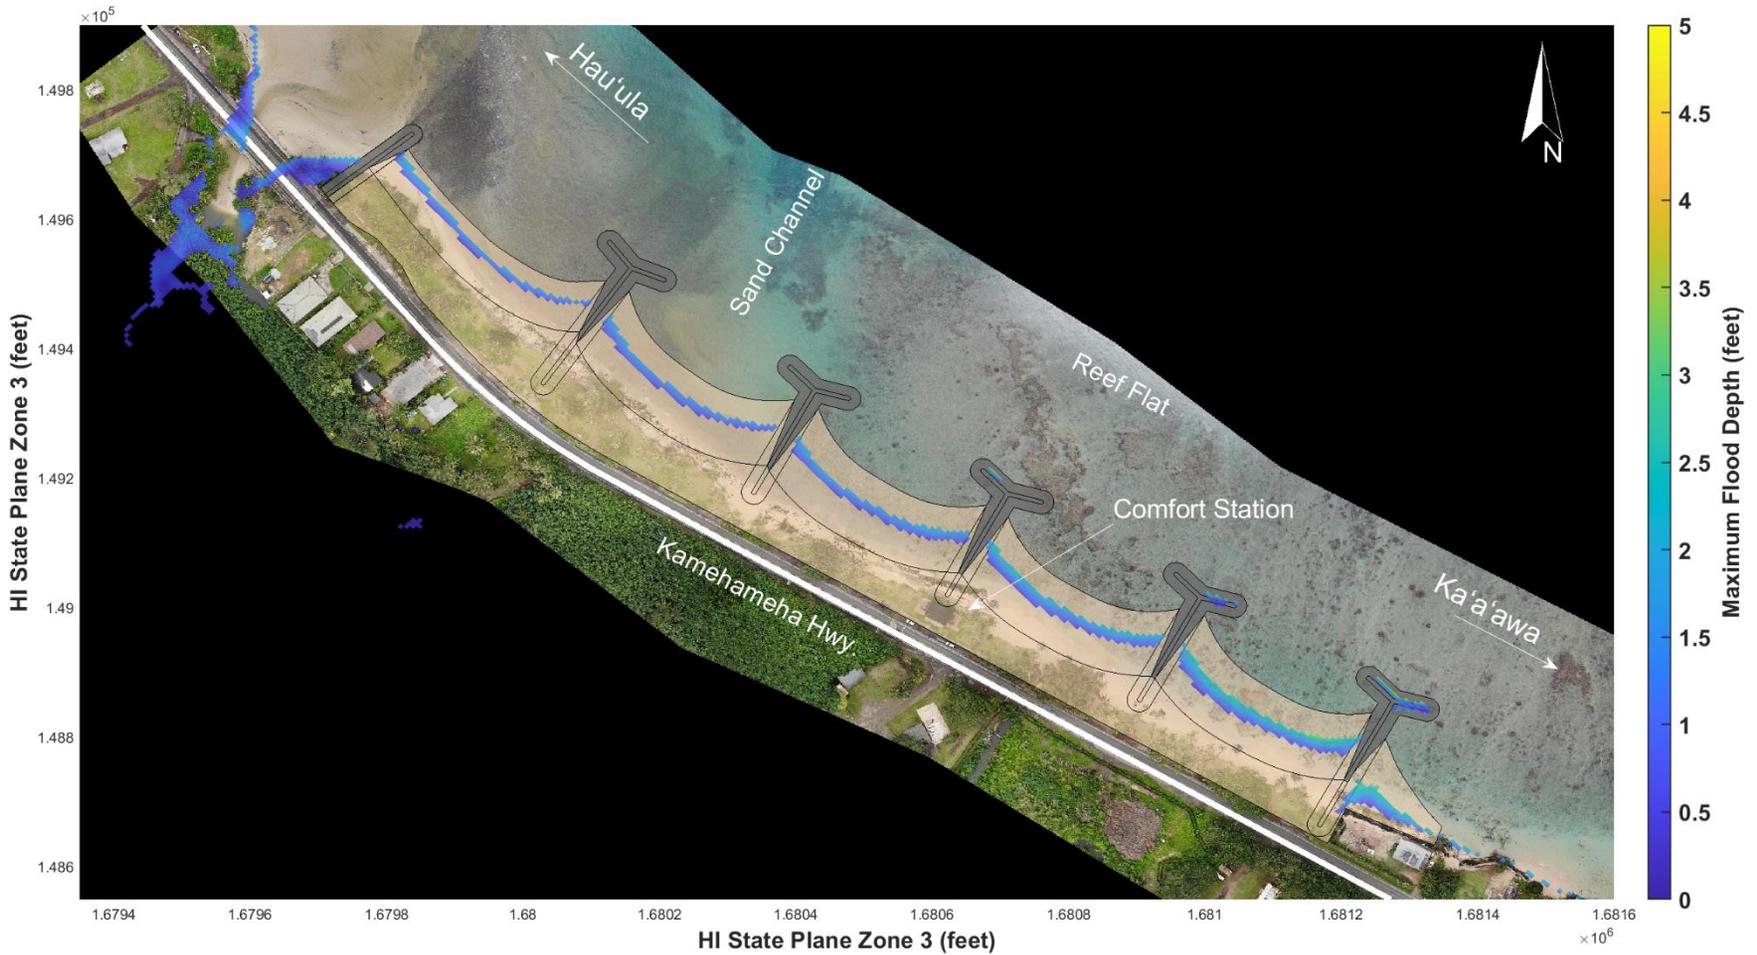
Figure 11-8. Maximum modeled flood depth for stabilized pocket beaches concept for existing sea level during an annual wave event

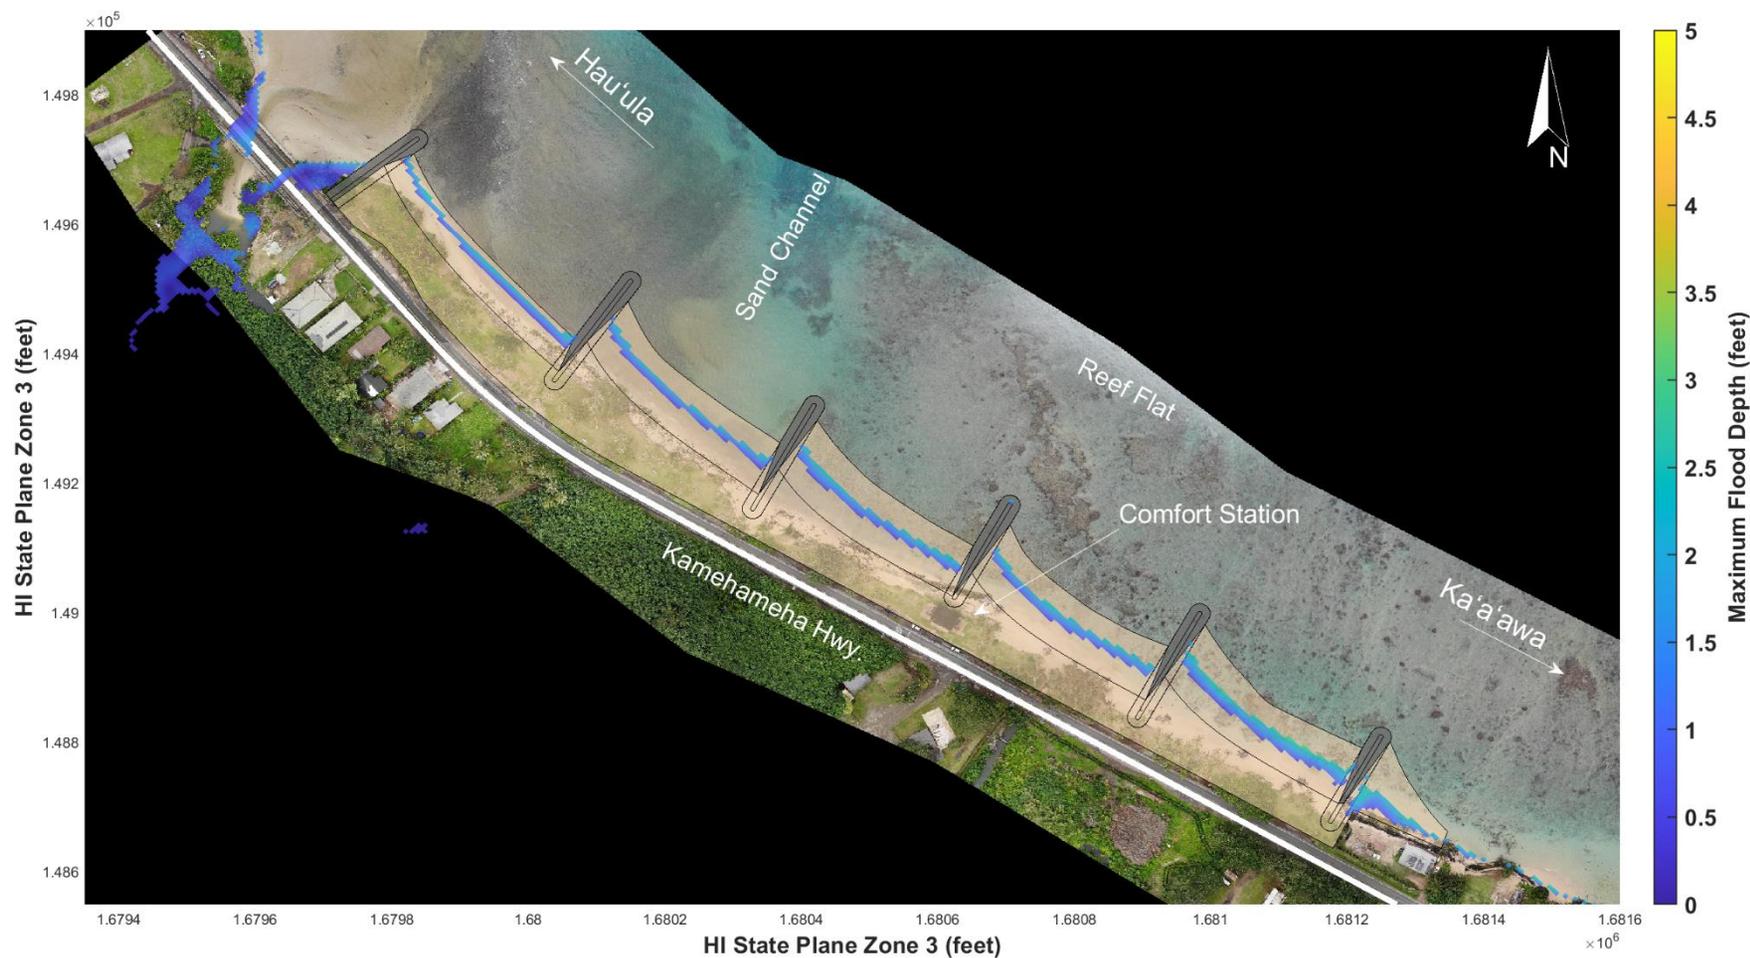
Figure 11-9. Maximum modeled flood depth for the partially stabilized pocket beaches concept for existing sea level during an annual wave event
