Punalu‘u Beach Restoration Feasibility Study

Punalu‘u Beach Park, O‘ahu

April 2024

Sea Engineering, Inc.
Makai Research Pier
41-305 Kalaniana‘ole Hwy
Waimānalo, Hawai‘i 96795

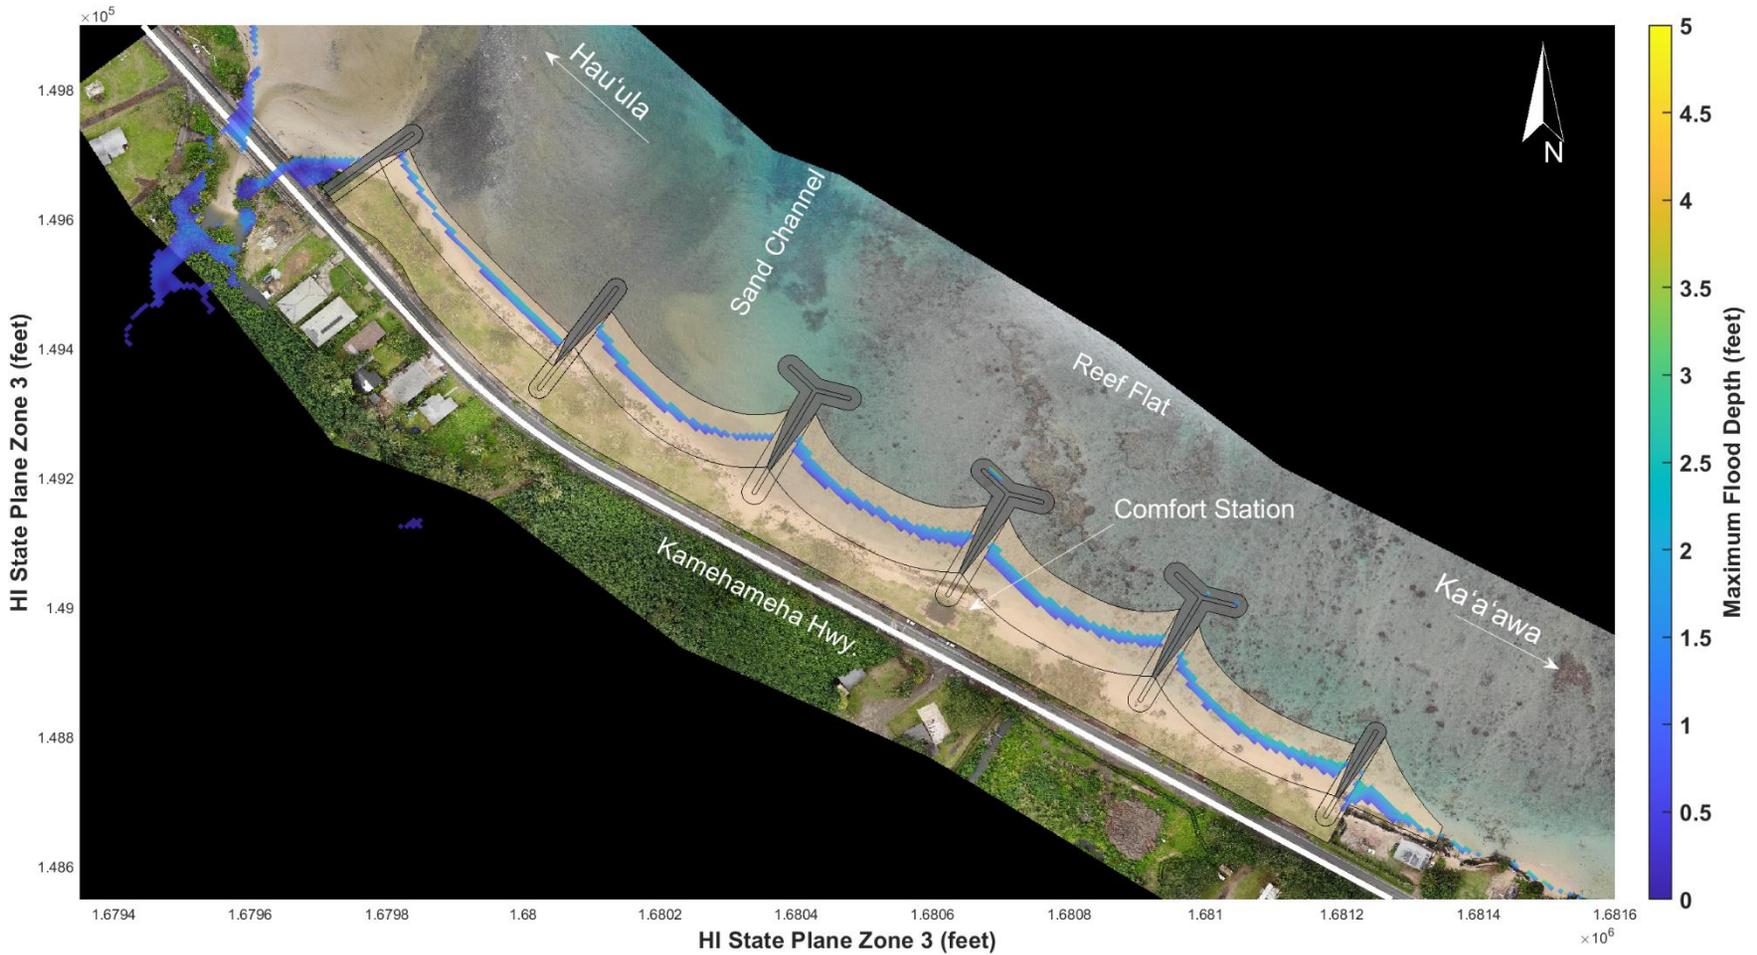
Figure 11-10. Maximum modeled flood depth for the hybrid stabilized pocket beaches concept for existing sea level during an annual wave event

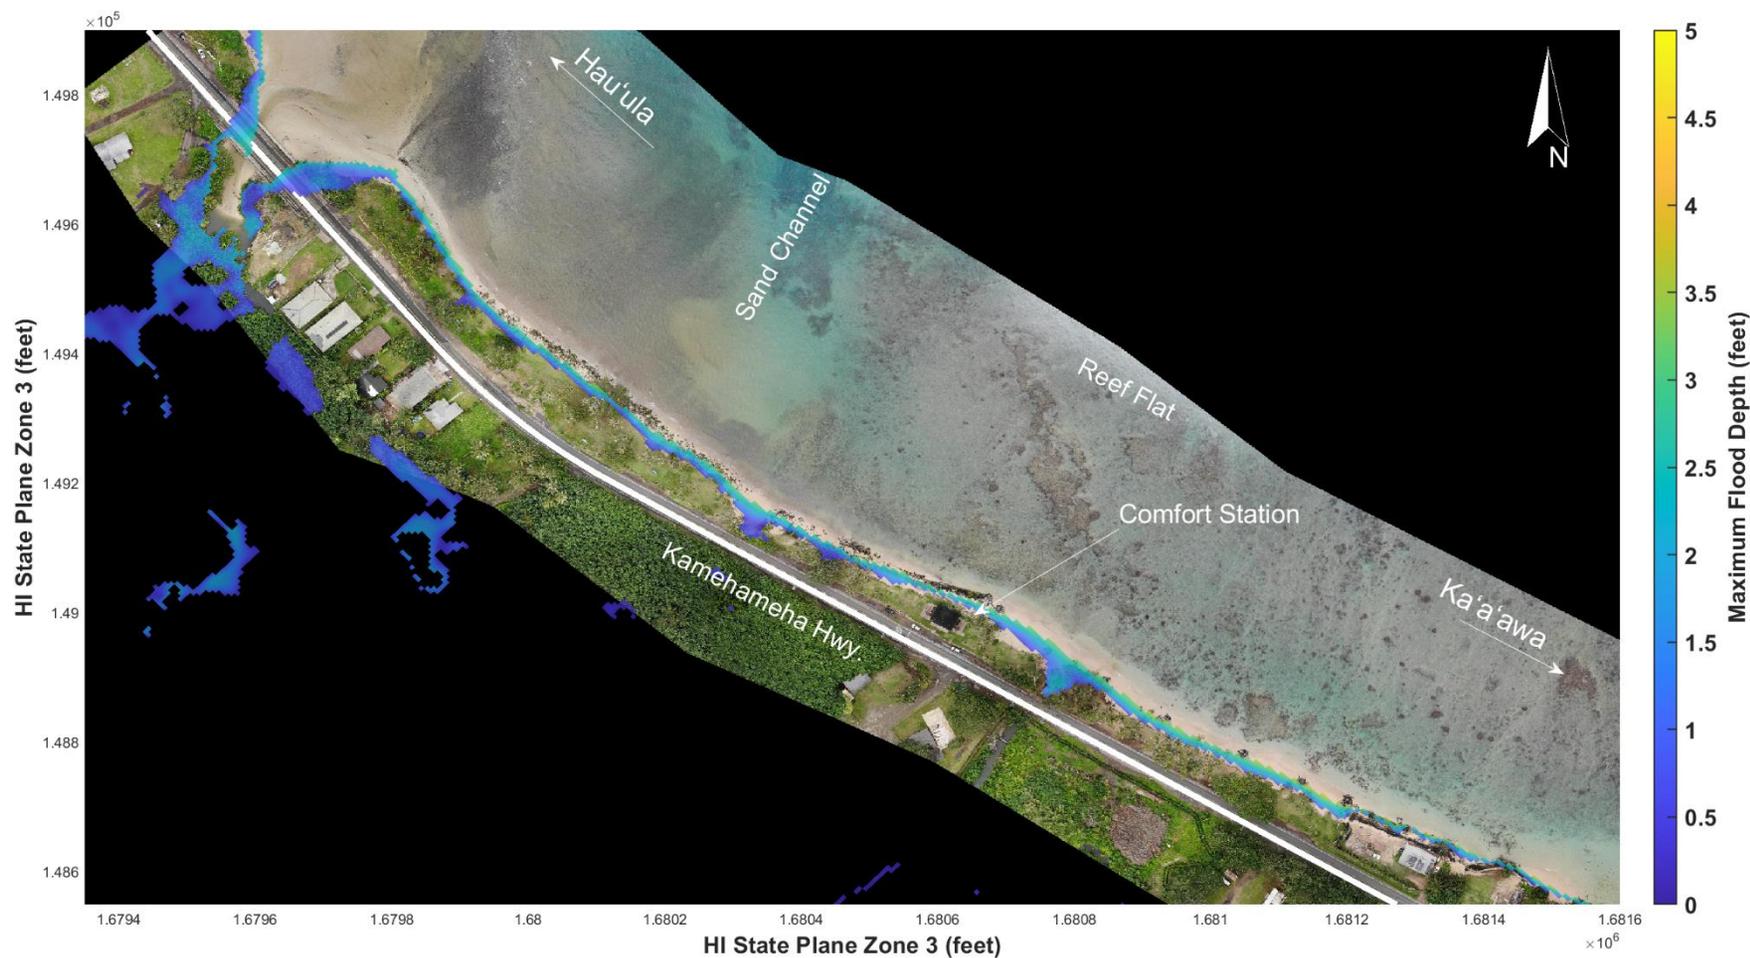
Figure 11-11. Maximum modeled flood depth for existing conditions with +1.6 ft of SLR during a prevailing wave event

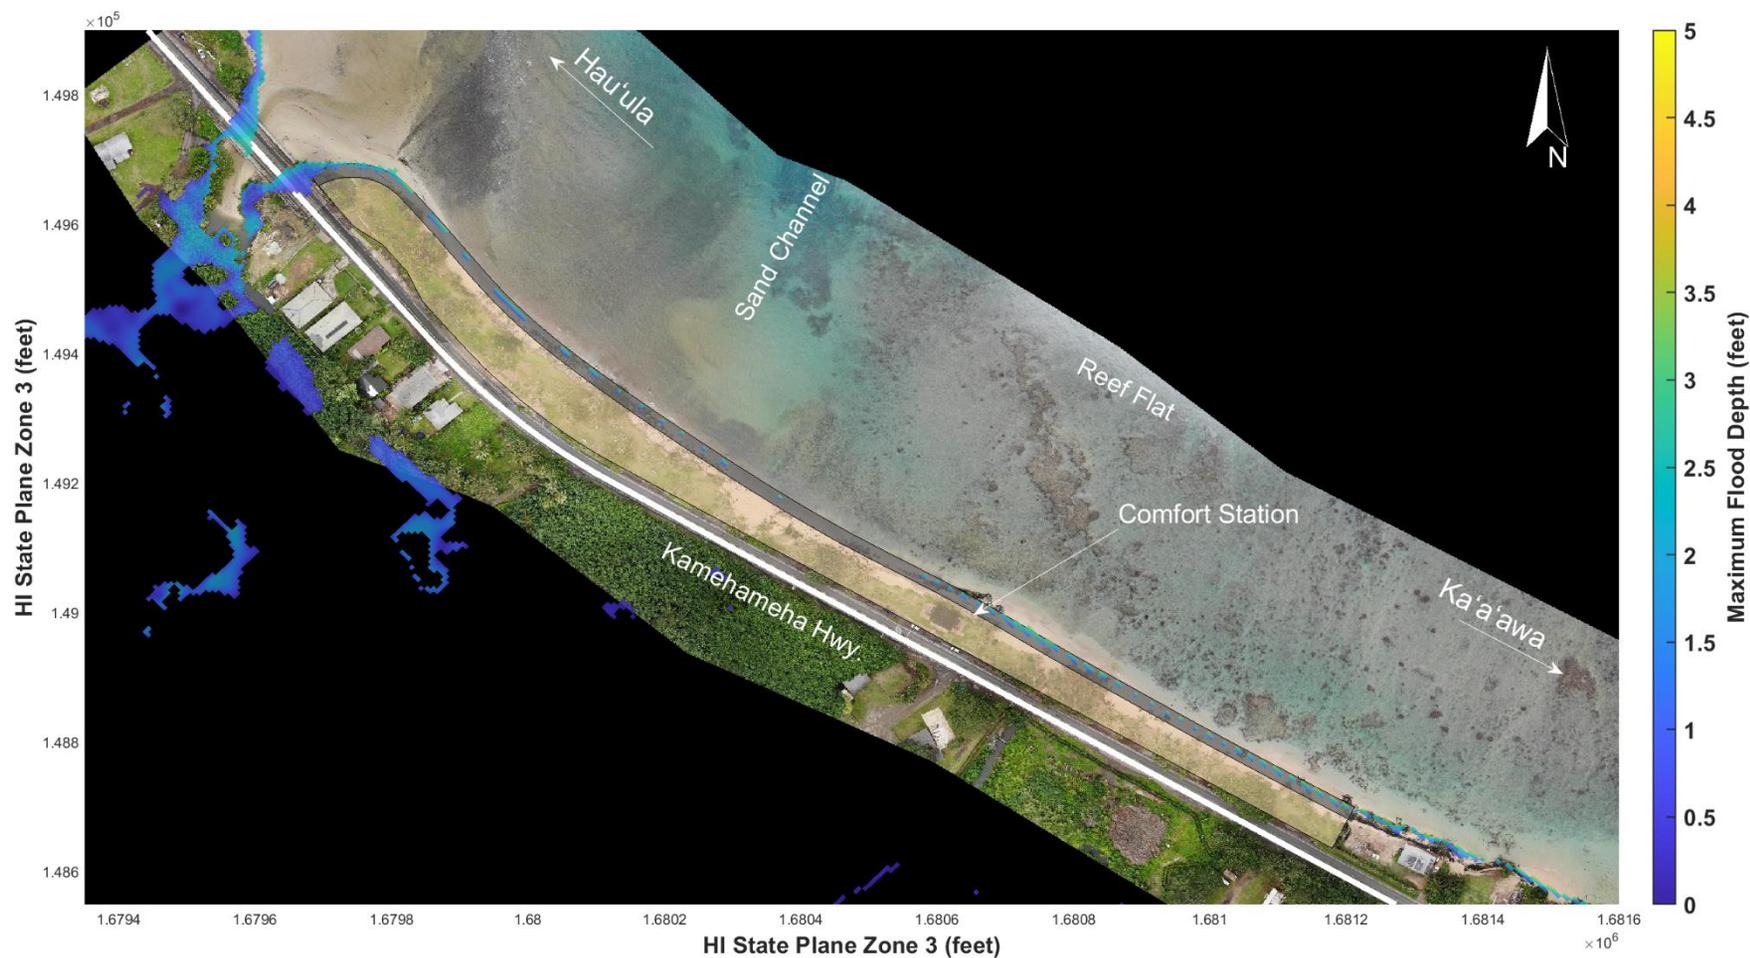
Figure 11-12. Maximum modeled flood depth for the revetement concept with +1.6 ft of SLR during a prevailing wave event

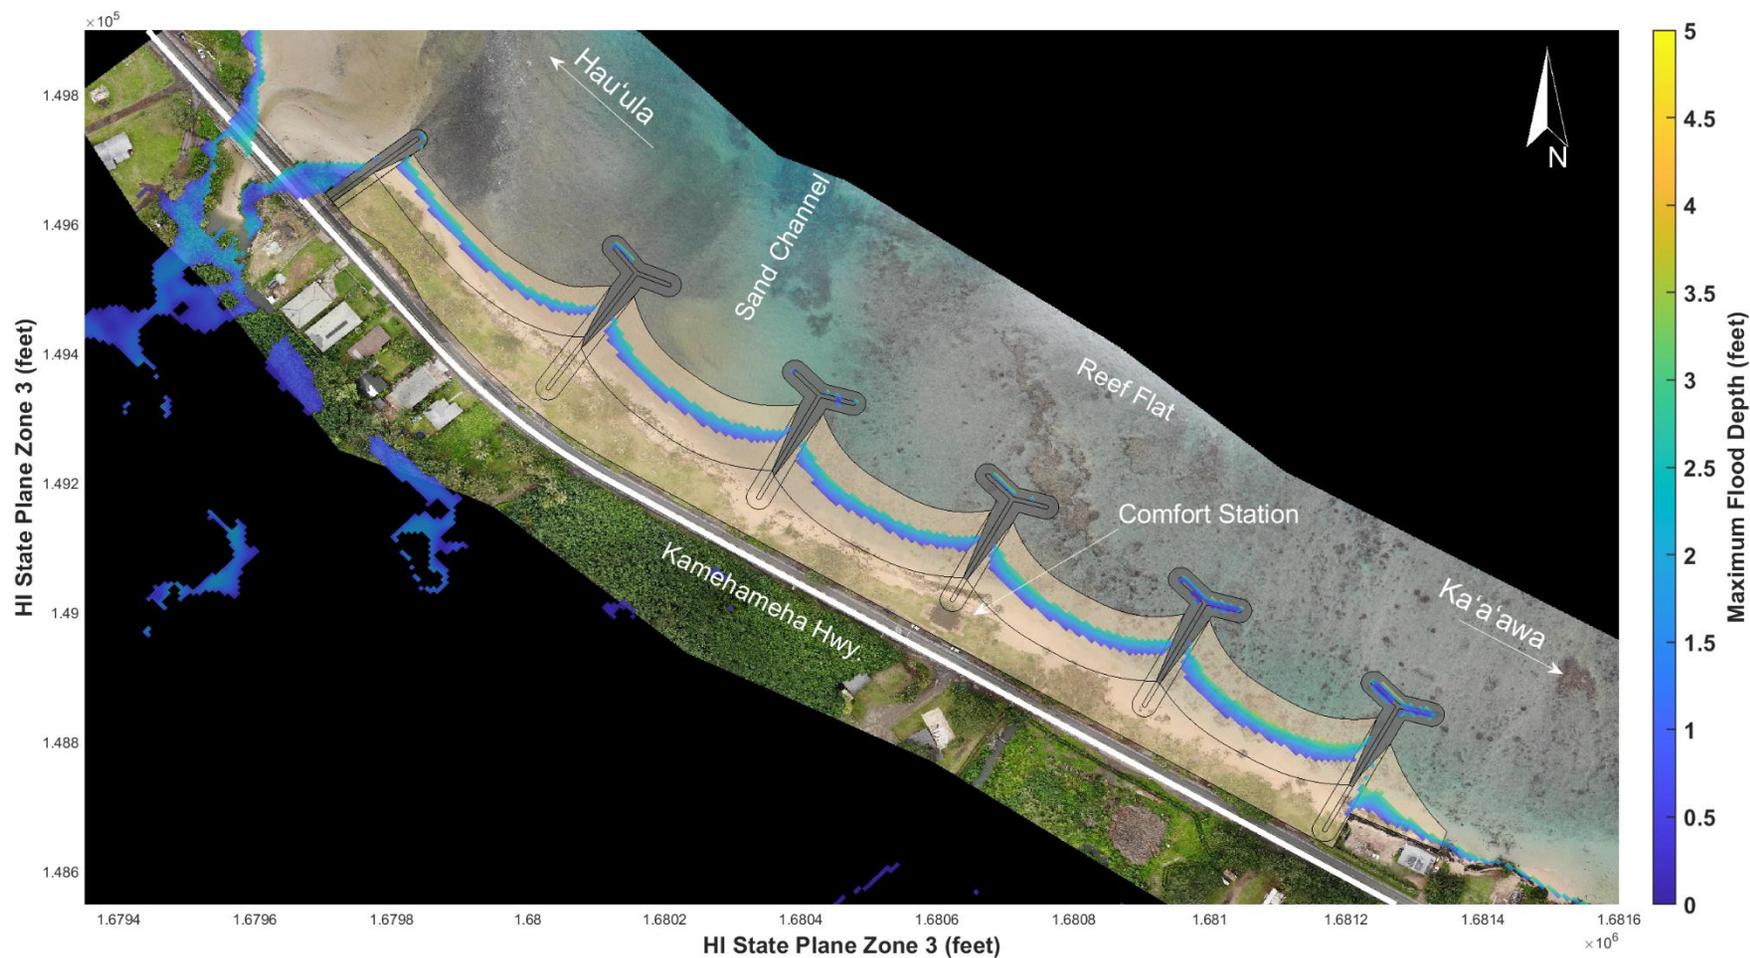
Figure 11-13. Maximum modeled flood depth for stabilized pocket beaches concept with +1.6 ft of SLR during a prevailing wave event

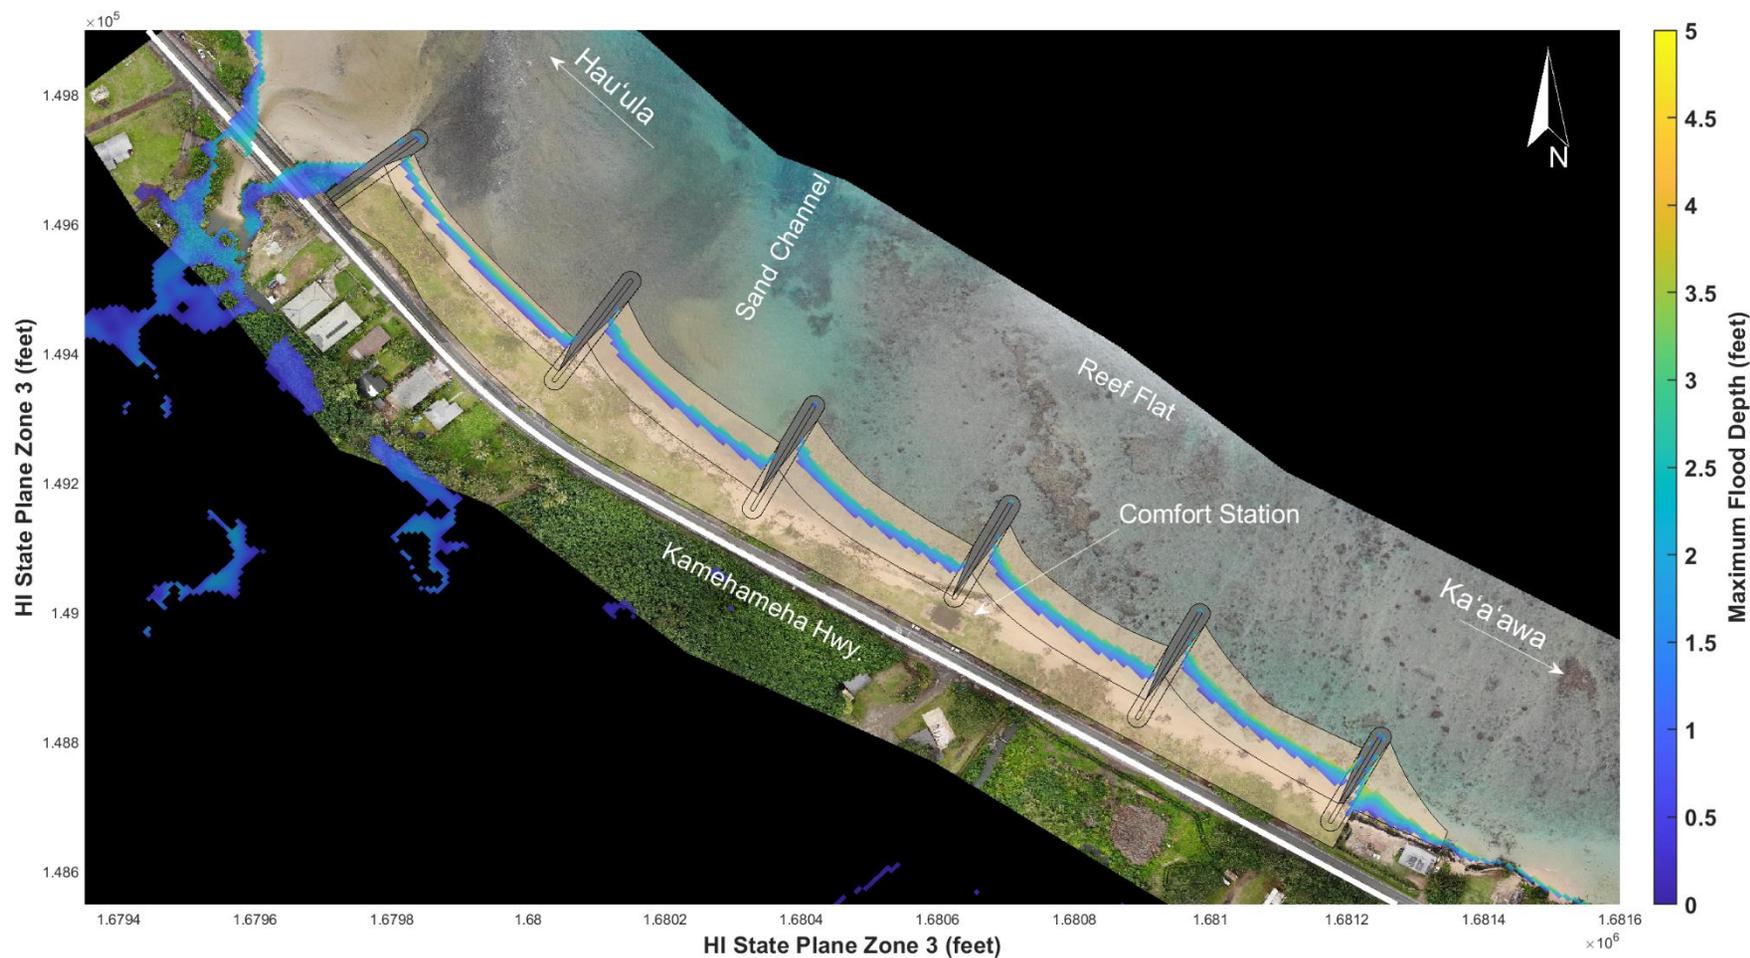
Figure 11-14. Maximum modeled flood depth for the partially stabilized pocket beaches concept with +1.6 ft of SLR during a prevailing wave event

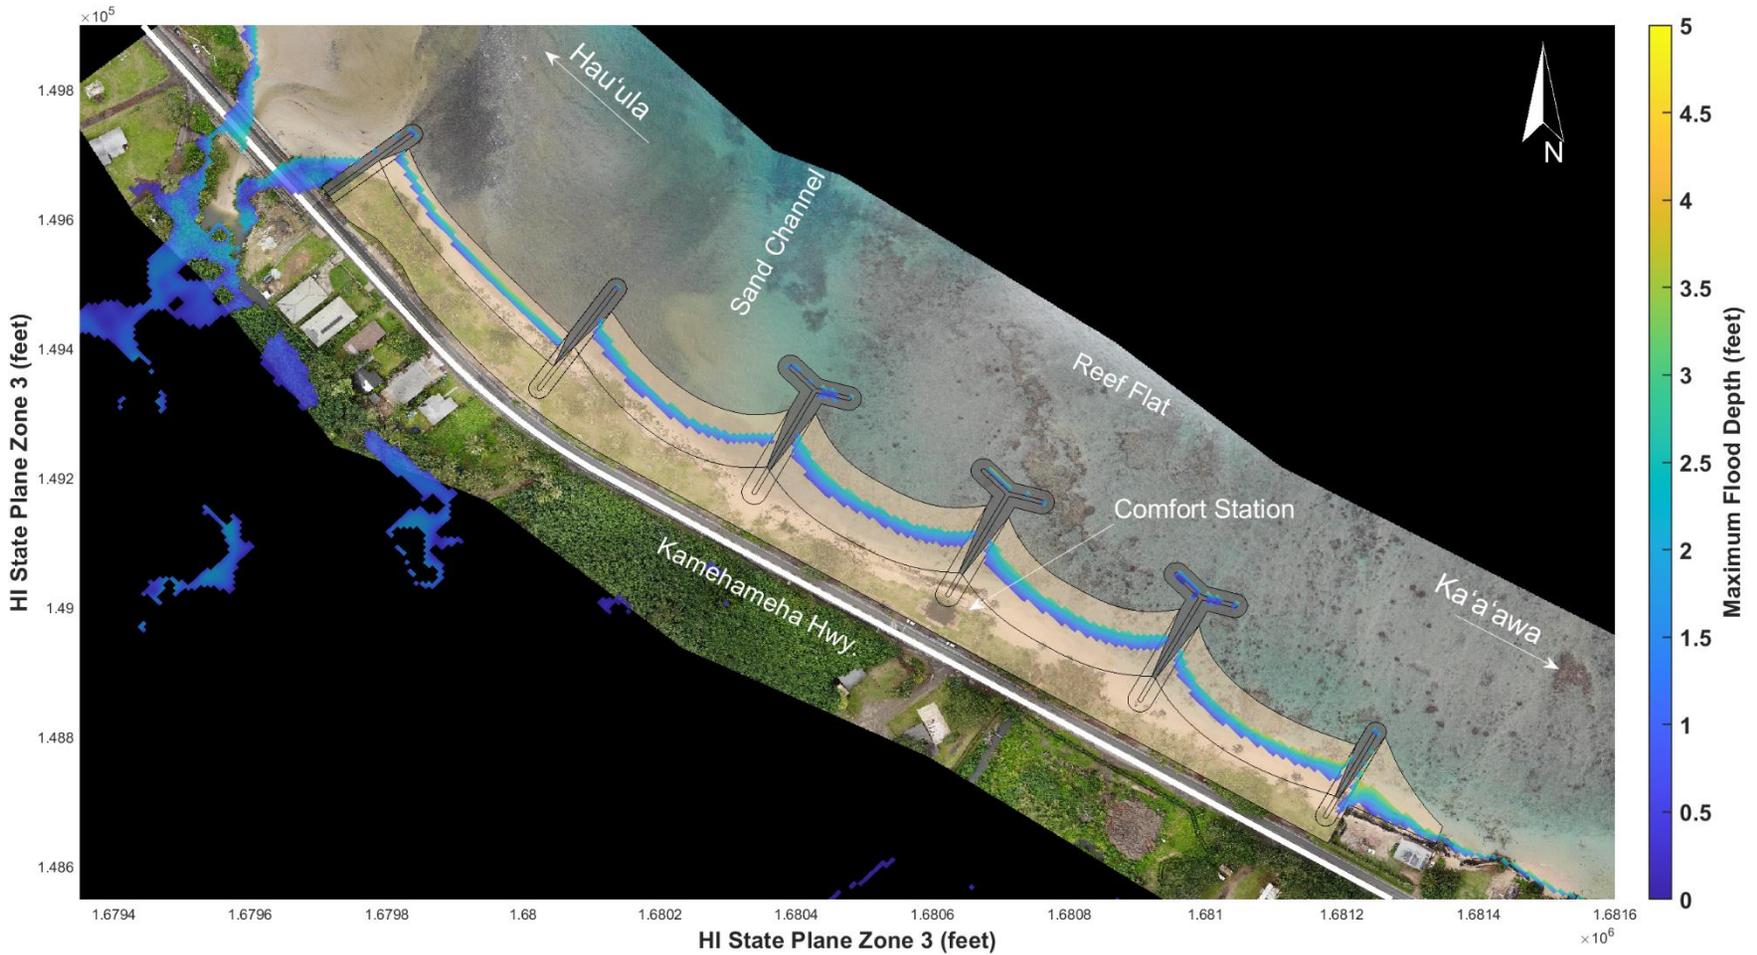
Figure 11-15. Maximum modeled flood depth for the hybrid stabilized pocket beaches concept with +1.6 ft of SLR during a prevailing wave event

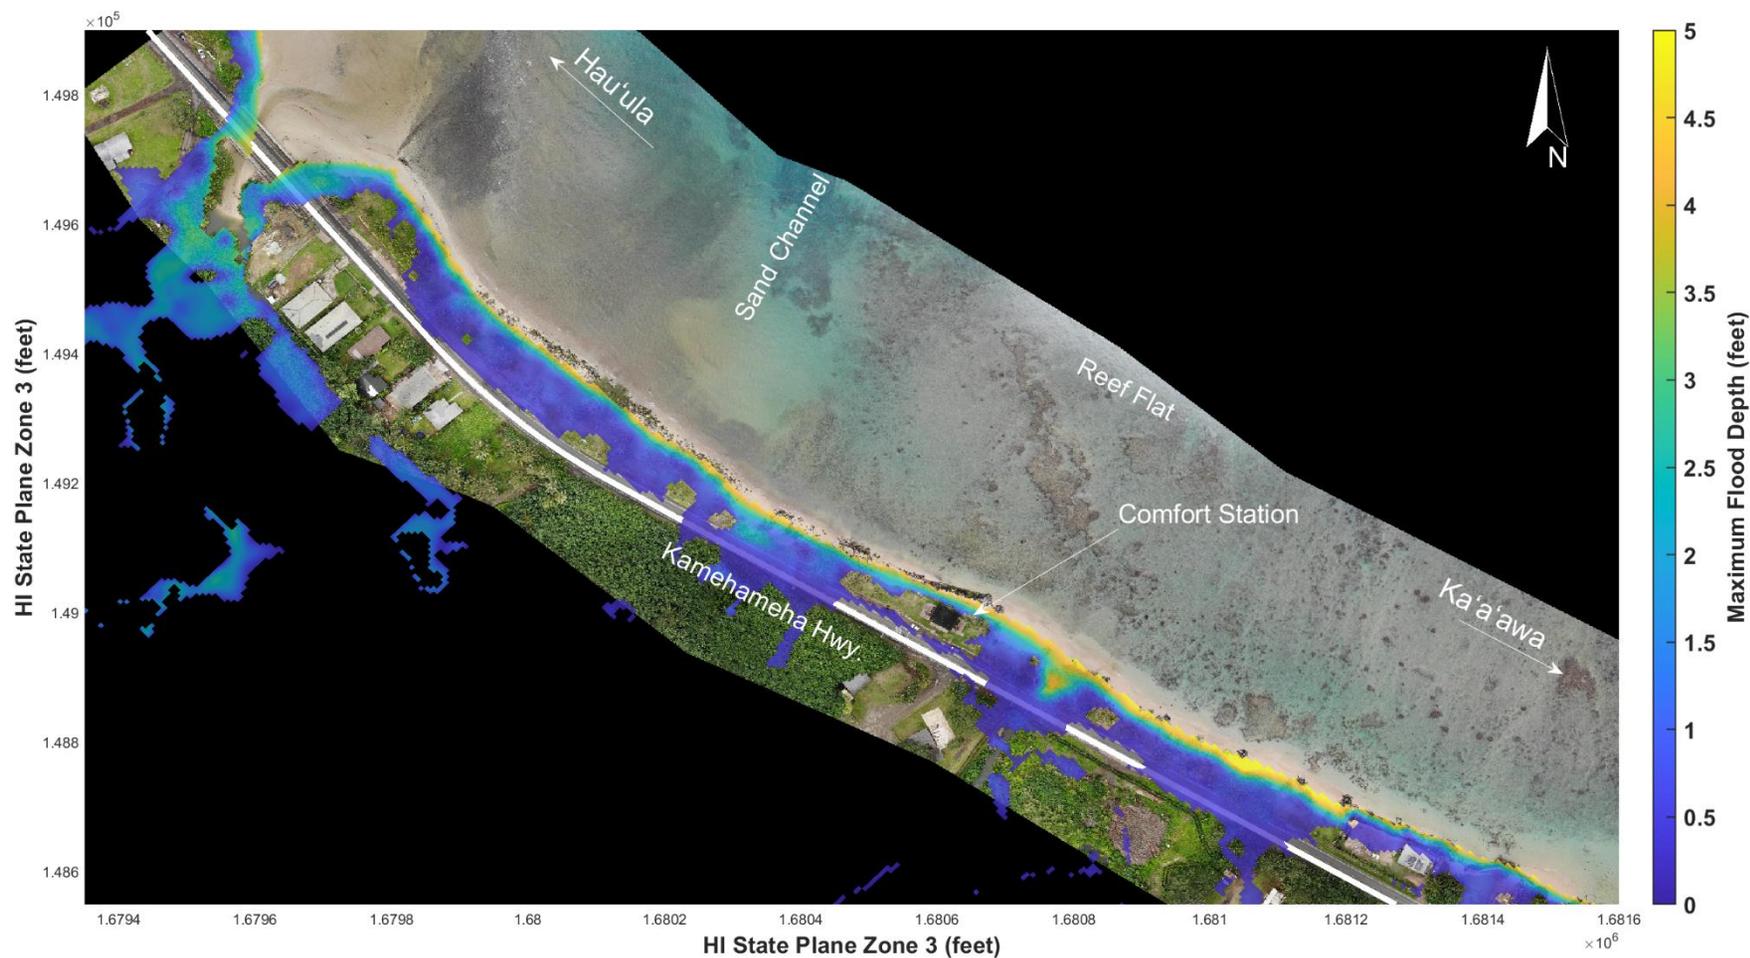
Figure 11-16. Maximum modeled flood depth for existing conditions with +1.6 ft of SLR during an annual wave event

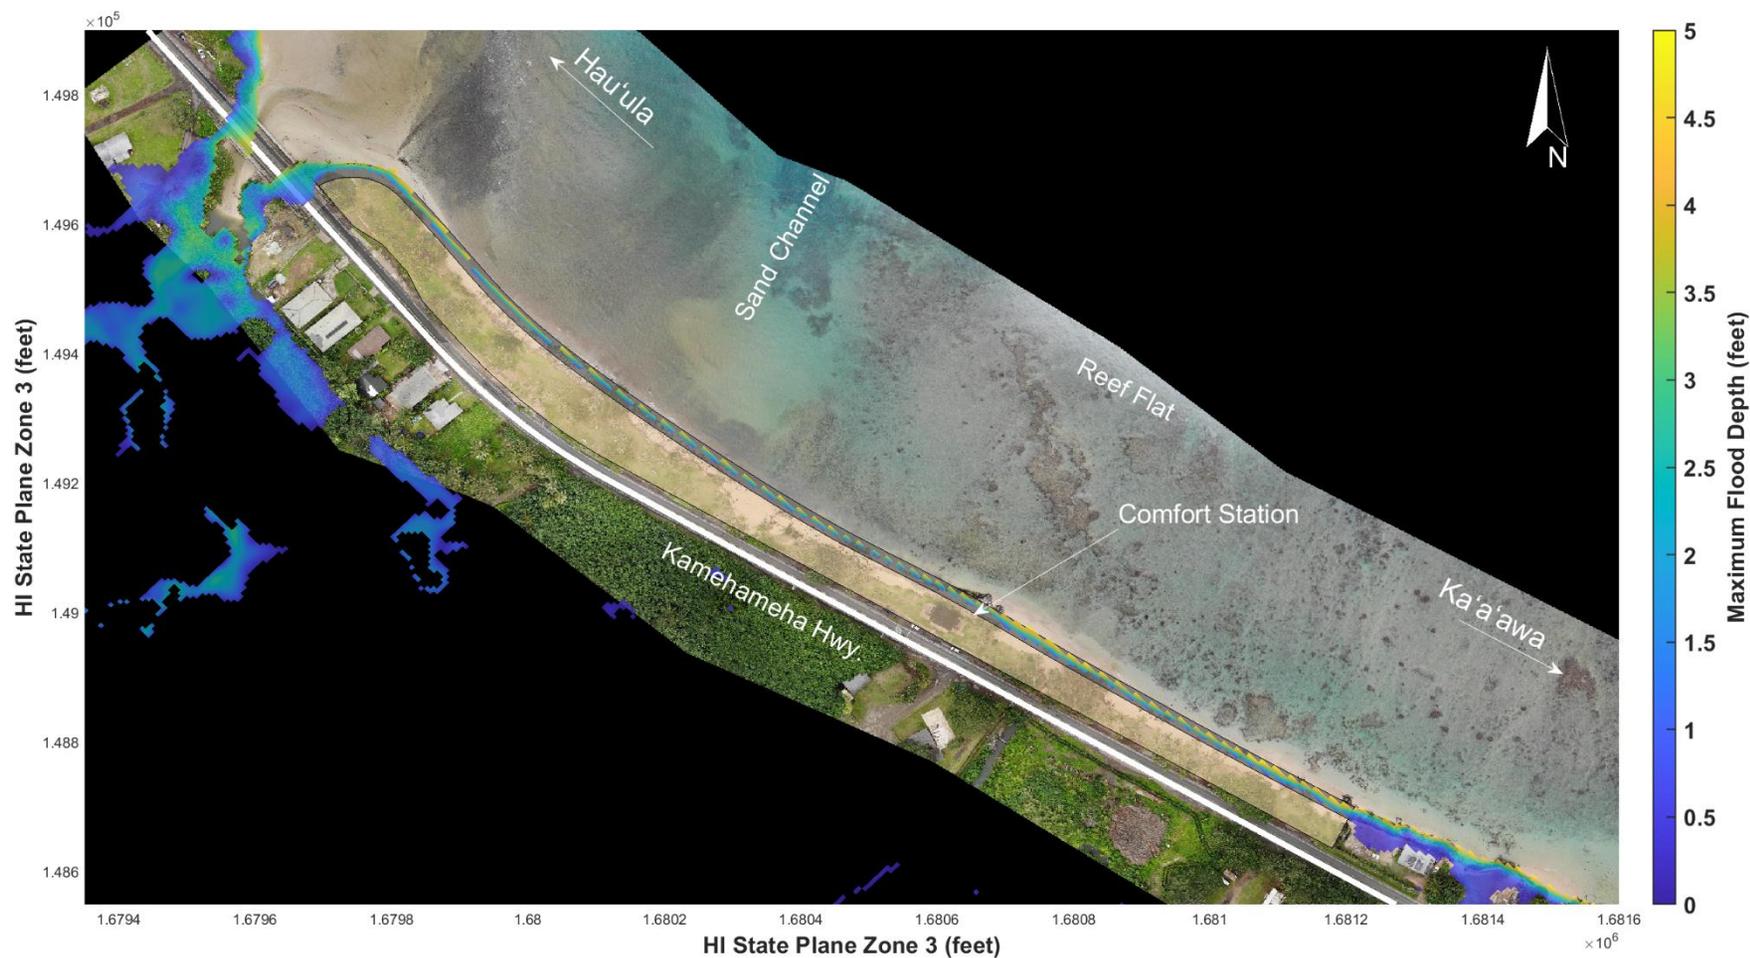
Figure 11-17. Maximum modeled flood depth for the revetment concept with +1.6 ft of SLR during an annual wave event

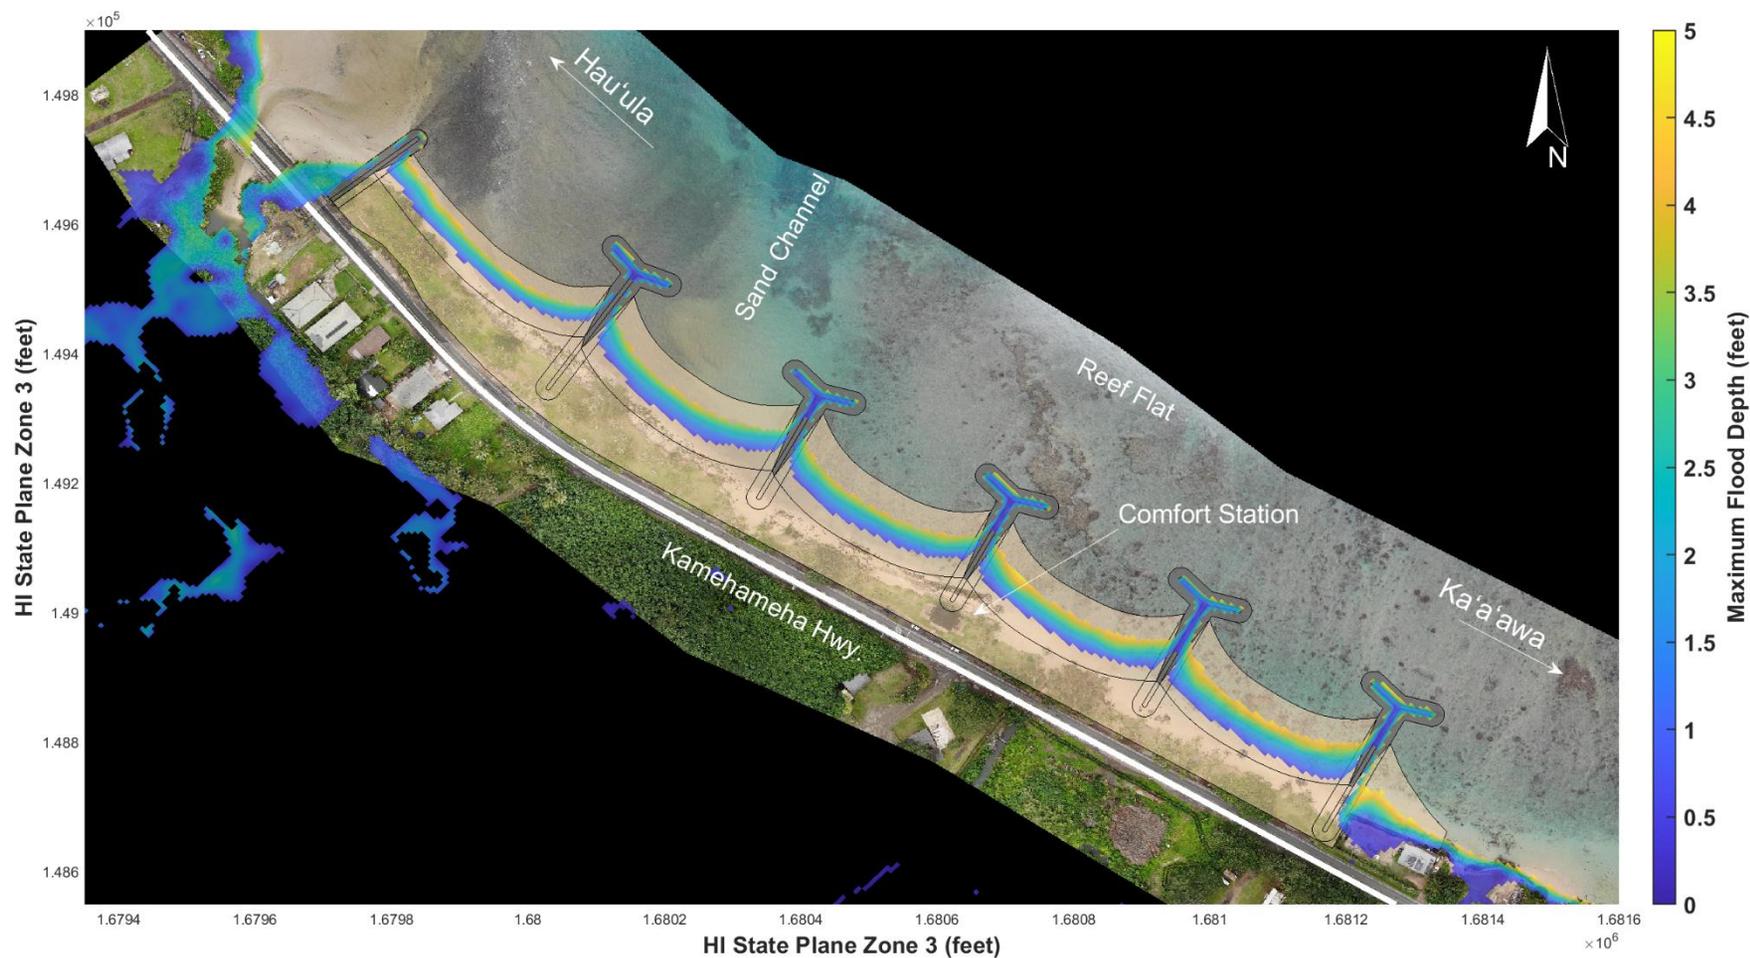
Figure 11-18. Maximum modeled flood depth for stabilized pocket beaches concept with +1.6 ft of SLR during an annual wave event

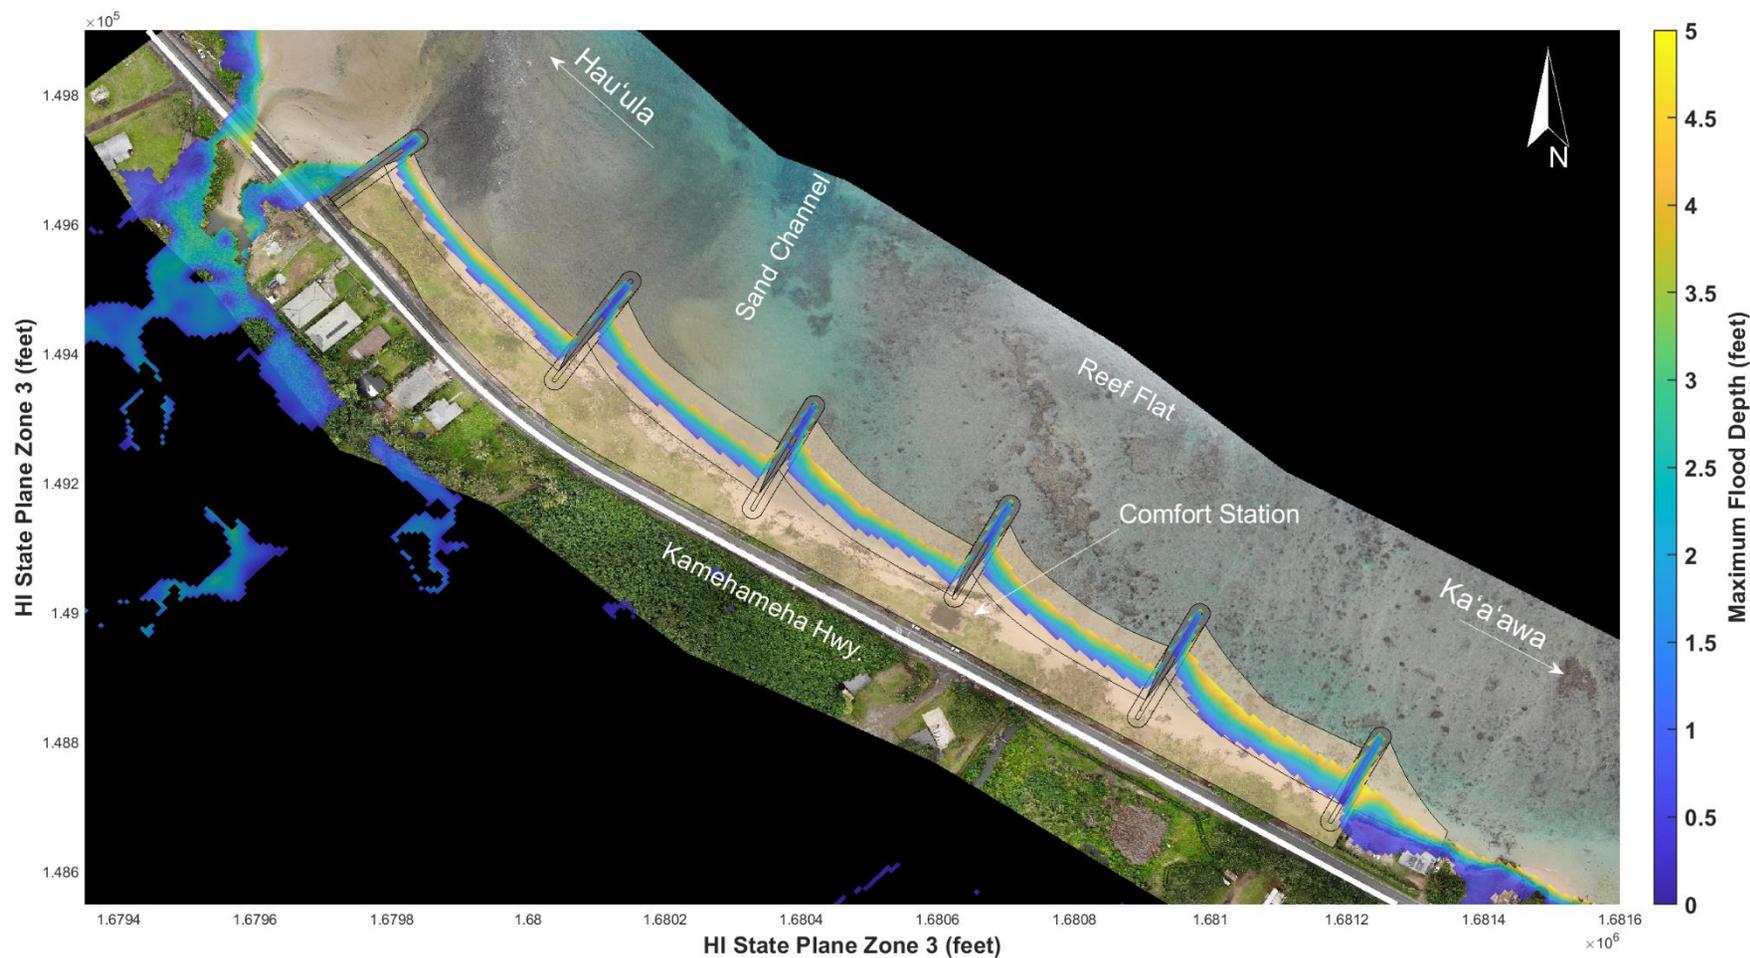
Figure 11-19. Maximum modeled flood depth for the partially stabilized pocket beaches concept with +1.6 ft of SLR during an annual wave event

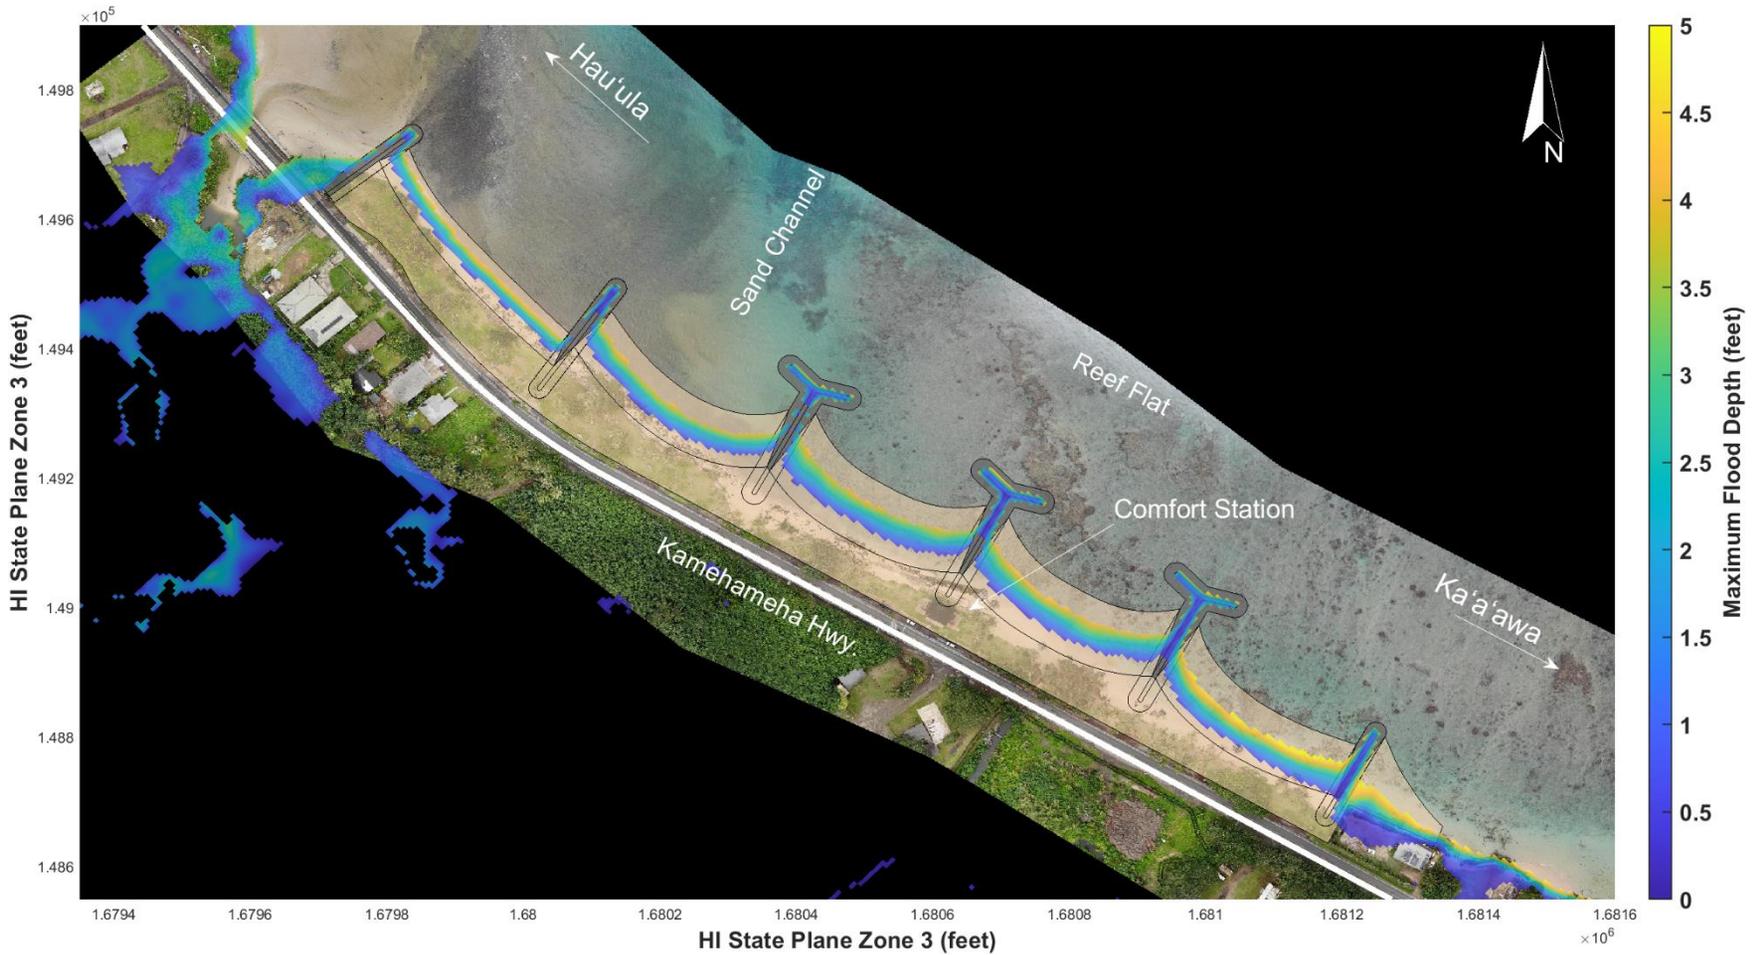
Figure 11-20. Maximum modeled flood depth for the hybrid stabilized pocket beaches concept with +1.6 ft of SLR during an annual wave event

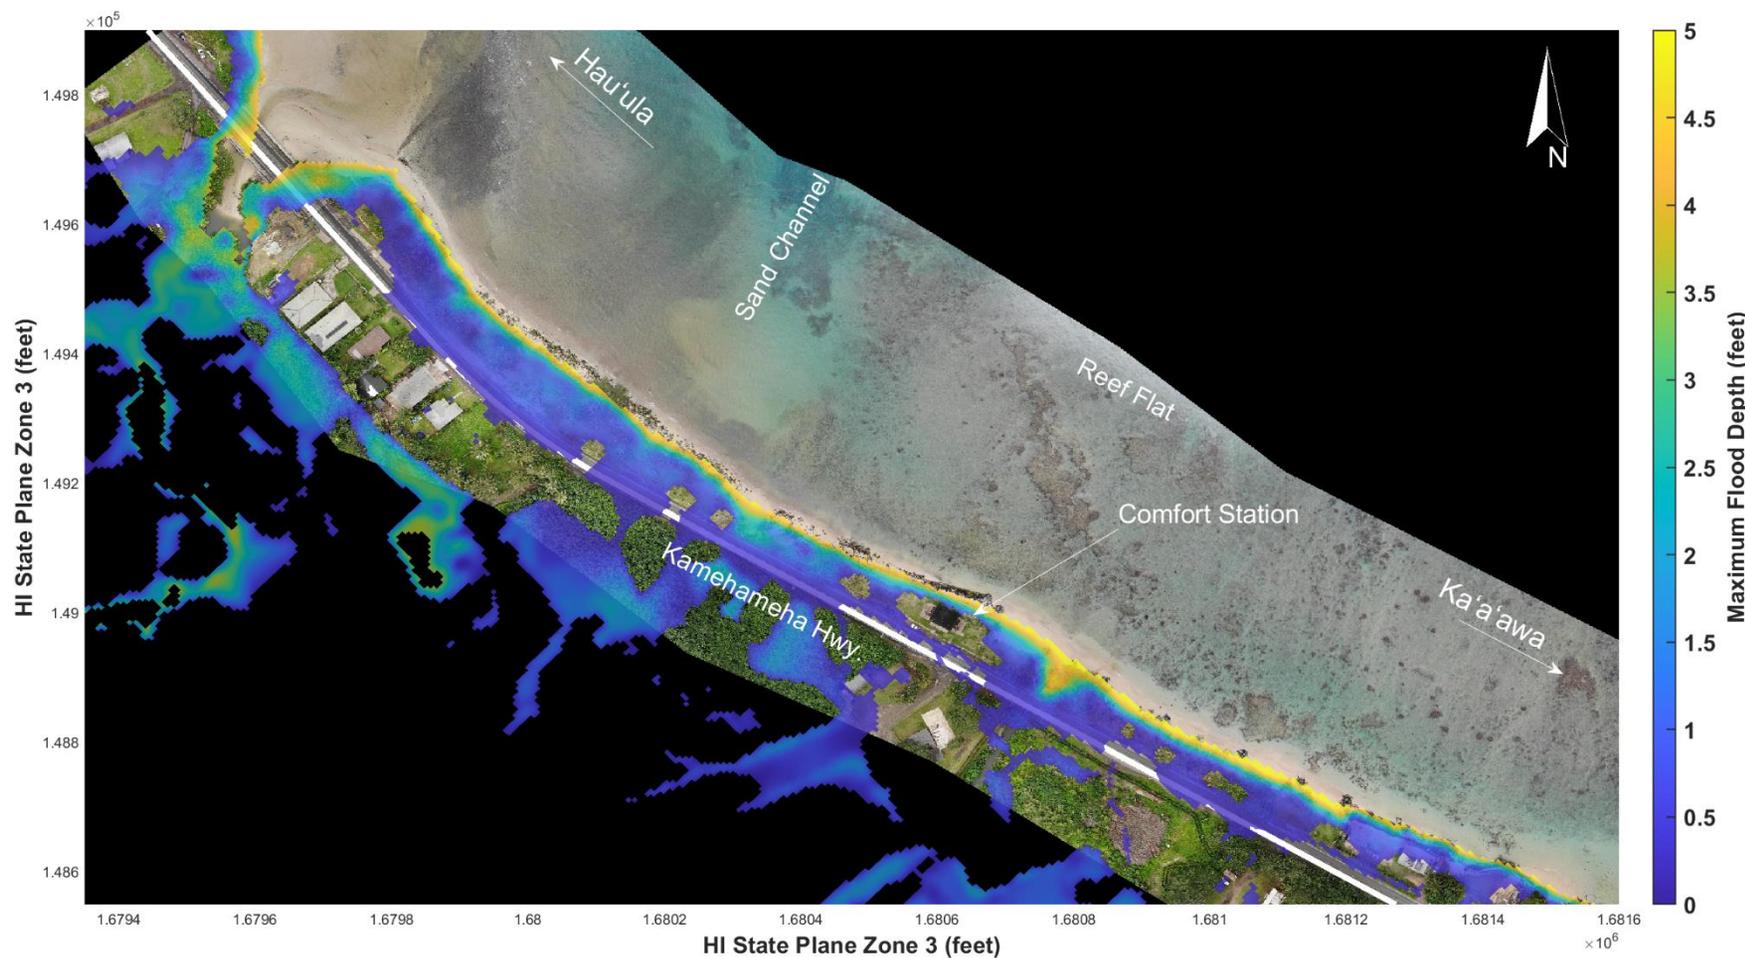
Figure 11-21. Maximum modeled flood depth for existing conditions with +3.2 ft of SLR during a prevailing wave event

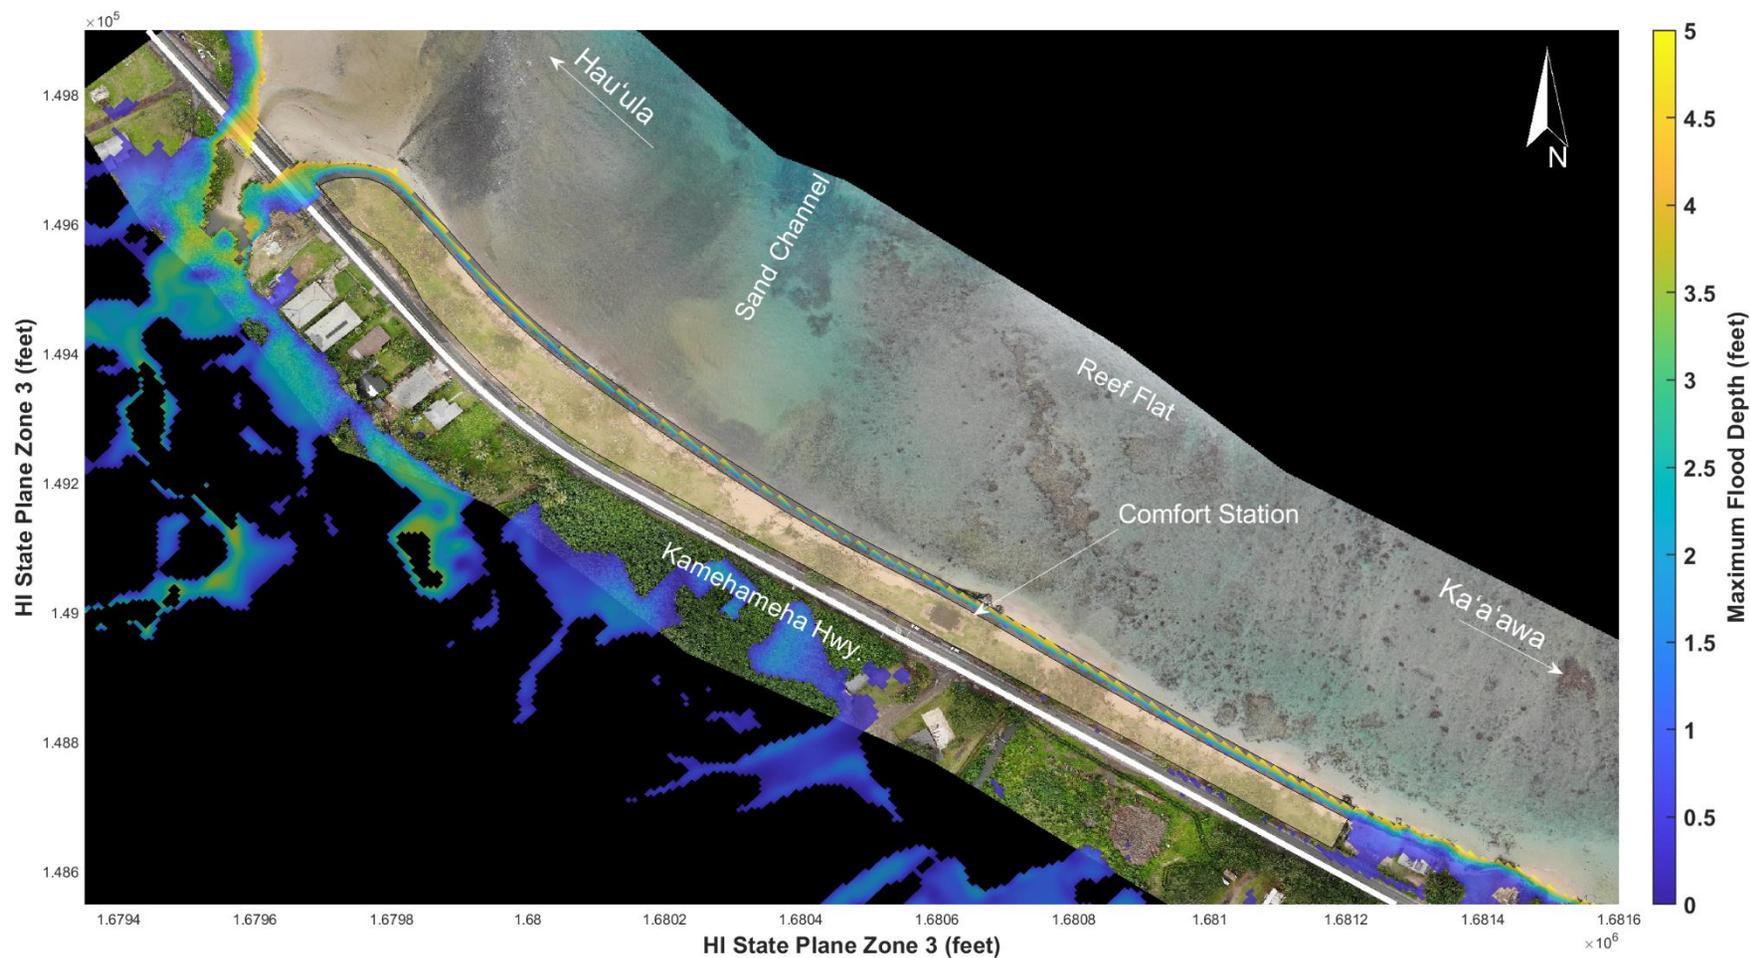
Figure 11-22. Maximum modeled flood depth for the revetment concept with +3.2 ft of SLR during a prevailing wave event
