Punalu‘u Beach Restoration Feasibility Study

Punalu‘u Beach Park, O‘ahu

April 2024

Sea Engineering, Inc.
Makai Research Pier
41-305 Kalaniana‘ole Hwy
Waimānalo, Hawai‘i 96795

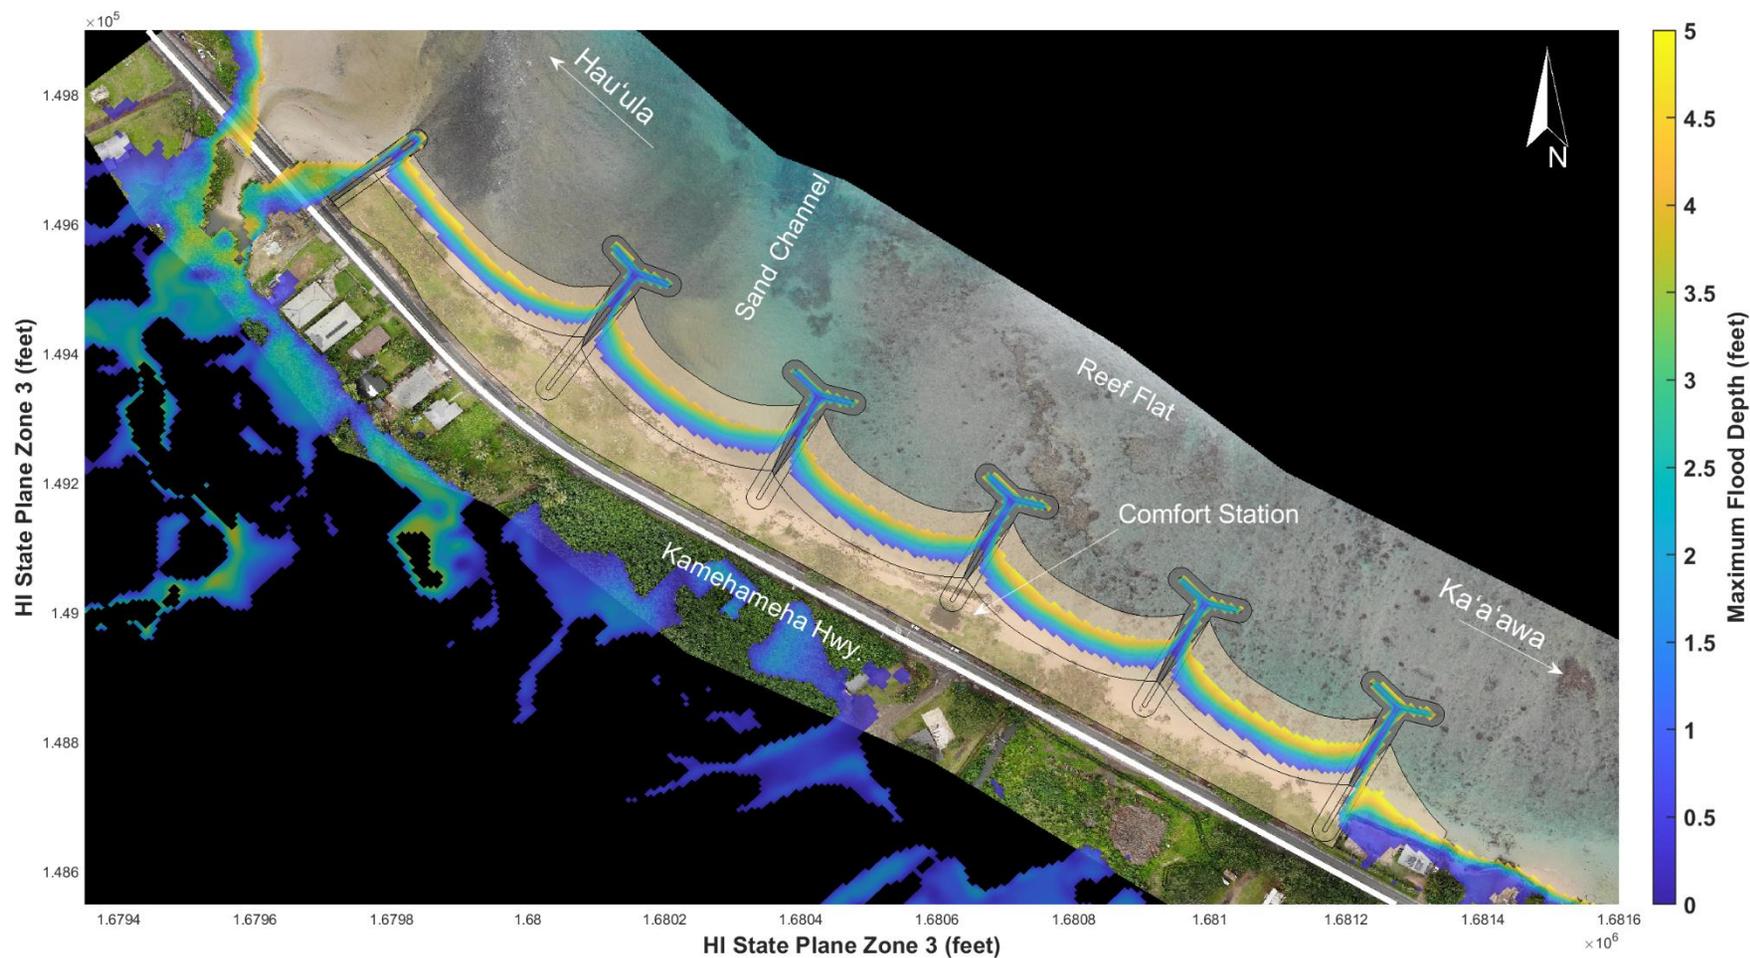
Figure 11-23. Maximum modeled flood depth for the stabilized pocket beaches concept with +3.2 ft of SLR during a prevailing wave event

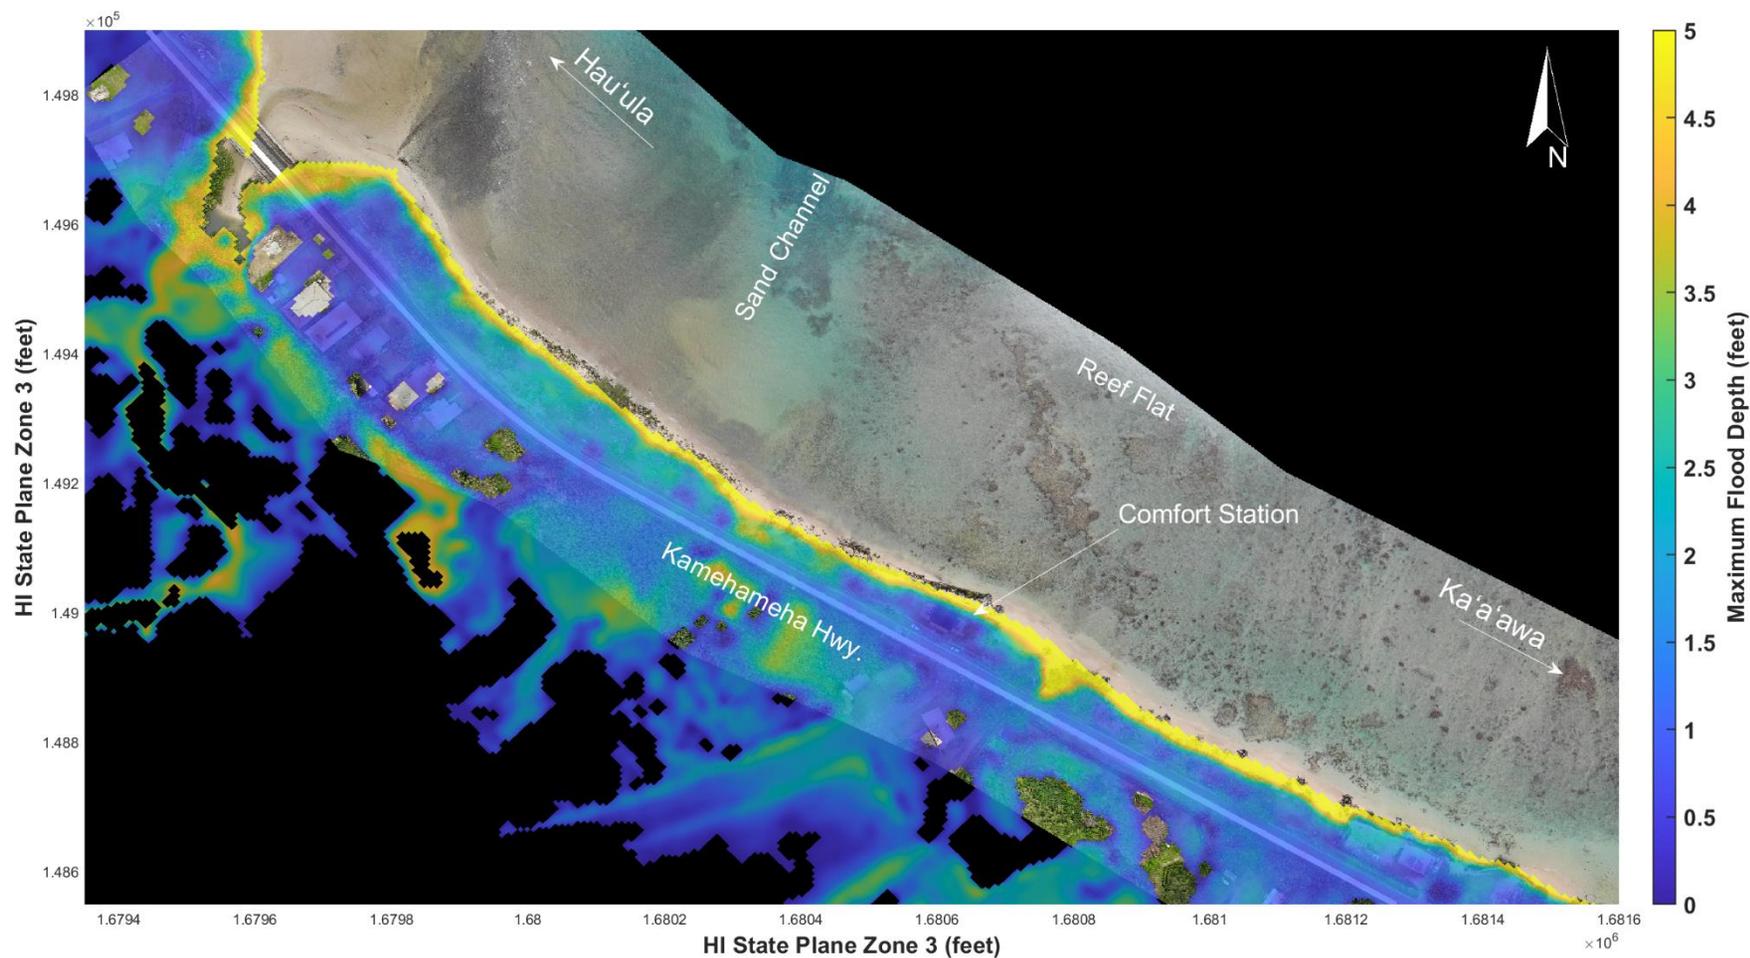
Figure 11-26. Maximum modeled flood depth for existing conditions with +3.2 ft of SLR during an annual wave event

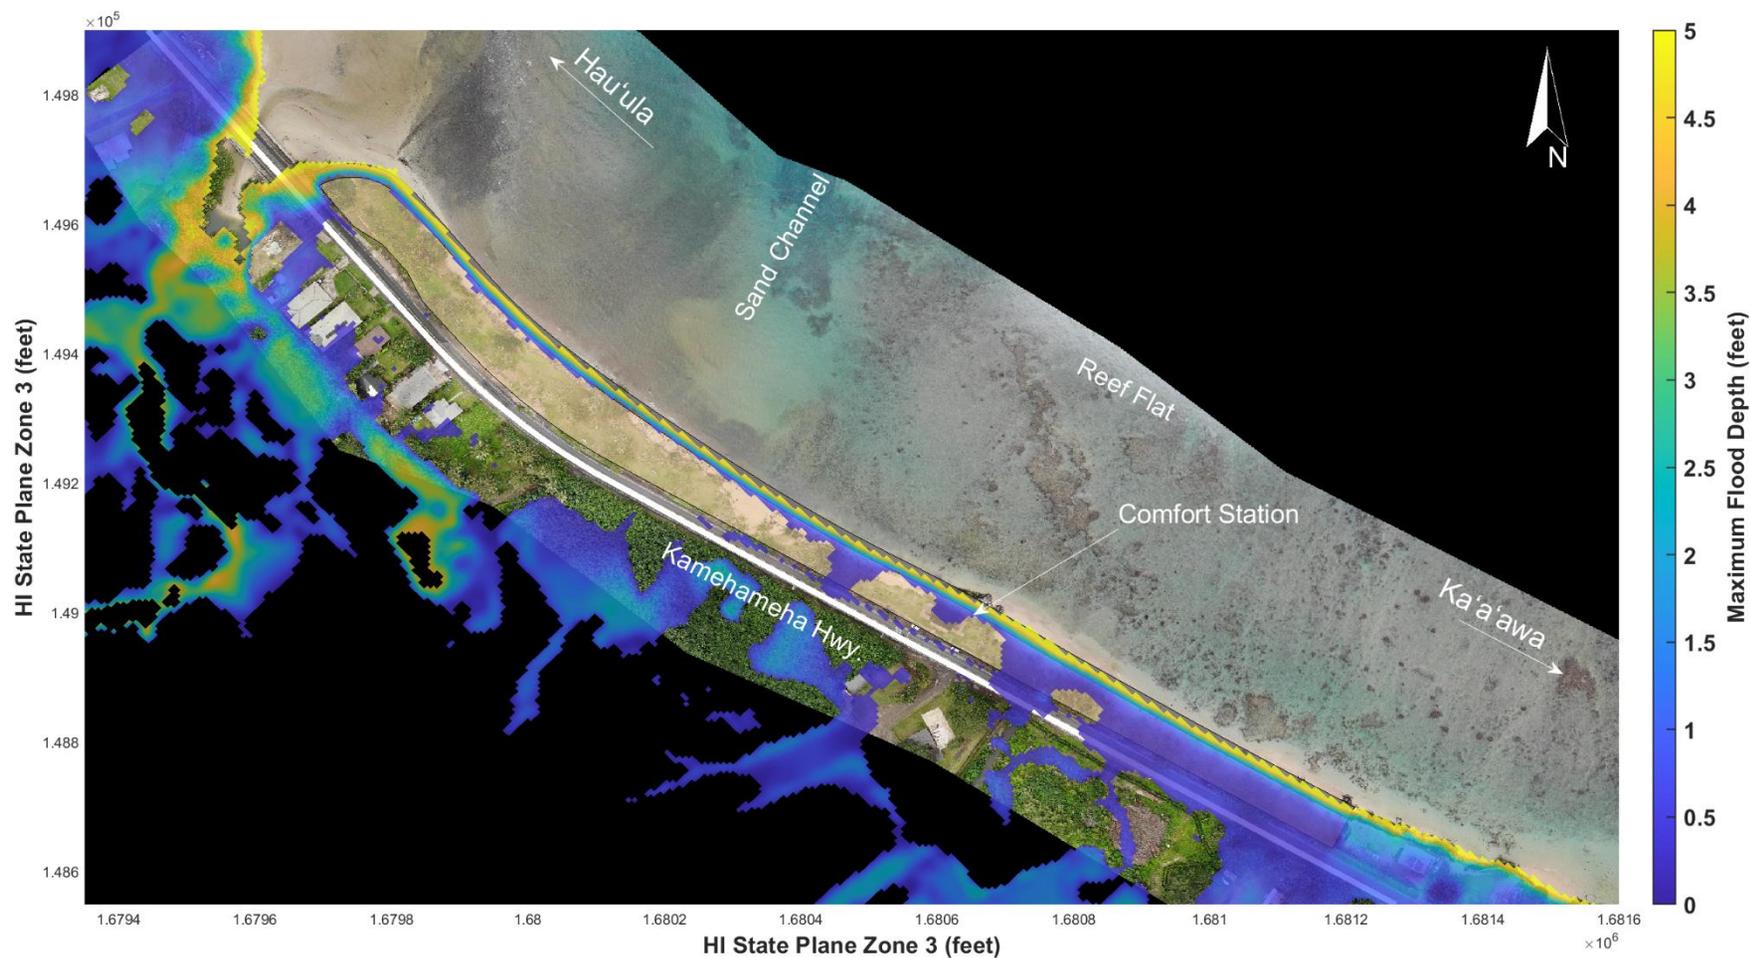
Figure 11-27. Maximum modeled flood depth for the revetment concept with +3.2 ft of SLR during an annual wave event

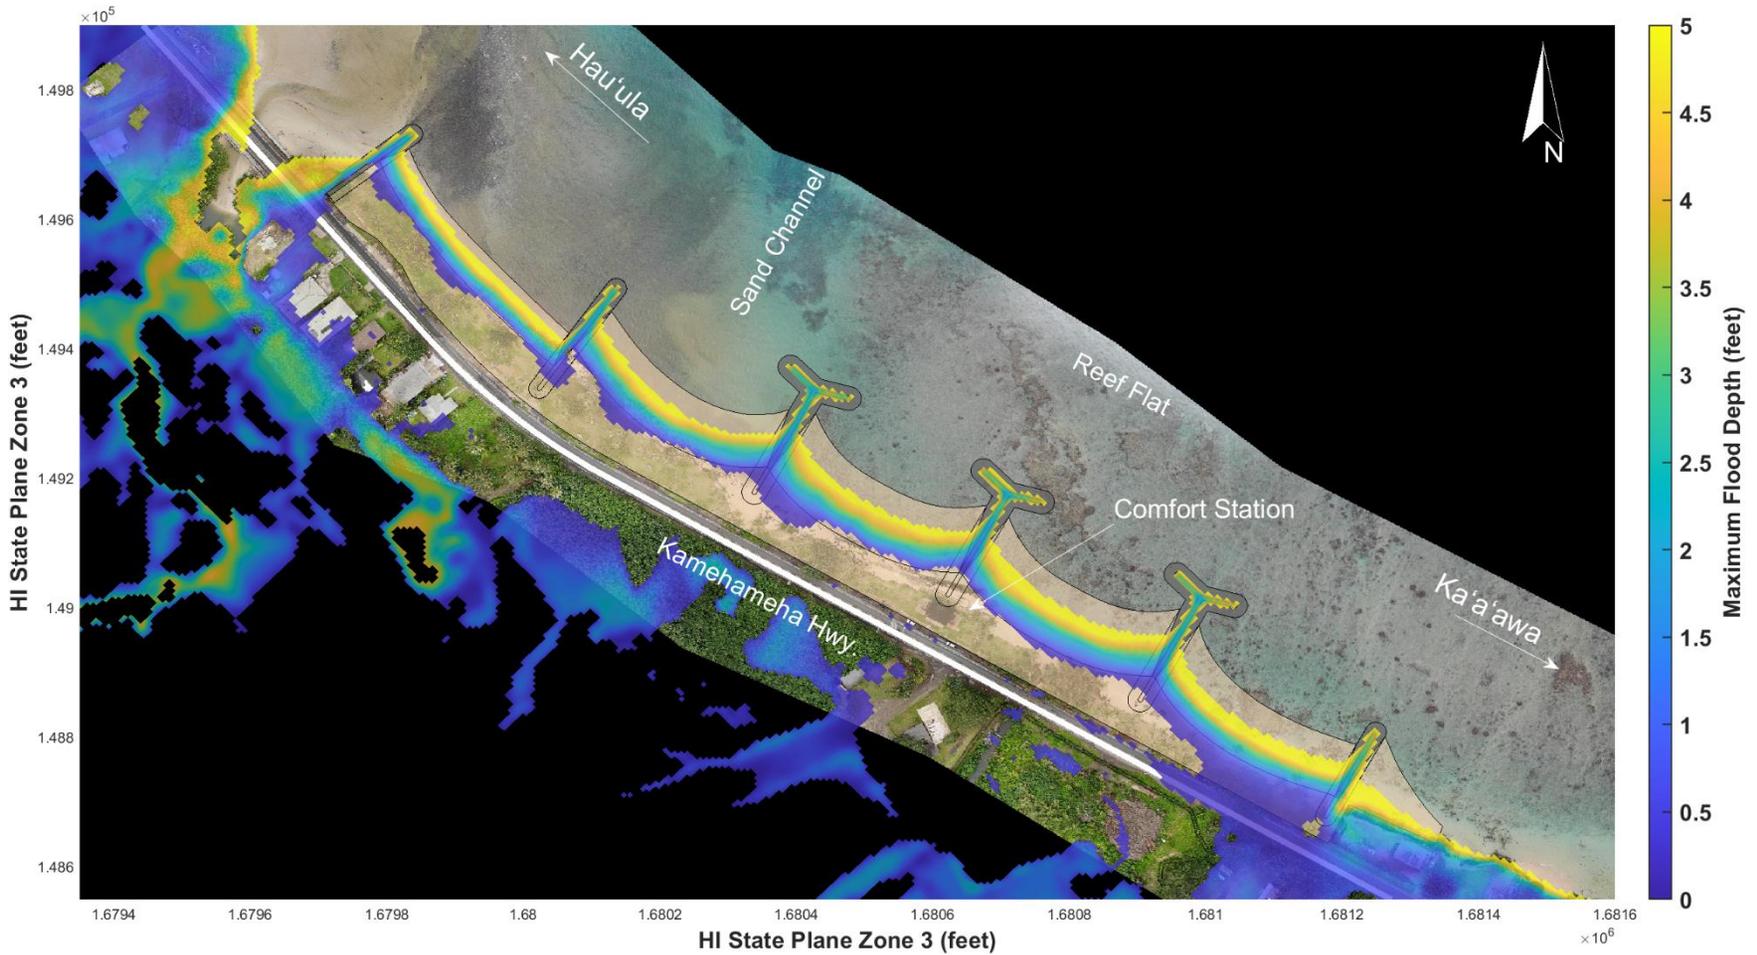
Figure 11-30. Maximum modeled flood depth for the hybrid stabilized pocket beaches concept with +3.2 ft of SLR during an annual wave event

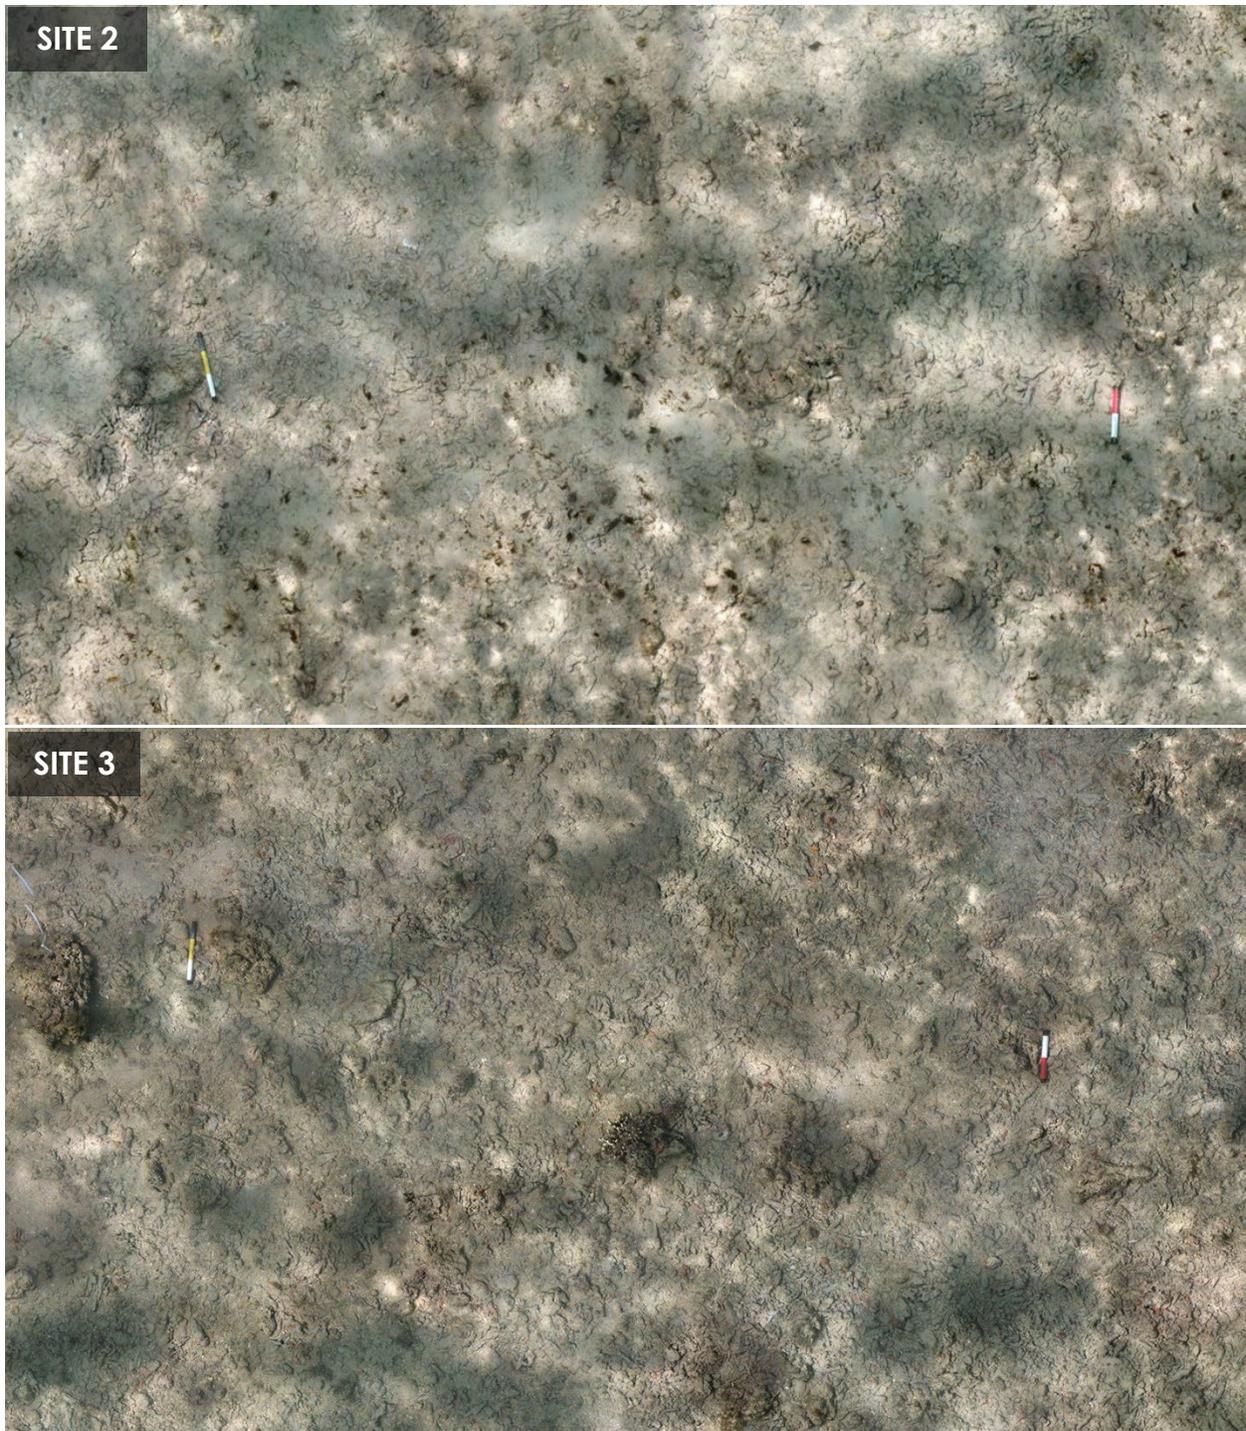
Figure 14 Orthomosaics at Permanent Monitoring Sites 2 and 3.
